Door failure and depressurisation involving a Cessna 441, VH-LBY

near Broome, Western Australia, on 22 July 2020

ATSB Transport Safety Report
Aviation Occurrence Investigation
AO-2020-036
[Final – 30/06/2021]

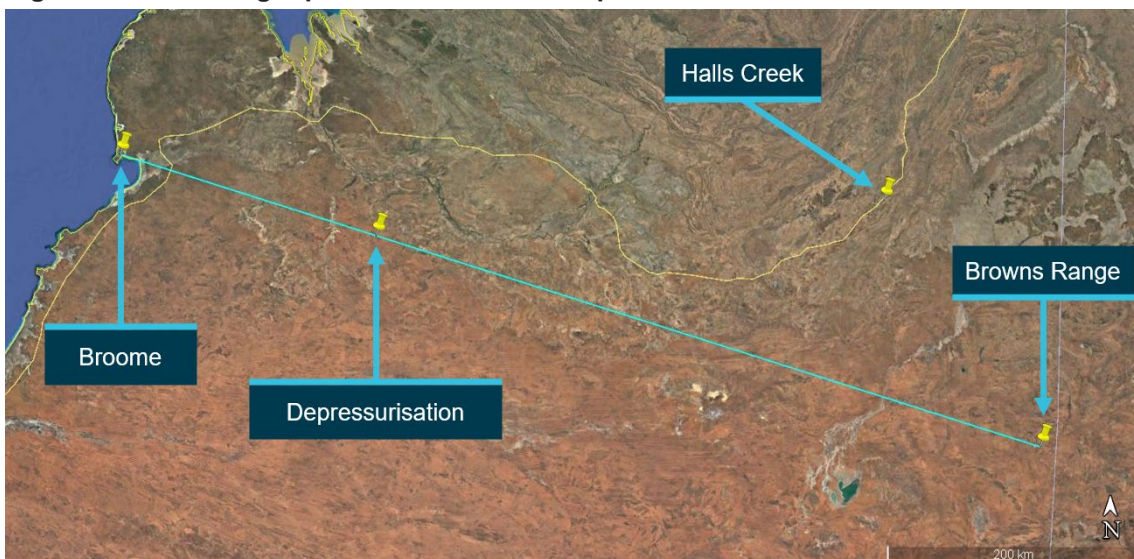
Figure 1: VH-LBY flight path and location of depressurisation

At about the same time the PIC was checking the warning light for the emergency pressurisation valve, the cabin altitude warning light and aural beeping tone activated. The PIC noted the cabin altitude gauge passing 25,000 ft, while the observation pilot (OP) in the right seat recalled observing about 27,000 ft, indicating a rapid depressurisation of the cabin. The pilots donned their emergency oxygen masks and the PIC initiated an emergency descent. The OP retrieved the emergency checklist and contacted air traffic control (ATC) to request a descent to FL 120. Figure 1 below depicts the incident flight path from Broome to Browns Range and approximate location of the depressurisation.
