Loss of control and collision with terrain involving de Havilland DH82A Tiger Moth, VH-UZB

Pimpama Airfield, Queensland, 28 December 2015

ATSB Transport Safety Report
Aviation Occurrence Investigation
AO-2015-150
Final – 1 March 2019

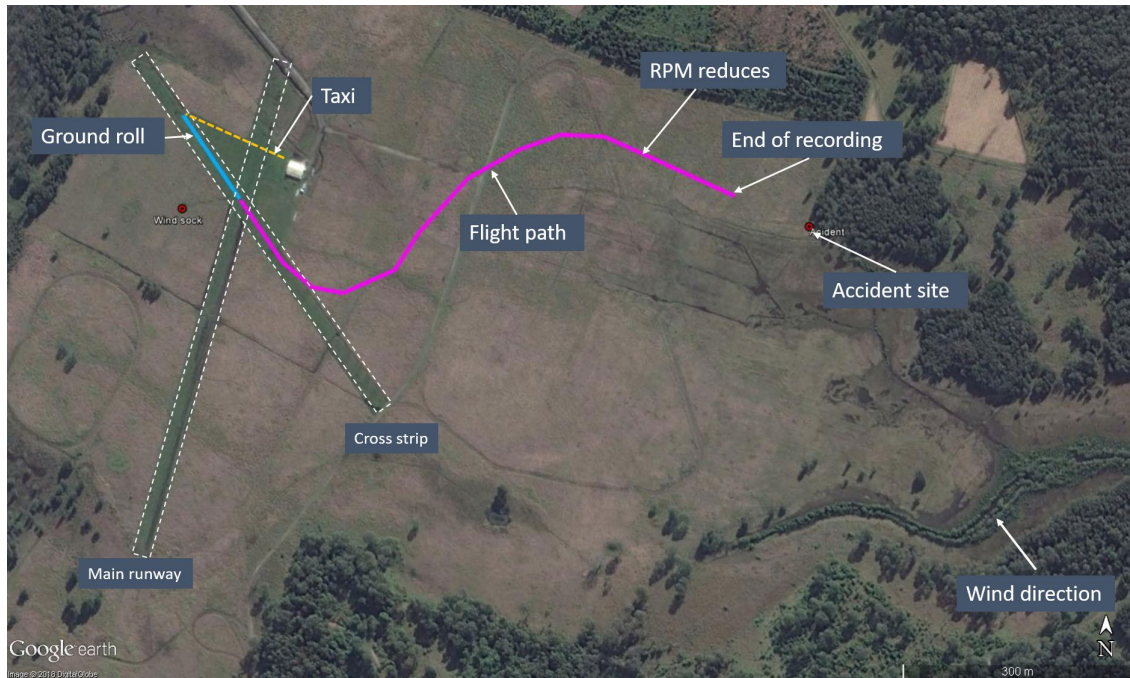
Figure 1: Flight path of the aircraft

The yellow dotted line indicates the aircraft's taxi, the blue line the ground roll and the pink the flight path, based on analysis of the on-board video recording (the recording stopped before the accident).

About 27 seconds after lift-off, when the aircraft was travelling approximately parallel to the take-off strip, the pilot observed a change in engine noise and a reduction in engine RPM.⁶ He reported that he retarded and then fully advanced the throttle but the engine only returned to a similar lower power condition.
