# Engine power loss and collision with terrain, Bell 206B3 helicopter, VH-FHW

107 km south-west of Jabiru, Northern Territory, on 21 May 2019

**ATSB Transport Safety Report**  
Aviation Occurrence Investigation (Defined)  
AO-2019-025  
Final – 26 February 2021

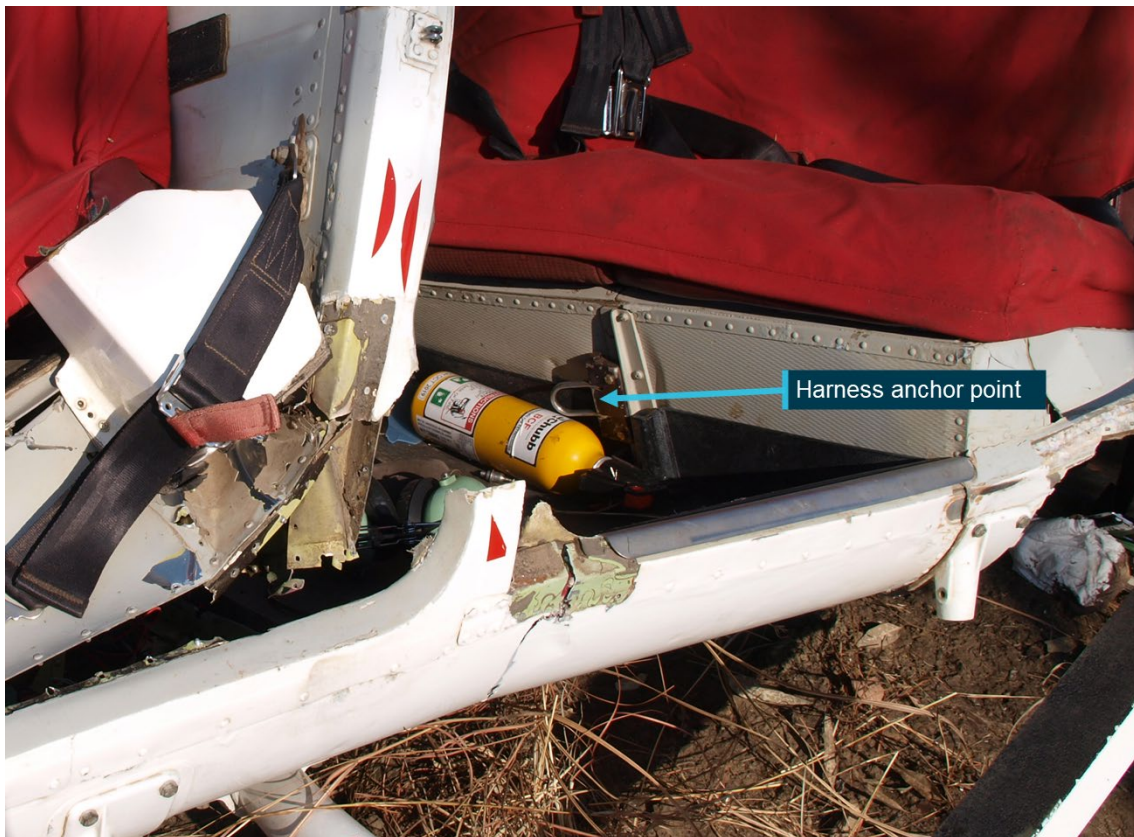
**Figure 8: Harness anchor point**

The harness's design complied with ATSO-C1003<sup>3</sup> and was a quick release type, that could be released under load using two distinct movements (Figure 7), and it was approved under Civil Aviation Safety Regulation (CASR) 21 (*Certification and airworthiness requirements for aircraft and parts*). It was attached to the aircraft with an adjustable strap. Figure 8 shows the location of the anchor point installation in VH-FHW, which was approved by an authorised engineer under CAR 35 (*Approval of design of modification or repair*). The anchor point design required it to be installed on the left side of the cabin for use at the rear right door.

Both the shooter's harness and the anchor point in VH-FHW carried a caveat. Figure 9 shows the harness manufacturer's statement:

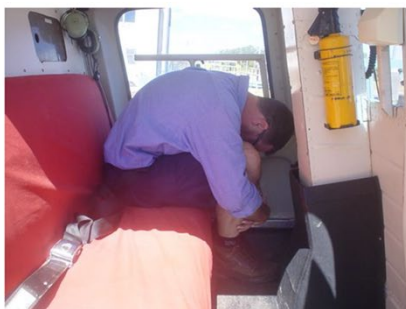
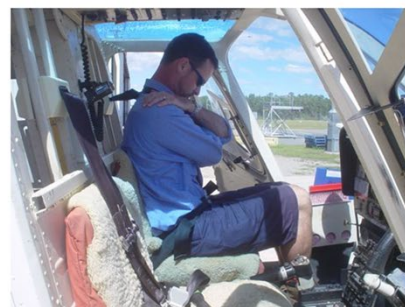
**Figure 9: Brace position information provided by operator**

Although the spotter was aware of the brace position, and the UTR held the spotter in their seat, they reported that they lifted their legs prior to impact. In contrast, the specified brace position required the occupant's feet to be flat on the floor, as depicted in Figure 9.

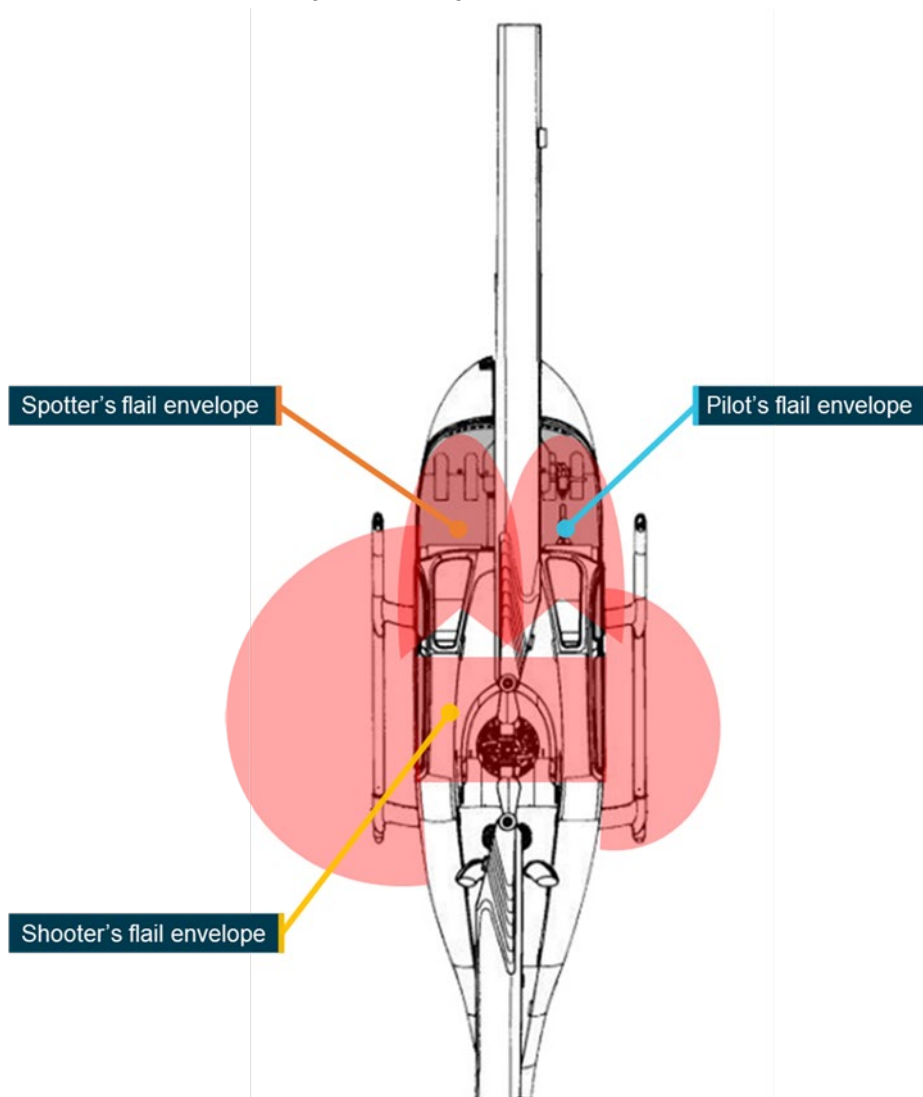
**Figure 10: Estimated flail envelope for occupants of VH-FHW**

Reducing the flail envelope of an occupant is a vital part of reducing harm in an impact sequence. Even short single-point restraints have been demonstrated to allow significant flail injury to occupants (see for example [AO-2014-053](#)). Figure 10 shows the estimated flail envelopes for the occupants of VH-FHW at the time of the accident. The shooter, with a single-point restraint, had a much larger flail envelope than the two front seat occupants.

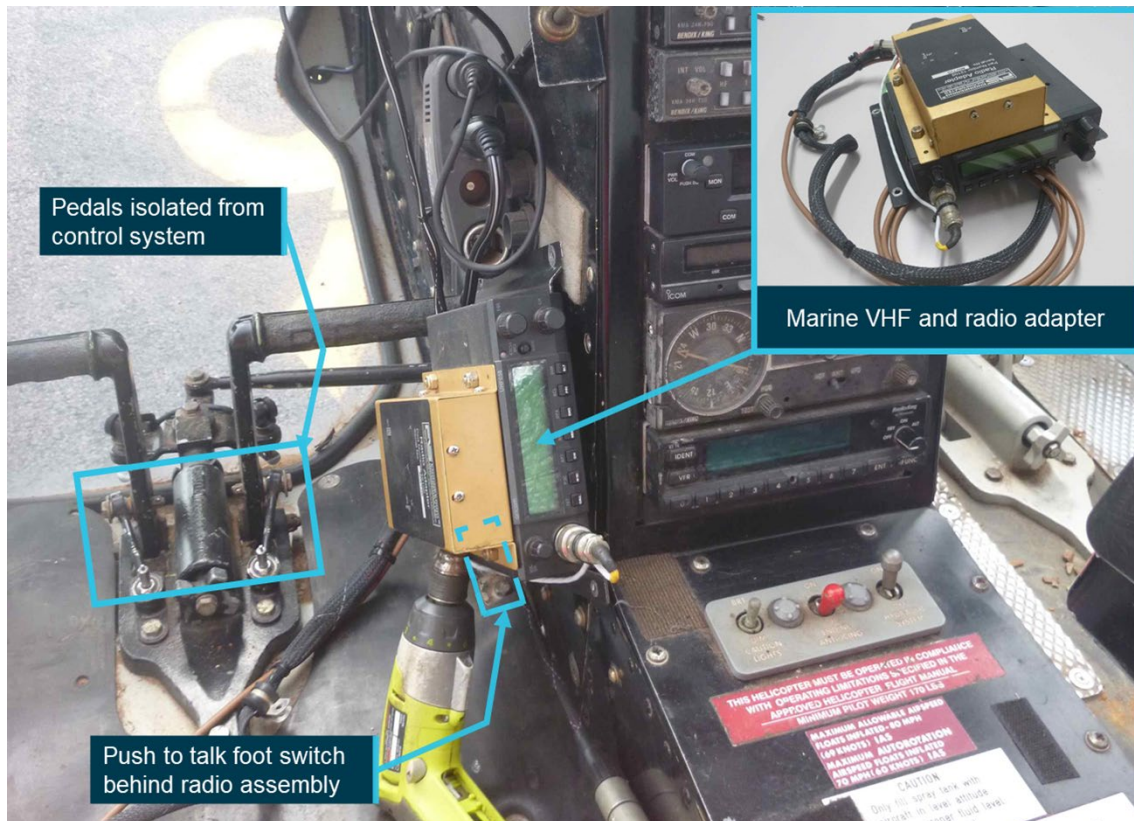
**Figure 11: Exemplar radio installation showing approximate position in footwell**

In 2015 an ancillary radio system was installed in the front passenger footwell of VH-FHW, in accordance with a CAR 35 engineering order. The installation protruded about 8 cm into the footwell (Figure 11). The radio system was a marine VHF/UHF radio, and it was not required for the aerial culling tasks. It had sharp small radii corners, and was not padded.

The pedals at the front left seat of VH-FHW were disconnected from the flight control system. That position can be equipped with flight controls for tasks that require two pilots. The protrusion of the radio installation in VH-FHW over the pedals would likely prevent a pilot from effectively operating the controls. The engineering order for the installation did not prohibit a second pilot from flying the aircraft from the left seat.

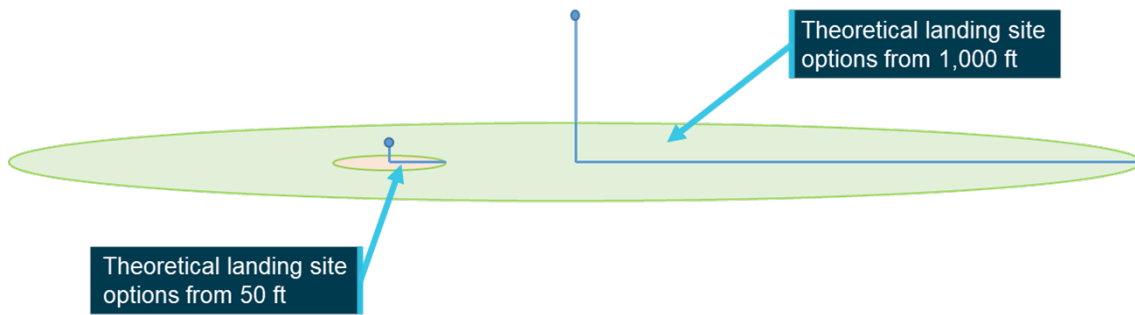
**Figure 12: Theoretical choice of forced landing area at best glide speed**

Low-level flight also vastly reduces the availability of forced landing sites (Figure 12) At best glide speed (69 kt in a B206B3), a glide ratio of around 4:1 is achievable. Low-level work ordinarily occurs at lower speeds than that, and in aerial culling the pilot must match the speed of the animals, further reducing choice of forced landing areas.

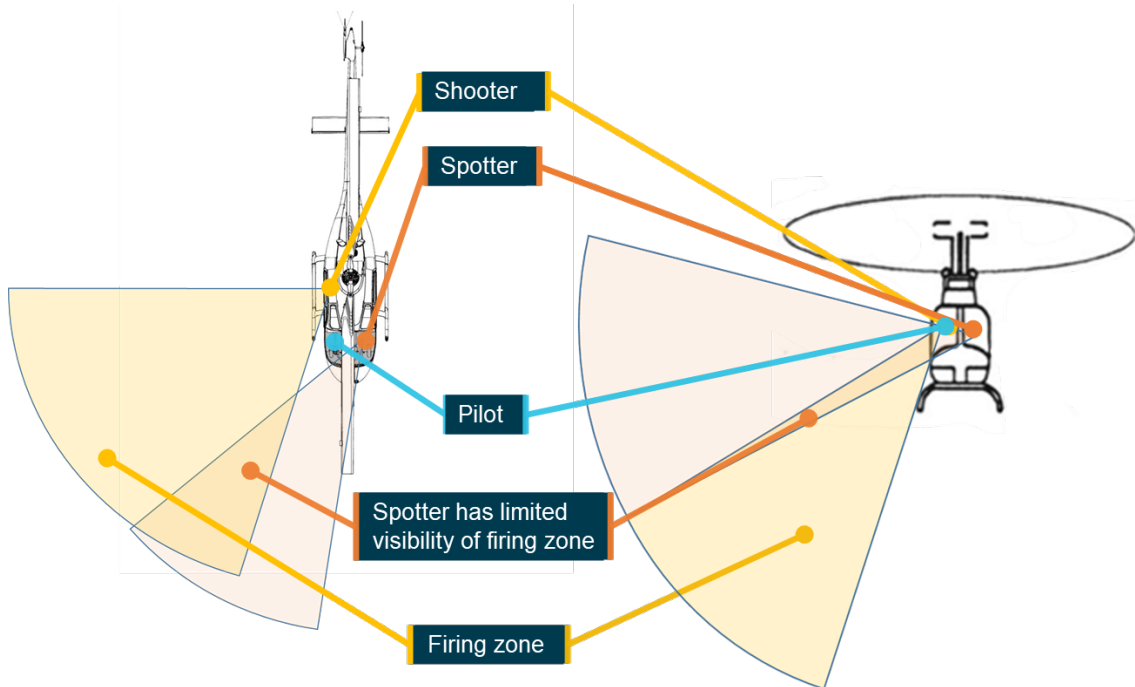
**Figure 13: Estimated firing zone and visibility**

During shooting, the pilot positioned the helicopter to the left of the mob of horses, and matched the speed and track of the helicopter to that of the animals. In a JetRanger, the spotter (seated in the front left seat) could not see what was happening on the right side of the helicopter where the shooting was taking place. The spotter would therefore require the input of the pilot and shooter to conduct the count (Figure 13).
