Rescue hoist cable failure involving AS 350 B3, VH-UAH

1 km south-west of Bulga New South Wales, 5 February 2020

ATSB Transport Safety Report

AO-2020-013

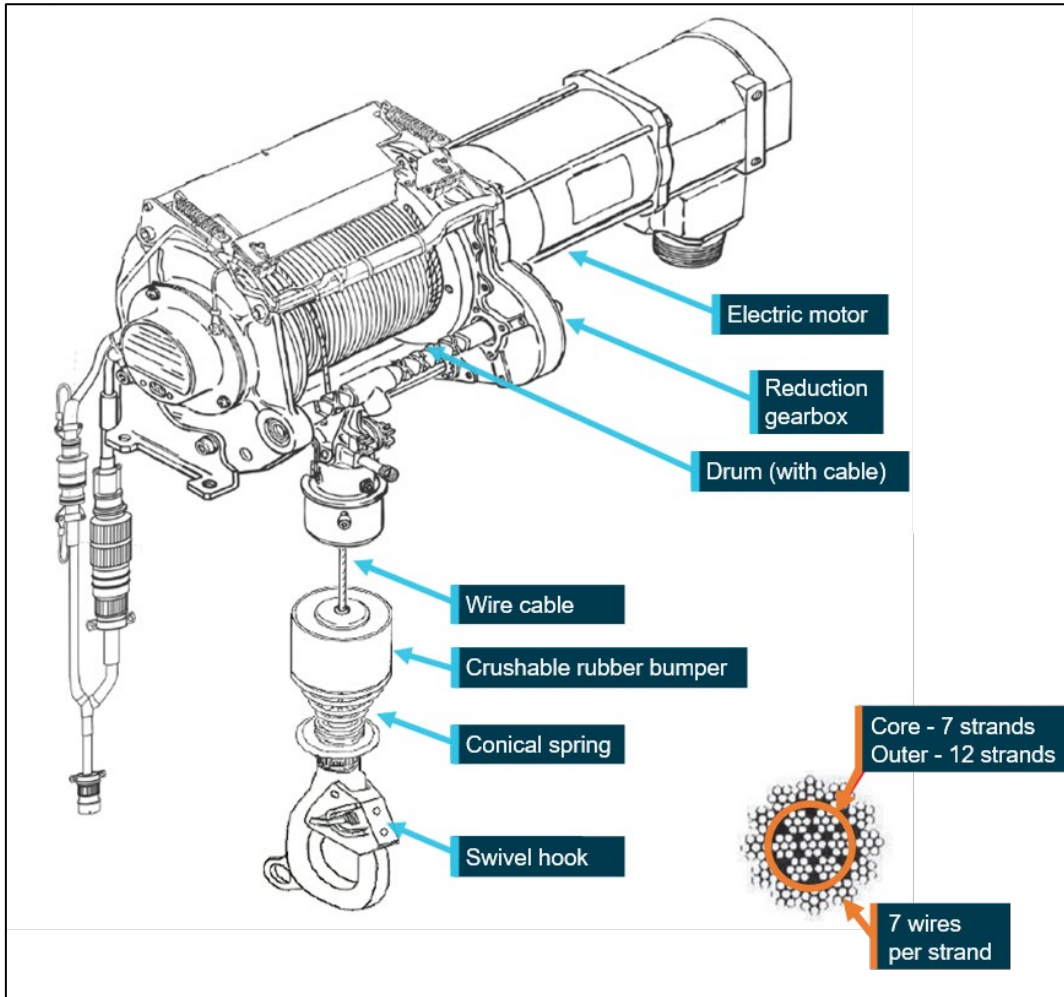
The load cable was specified to be manufactured from 0.156 inch diameter corrosion-resistant stainless steel into a 19-strand by 7-wire configured arrangement comprising an inner core and outer layer (Figure 2). To resist rotation during use, the outer strands were woven in the opposite direction to the inner core. A stainless-steel fitting with a spherical ball-end was swaged onto the termination of the cable to enable secure fitment of the swivel hook and bump stop assembly.

Figure 2: Breeze-Eastern HS-29700 rescue hoist and cross-section of the load cable showing its 19 strand x 7 wire configuration

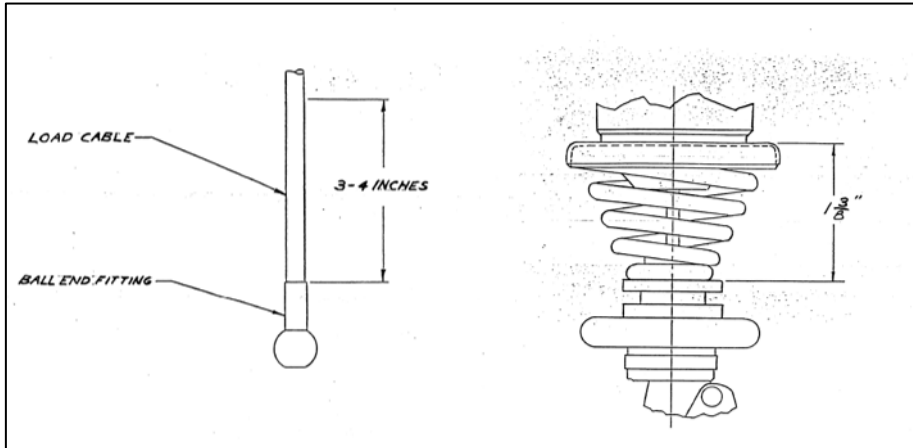
achieved by grasping it and rocking it fore and aft. Importantly, the advice from Breeze-Eastern within CAB-100-30 also indicated that during the post-flight inspection of the swivel hook, the degree of spring compression was required to be measured to verify proper homing of the hook, as identified in Figure 8.

Figure 8: Extract from Breeze-Eastern CAB 100-30 describing the inspection requirements 1) the load cable and 2) the hook and bumper spring compression measurement
