Defective axle bearing leading to fire on passenger train SN68

Yerrinbool, New South Wales, on 13 October 2020

ATSB Transport Safety Report
Rail Occurrence Investigation (Defined)
RO-2020-017
Final – 20 January 2022

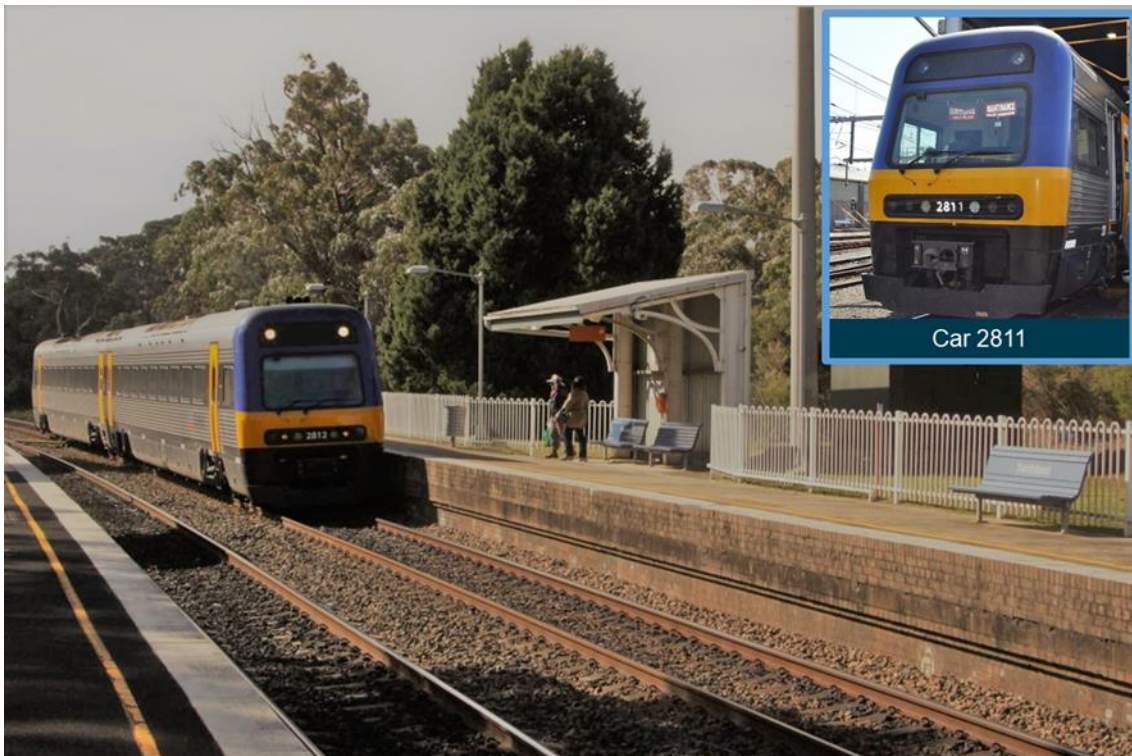
Figure 3: South-bound Endeavour two-carriage set at Yerrinbool Station

The figure shows south-bound (Down) Endeavour set at Yerrinbool Station. Image of car 2811 inset
 Source: railgallery.wongm.com, annotated by OTSI

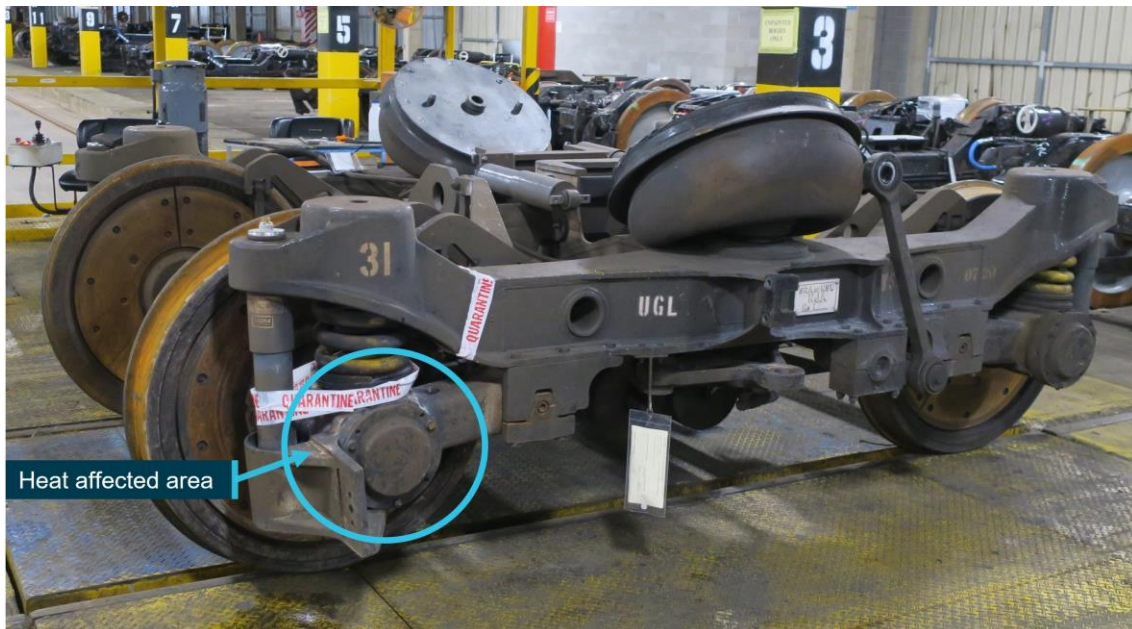
Figure 4: NJA31 bogie

The bogies fitted to the Endeavour and Xplorer sets are NJA and PJA bogies. The bearing collapse occurred on an NJA bogie, the rear trailing bogie on car 2811. The NJA bogie is the trailer bogie (Figure 4), as opposed to the PJA powered bogie. Built for the State Rail Authority in 1994, the bogie involved in this incident was designated as NJA31. This bogie was installed on car 2811 on 7 July 2020 and had travelled approximately 66,087 km since installation.

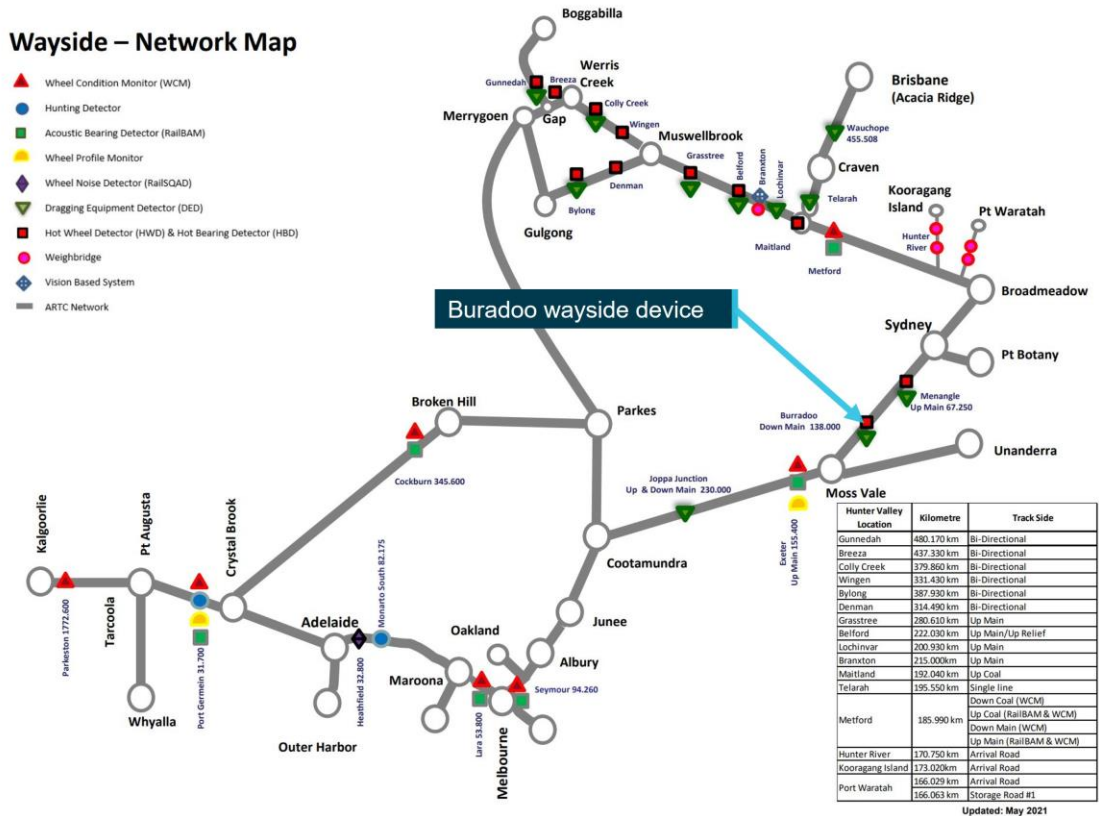
Figure 10: ARTC Network wayside detectors

The ARTC, operates and maintains the wayside monitoring systems in the vicinity where this incident occurred. There are different types of wayside devices including but not limited to detectors for hot bearings, wheel impact loads, acoustic wheel monitoring, and dragging equipment (Figure 10).
