AIRCRAFT ACCIDENT REPORT

Controlled Flight into Terrain

Ilyushin IL-76 TD, RDPL-34141
Baucau, Timor-Leste
31 January, 2003

Australian Transport Safety Bureau

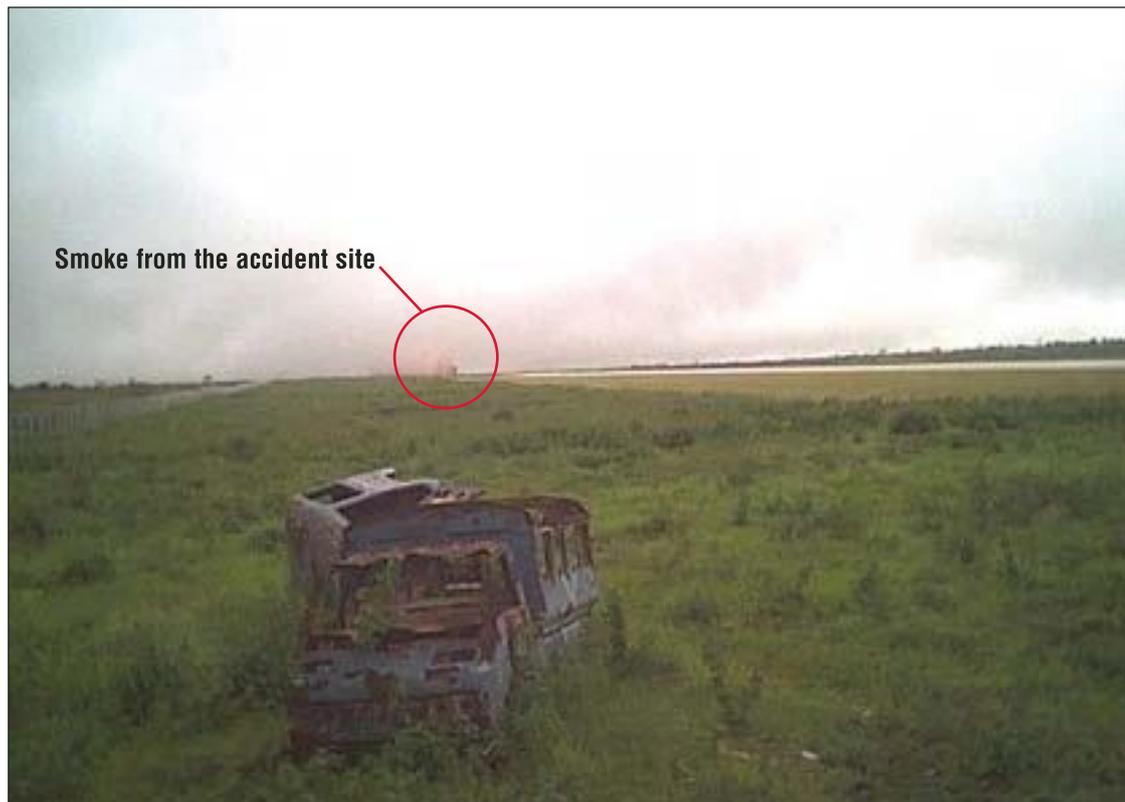
FIGURE 5:
Smoke seen to the northwest of the aerodrome

- the aircraft landing gear was not extended as it overflew the aerodrome on the first occasion (see Figure 3)
- the aircraft landing gear was extended during the first landing approach (see Figure 4), but the aircraft appeared too high to be able to land, and discontinued the landing approach
- the weather at the time was overcast with a low cloud base
- a few minutes after the discontinued first landing approach, they heard an explosion to the northwest of the aerodrome, and saw flames and smoke in that vicinity (see Figure 5).

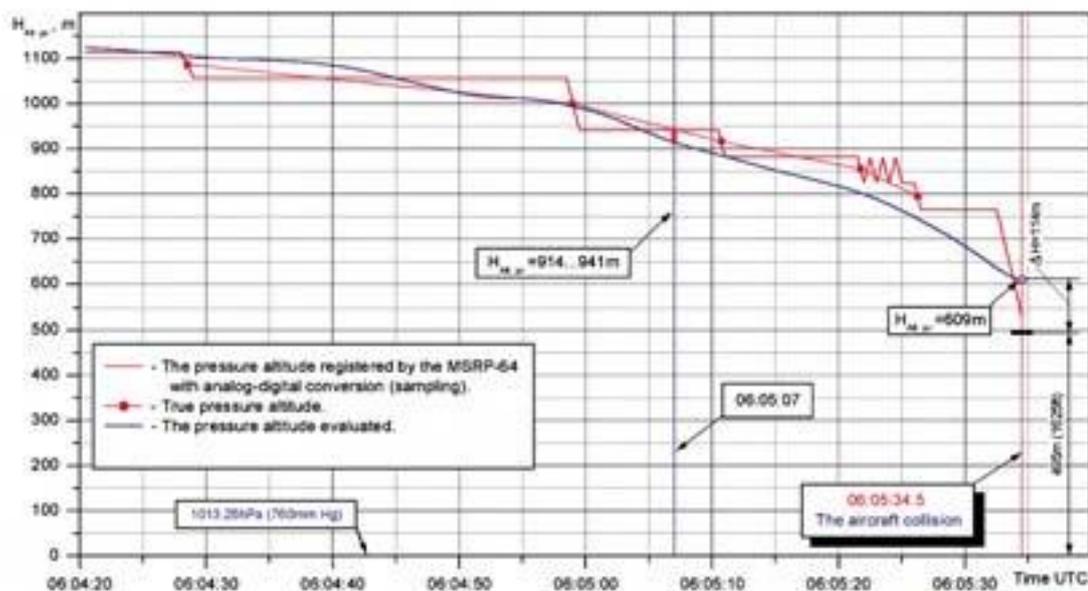
FIGURE 14:
Evaluated aircraft barometric altitude

The IAC reported that the FDR recorded barometric altitude in 60 m increments, and that it was possible there could be as much as a 120 m error in the barometric altitude plot. The IAC ‘smoothed’ the recorded barometric altitude data to take into account the variable quality of the recorded data and to derive true pressure altitude. It then applied recorded vertical acceleration (‘g’) to the derived true pressure altitude data to provide an evaluation of the actual aircraft barometric altitude (see Figure 14).

The evaluated pressure altitude varied slightly from the 'smoothed' true pressure altitude derived from the variable recorded barometric altitude data. The impact point was 495 m (1,625 ft) above the 760 mm Hg (1,013.2 hPa) datum. The evaluated pressure altitude at impact was 609 m (1,998 ft), indicating a discrepancy of 114 m (374 ft) between the recorded barometric data and the evaluated pressure data.

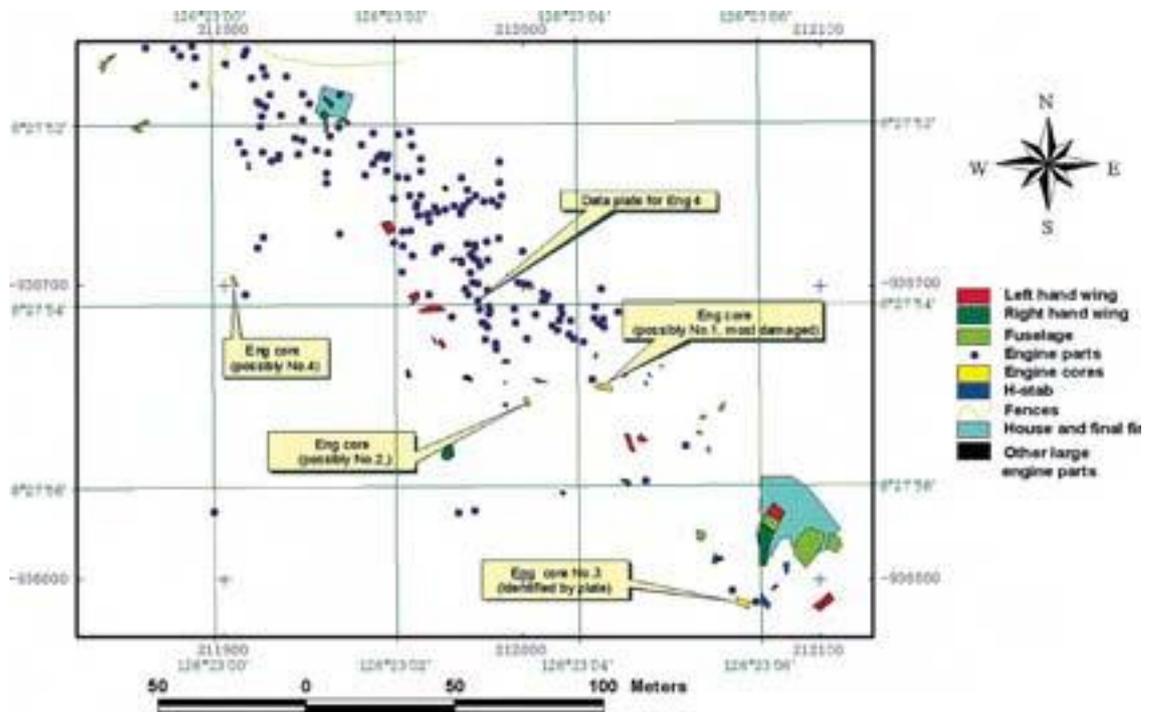
FIGURE 16:
Location of engines

The engine cores and accessories were mostly intact, however each engine fan assembly had separated from its respective engine, and fan blades were spread throughout the accident site (see Figure 16).

The post-occurrence technical examination of the engine fan blades found in the wreckage did not display any evidence of bird strike or blending repairs.³⁰ It was not possible to determine whether the engines had sustained any foreign object damage before impact because of the significant damage resulting during from the impact sequence. The FDR EGT and N2 plots are depicted at Figures A.8 and A.9 in Appendix A. The plots revealed no apparent aircraft engine anomalies during the descent into Baucau or during the approach sequences. The extent of the typical resultant engine damage is depicted at Figures 17 and 18.

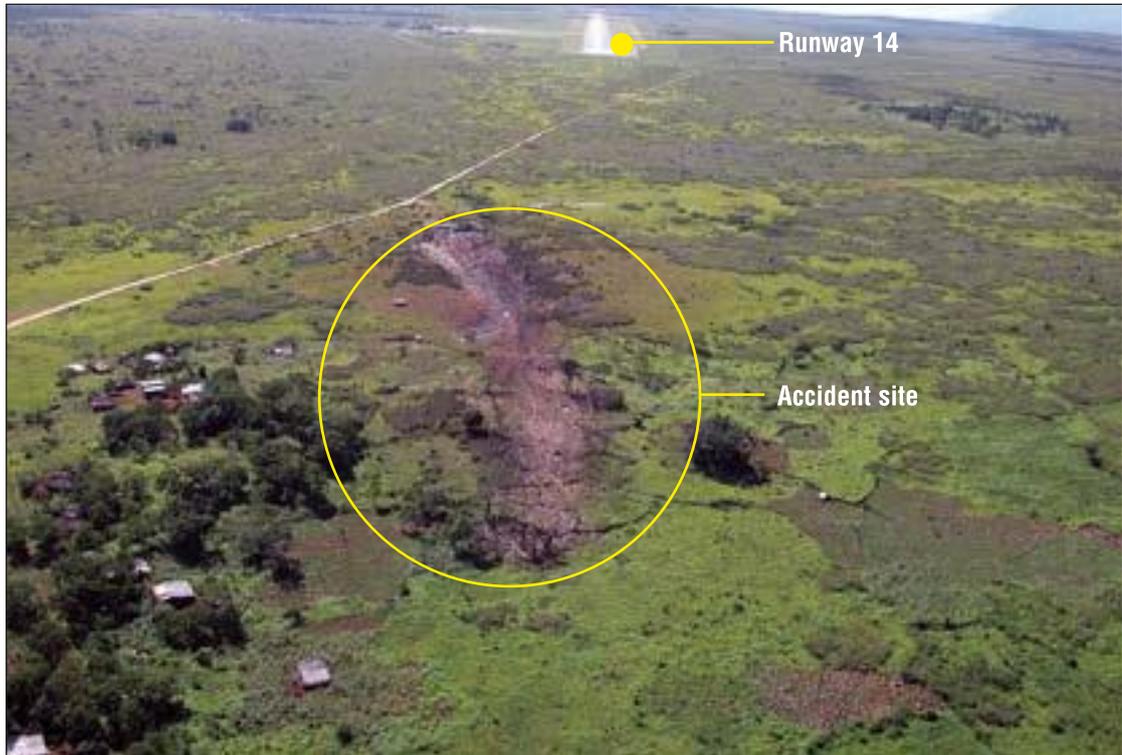
FIGURE 19:
Accident site in relation to Baucau runway 14

The aircraft impacted terrain about 1 NM (2 km) to the north-northwest of Baucau aerodrome. The accident site is depicted at Figures 19 and 20.

The terrain between the impacted trees and the aerodrome contained no other significant groups of trees of similar height to those impacted (see Figures 19 and 20). The investigation concluded that had the correct QNH had been used to establish QFE, impact with the trees may have been avoided. The investigation also concluded, however, that the likelihood of impact with terrain at a point closer to the runway would probably have remained almost certain. Under those circumstances, even though the aircraft would probably have sustained severe damage by impact forces, the consequences of the CFIT event may not have been as catastrophic.

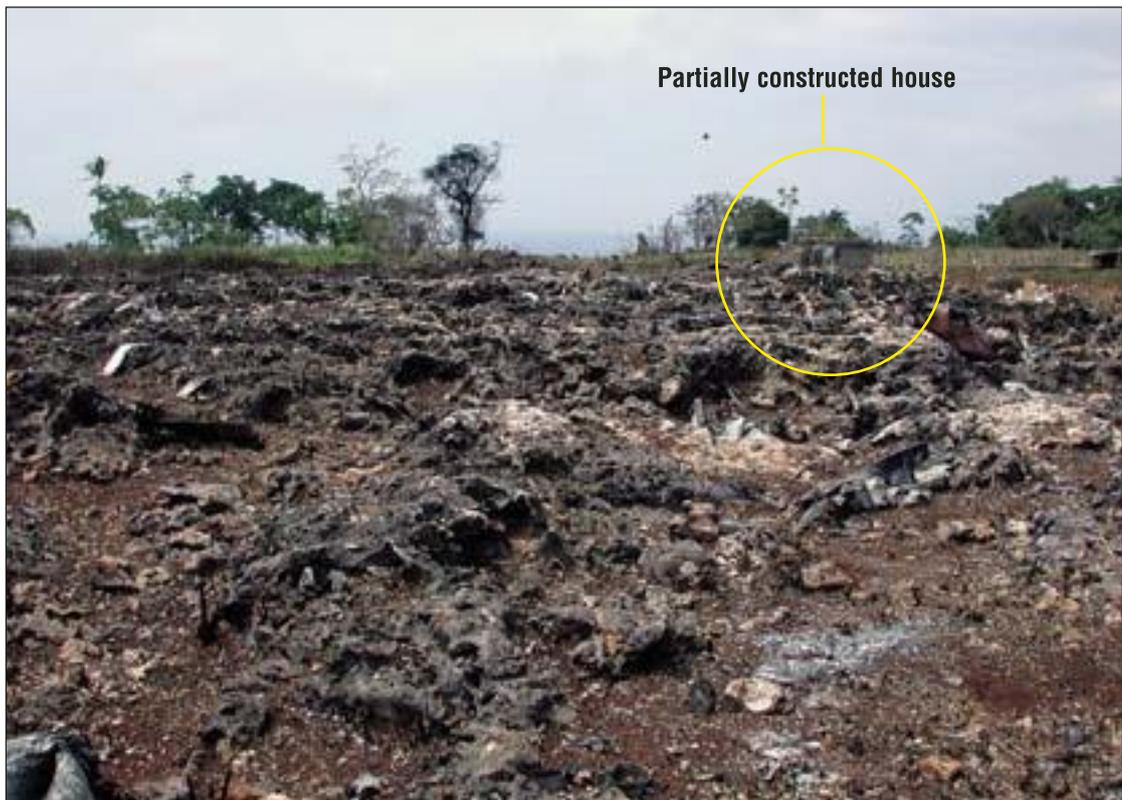
FIGURE 22:
Terrain within the wreckage area

A serrated area of rising ground consisting of coral outcrops up to a metre (3.3 ft) high was located just past the partially constructed house that was struck by the aircraft during the impact sequence. The area was difficult to traverse on foot, and the Australian investigation team likened it to an 'enormous cheese-grater' (see Figure 22).

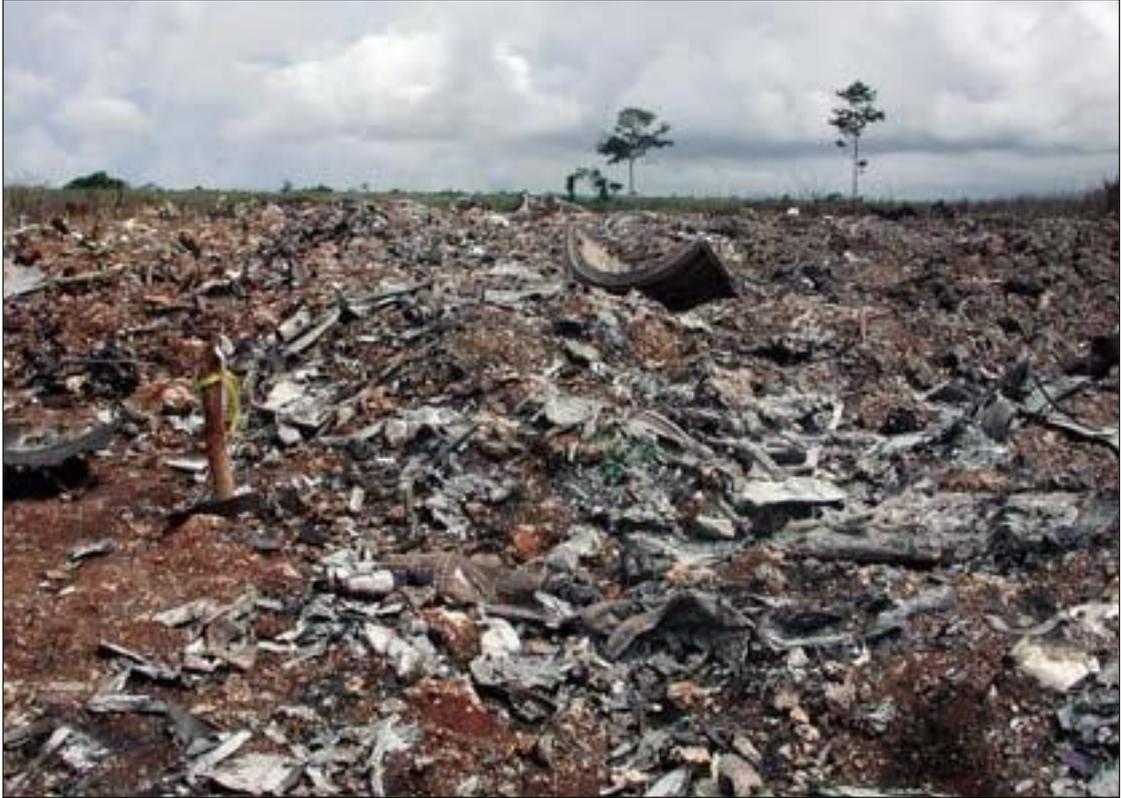
FIGURE 23:
Commencement of the cockpit wreckage area

Many small parts of the forward fuselage section, wing sections, and engine fan blades were found to the left of the wreckage trail, starting from the beginning of that serrated portion of ground. Several of the cockpit instruments, controls, the quick access recorder, the remains of most of the occupants, and large sections of the cockpit windows were also found to the left of and beyond that area (see Figure 23). The area also displayed evidence of an intense short-duration fire.

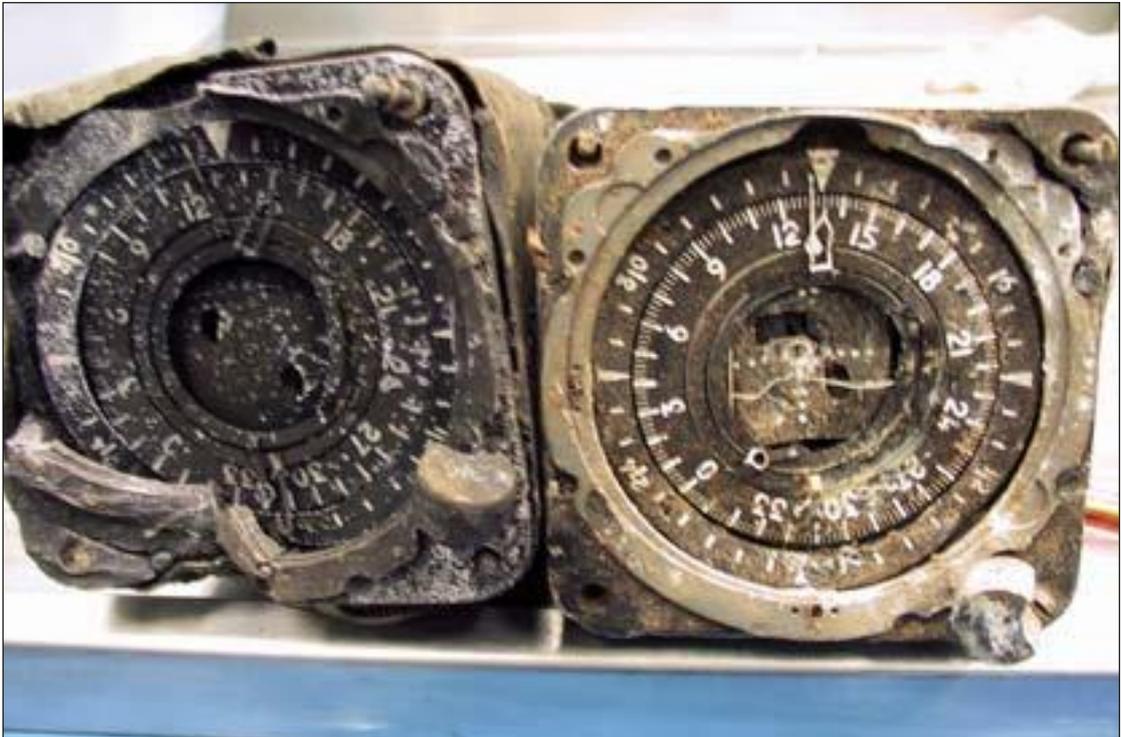
FIGURE 24:
Course Indicators recovered from the wreckage

Two CIs were recovered from the wreckage (see Figure 24).

The impact forces had substantially damaged both the CIs. One was badly sooted from exposure to the post-impact fire around where it lay after being dislodged from the instrument panel. The 3K desired heading pointer on the less-damaged CI was aligned to a magnetic heading of about 134 degrees. The 3K desired heading pointer of the more-damaged CI had been bent during the impact sequence.

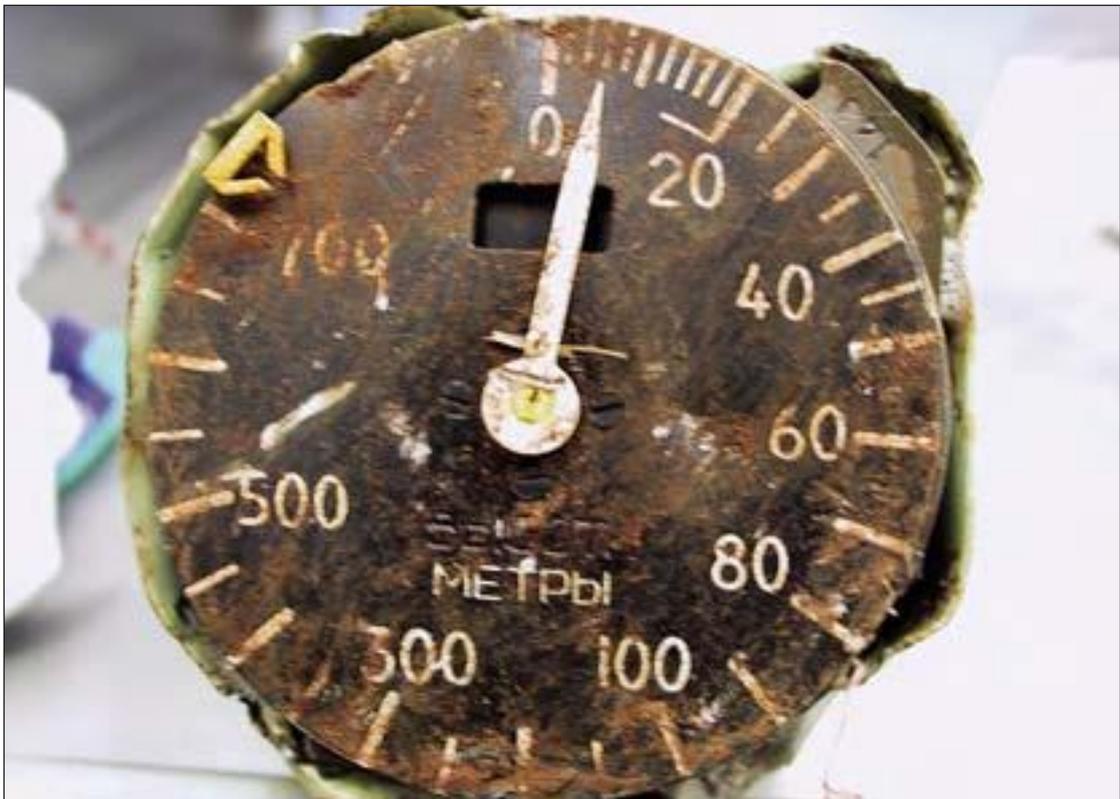
FIGURE 26:
The PB-750 radio altimeter indicator located in the aircraft wreckage

The more-damaged indicator was a PB-750 m scale unit (see Figure 26). The reference bug on that indicator was set to 750 m.

A number of other instruments were also found in the cockpit wreckage area. The casings of many of those instruments were badly distorted from impact forces, and some of the instruments were damaged to such an extent that they provided no reliable information.

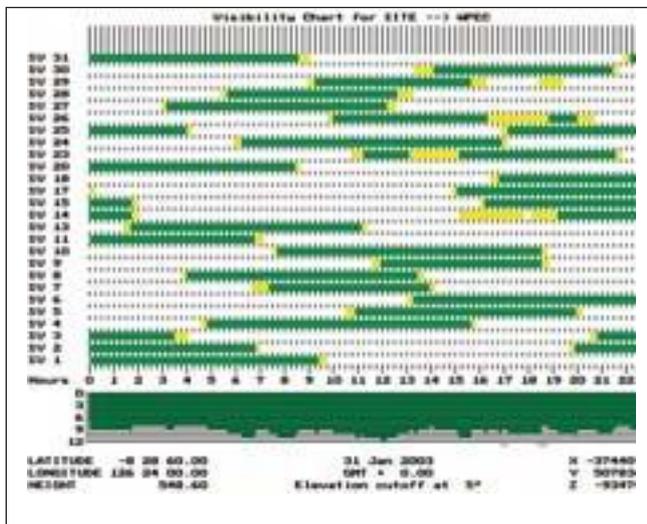
FIGURE 35:
GPS satellite coverage at Baucau

In certain locations, there are insufficient satellites in view to provide RAIM integrity monitoring. Those gaps in coverage are referred to as RAIM holes. There were 11 satellites in view at Baucau at the time of the occurrence (see Figure 35). Green signifies a satellite's elevation of greater than 5 degrees above the horizon and yellow signifies a satellite's elevation of between 0 degrees and 5 degrees above the horizon.

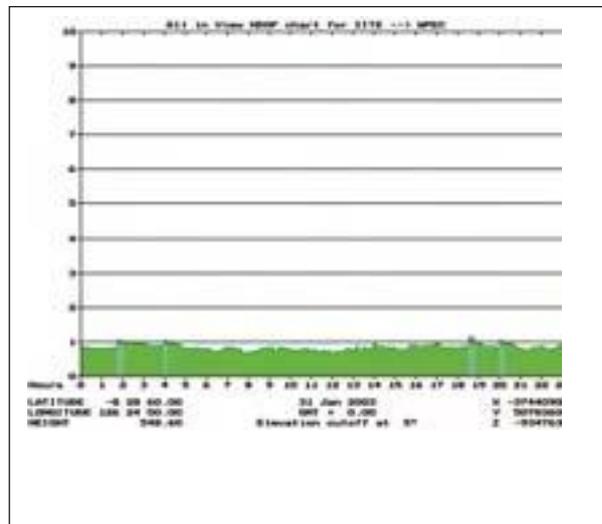
FIGURE 36:
Satellite HDOP at Baucau

Dilution of precision may also affect the integrity of navigation data provided by a GPS, and its extent is dependent on the number of satellites in view to a GPS, and also the geometry of those satellites relative to the user. Under ideal conditions, the calculated position of a GPS will be at the point where two satellite range rings intersect. However, in reality the calculated position will be in an area of uncertainty, because of errors in the satellite ranges, and the area of uncertainty will become greater as the two satellites get closer to each other. Dilution of precision occurs in both vertical (VDOP) and horizontal senses (HDOP), with HDOP being more critical in terms of the integrity of lateral navigation solutions. The calculated HDOP at Baucau at the time of the occurrence was less than 1, and would have resulted in little effect on the integrity of lateral navigation data that was being provided by the aircraft's GPS (see Figure 36).

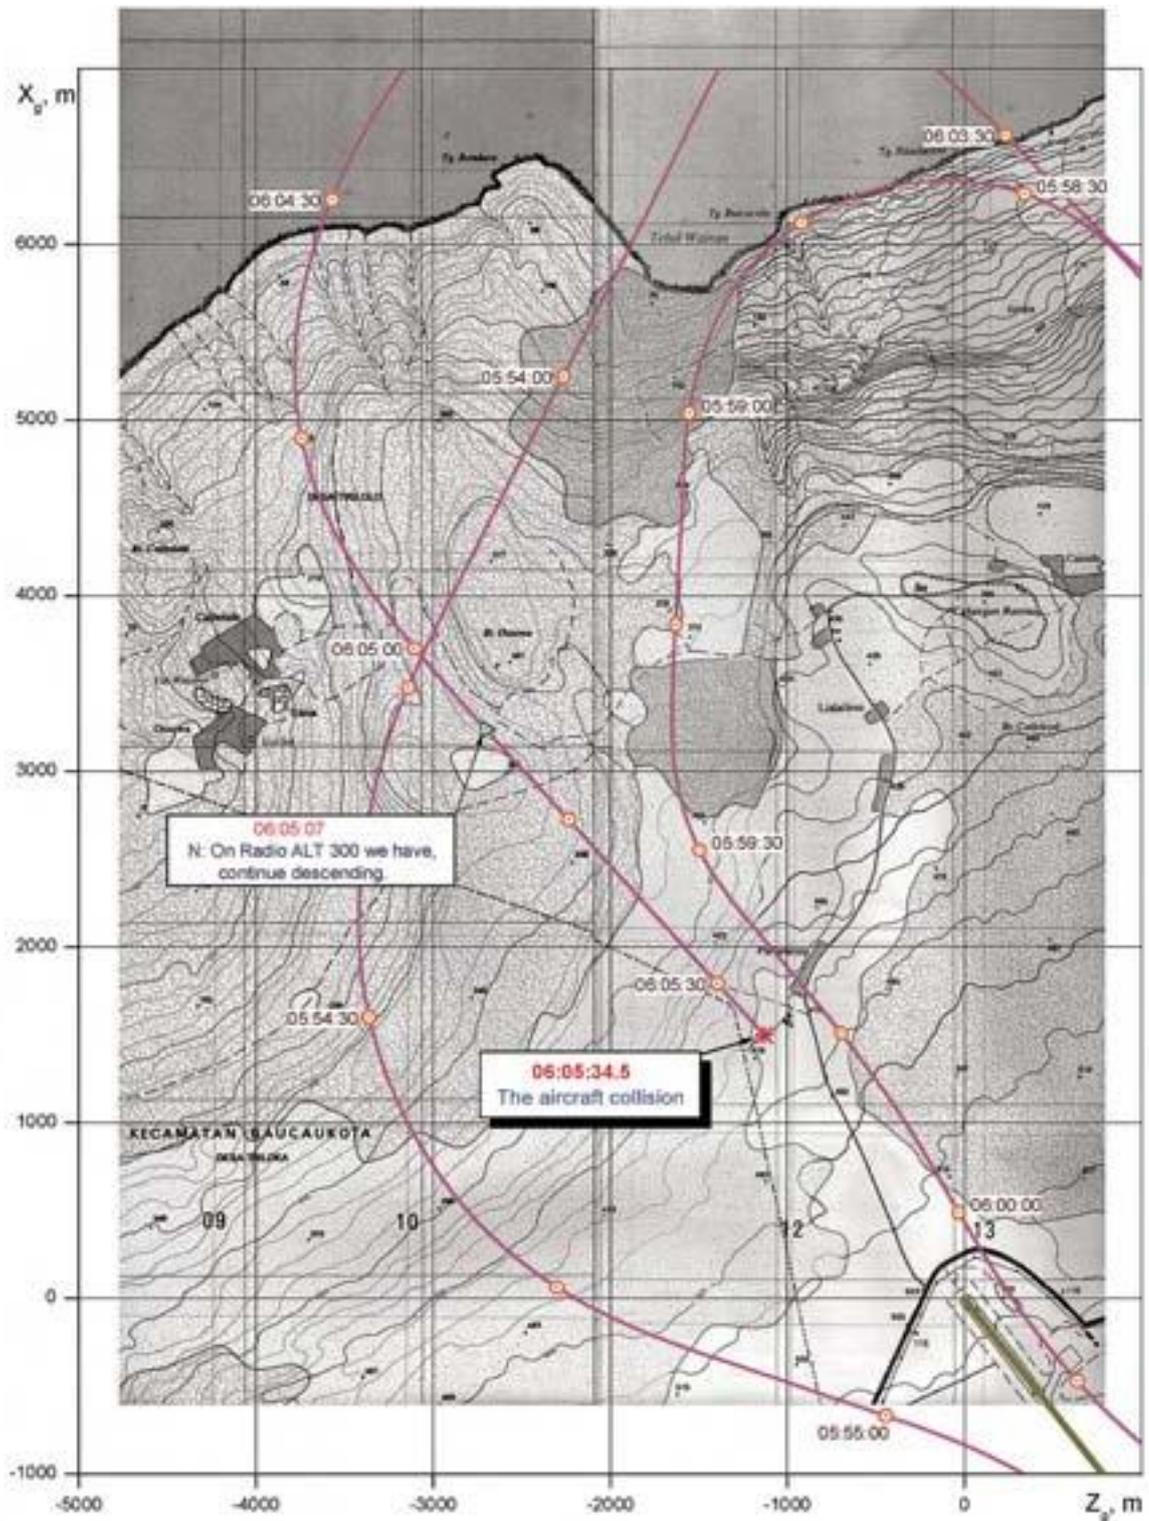
FIGURE 37:
Aircraft position over the terrain at 06:05:07

The IAC plotted the aircraft's flight path onto the Baucau, East Timor 2507-42 T754 Edition 2 topographic map. The map displayed contour elevations in metres AMSL. The IAC reported that it concurred with the Australian investigation team that the aircraft had been overhead the 320 m (1,050 ft) contour at time 06:05:07 (see Figure 37).

The IAC reported that at time 06:05:07 the aircraft was therefore at about 300 m (984 ft) barometric altitude with the altimeter subscales set at 714 mm Hg, and not at 300 m absolute altitude. The IAC concluded that under those circumstances, the flight navigator had mistakenly referred to barometric altitude as radio altitude. The Australian investigation team concurred with the IAC's conclusion.

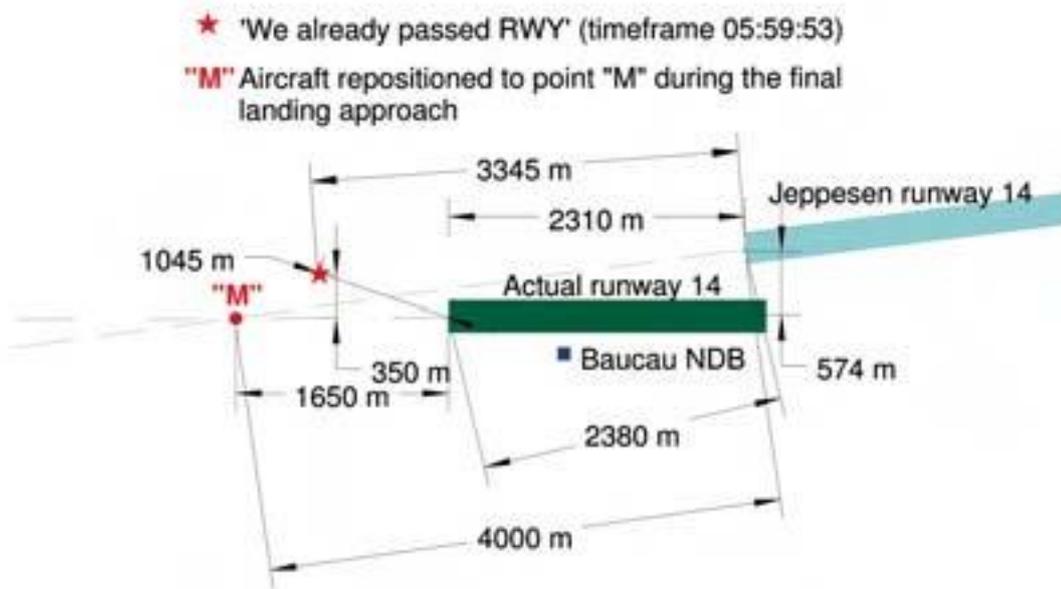
FIGURE 38:
Navigation distances for the actual position of runway 14 vs. the Jeppesen runway position

The flight navigator appeared to have assumed that the aircraft was overhead the runway when the pilot in command stated 'We already passed runway'. The aircraft was not overhead the runway at that point, but was still 1.04 km (0.56 NM) to the north of the threshold. The distance between the actual position of the threshold of runway 14 and its position as depicted on the Jeppesen chart, was 2.38 km (1.24 NM). At 05:59:53, the onboard navigation equipment would therefore have showed that the aircraft was still about 3.34 km (1.80 NM) from the Jeppesen runway 14 threshold (see Figure 38).

The CVR data revealed that the flight navigator decided to apply a 4 km (2.16 NM) correction to the Jeppesen data for the second landing approach. That decision was based on his assumption that the aircraft was overhead the runway at 05:59:53. The flight navigator therefore appeared to have reached a preconceived conclusion on the basis of limited information, and to have assumed that conclusion was correct without giving consideration to, or ignoring, other relevant information. Had the flight navigator visually confirmed when the aircraft was abeam the threshold of runway 14, at about time 06:00:05, the onboard navigation equipment would have shown that the aircraft was about 2.38 km (1.30 NM) from the position depicted on Jeppesen charts of where the runway 14 threshold was located. A correction of 2.38 km to the Jeppesen data would therefore have provided accurate navigation data to reposition the aircraft to the actual threshold of runway 14.

By applying the 4 km correction, the flight navigator was providing the pilot in command with inaccurate data, and resulted in the aircraft being repositioned towards point "M", depicted at Figures 38, and A5 and A6. That point was about 1.65 km (0.88 NM) northwest of the actual position of the threshold of runway 14. That incorrect data substantially increased the hazards of the user-defined approach procedure, and the risk of a CFIT event at that stage of the flight increased to a high degree. The flight crew did not appear to identify the hazards associated with the intended improvised approach procedure, and were therefore not in a position to manage the associated risks.

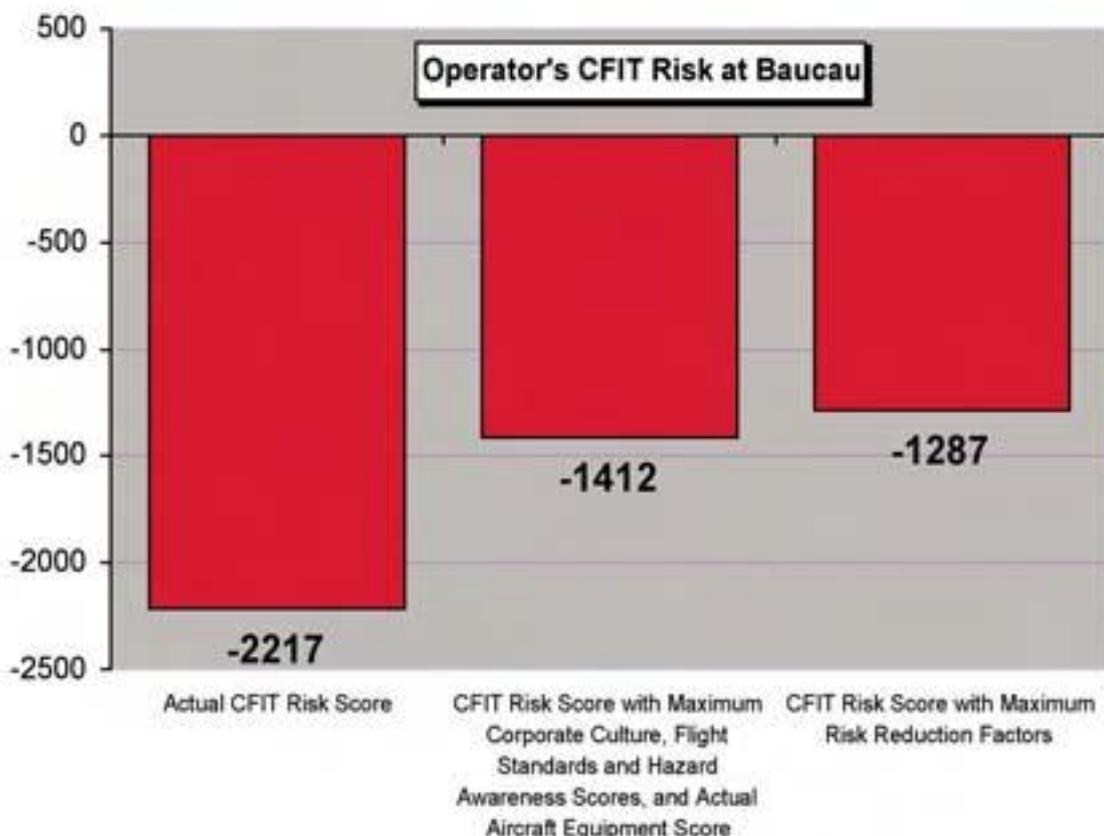
FIGURE 39:
CFIT Risk at Baucau

The alternative CFIT risk scores discussed above are depicted at Figure 39.

CFIT events involving transport-category aircraft will almost certainly result in major to catastrophic consequences involving fatal or life threatening injury, and damage to property and/or the environment, as this occurrence demonstrates. During the second landing approach at Baucau, the likelihood of CFIT increased to the point where it became unavoidable. The flight crew seemed unaware of the severity of the risk until they recognised that impact with terrain was imminent. At that stage, however, the risk could no longer be treated.
