# Wirestrike and collision with terrain involving Robinson R44, VH-HNF

69 km south-east of Hay Airport (Steam Plains), New South Wales, on 31 July 2020

AO-2020-040

Final – 4 March 2022

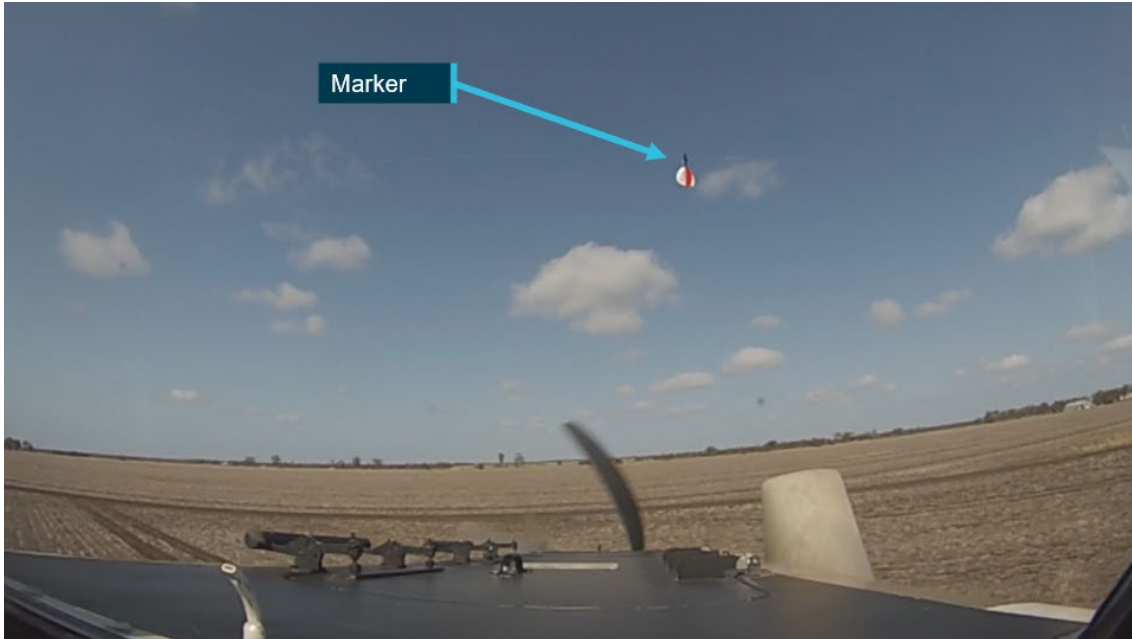
**Figure 2: Example of a wire aerial marker**

The powerline was not marked and was not required to be, according to Australian Standards 3891.1 and 3891.2.<sup>4</sup> Following a wirestrike of a powerline owned by Essential Energy, field workers assess the risk of another strike. If it is considered likely, at least one aerial marker (Figure 2) is fitted to the wire. It was assessed at the time that a subsequent wirestrike was unlikely to occur due to the remoteness of the location and because the helicopter was spraying weeds along the perimeter fence rather than crop spraying. As a result, no markers were fitted to the wire when it was restrung or subsequently.

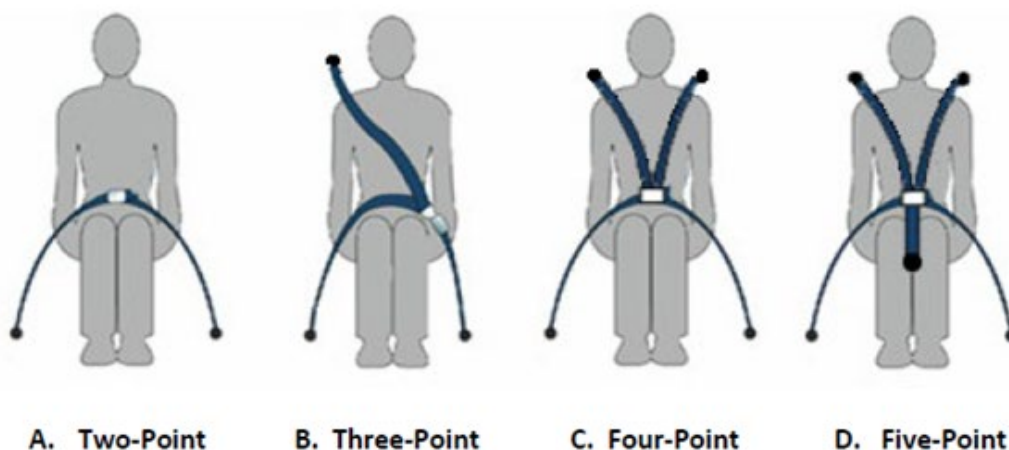
**Figure 6: Aviation restraint types**

The Australian Civil Aviation Safety Order 20.16.3 required at least one pilot crew member to wear a seat belt or safety harness at all times during flight. Civil Aviation Safety Regulation Part 137.225 required fitment of a 4-point harness to fixed-wing aeroplanes operating in the Restricted category – for example, when fitted with ‘role equipment’ such as a spray system – however, this requirement did not apply to helicopters operating in the Restricted category. CASA advised that a proposal to amend Part 137 to include Rotorcraft was expected to commence by the end of 2022. Civil Aviation Safety Regulations Part 90.105 required helicopters to be fitted with a safety harness that ‘must consist of a lap belt and at least 1 shoulder strap’ (3-point harness). Figure 6 illustrates 2-, 3-, 4- and 5-point harnesses.

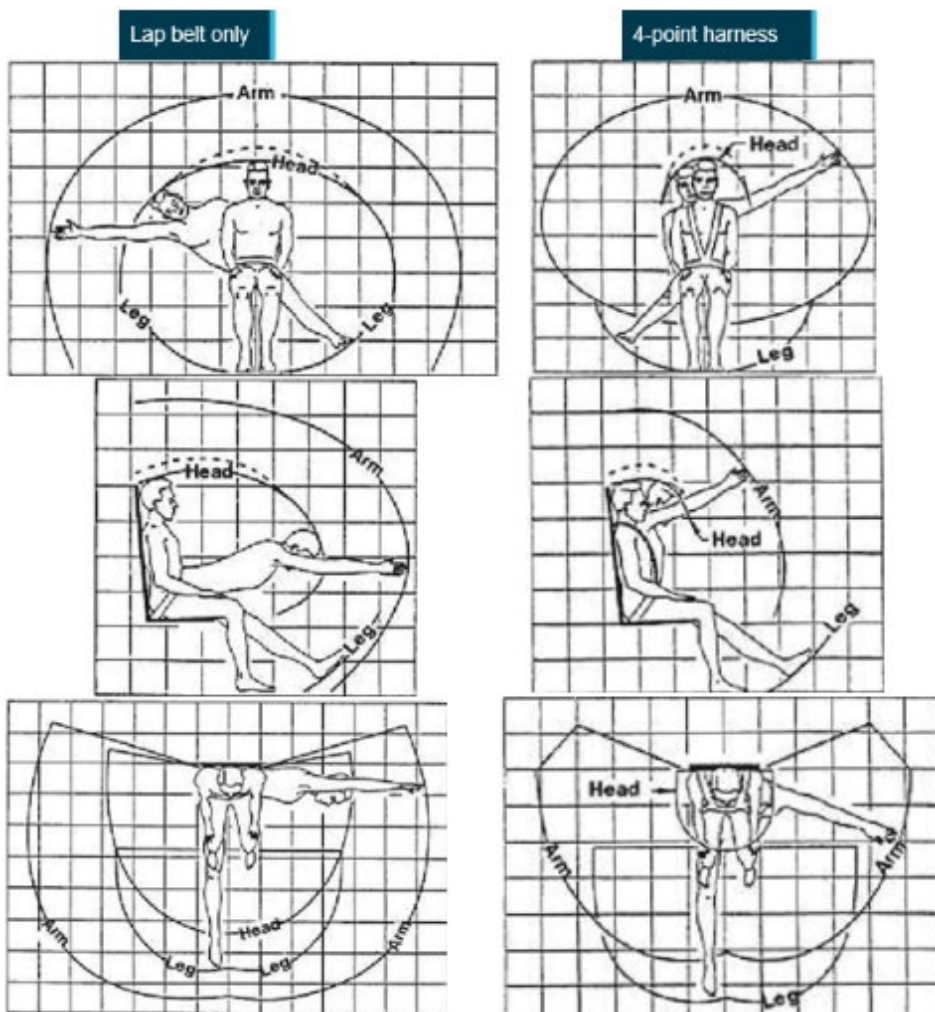
A comparison between the flail zone for an occupant wearing a lap belt only (2-point harness) and a 4-point harness is depicted in Figure 7. These images show that the maximum head strike distance is reduced to 50 per cent with the 4-point restraint. Reducing the flail zone significantly reduces injury risk by reducing the number of objects that could cause strike injuries. In particular, this reduces the risk of potentially fatal head injuries, which was the most common cause of death in aircraft accidents (Crowley and others 1992).

Figure 7: Lap belt only (2-point harness) and 4-point harness flail zone

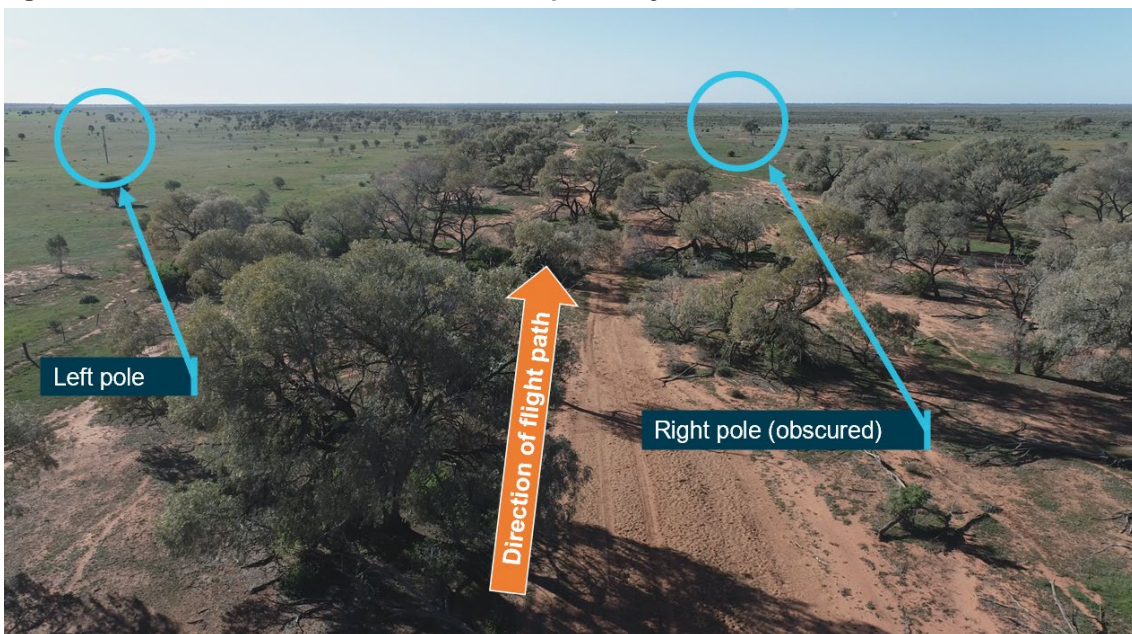
Figure 13 shows the two closest power poles located either side of the helicopter's flight path. From ATSB RPA footage taken along the estimated flight path, at times, both poles were obscured by trees and lacked contrast and texture variation from their background (Figure 14 and Figure 15). The two power poles should have been visible within the pilot's peripheral vision, however it is likely that the pilot's visual acuity was affected by contrast sensitivity, resulting in the pilot being unable to discriminate the poles from their background. Additionally, based on the powerline's location on the pilot's map, the pilot may not have been looking for cues at that time.

**Figure 14: RPA footage of reconstructed flight path showing location of poles left and right of track from about 160 and 350 m respectively**

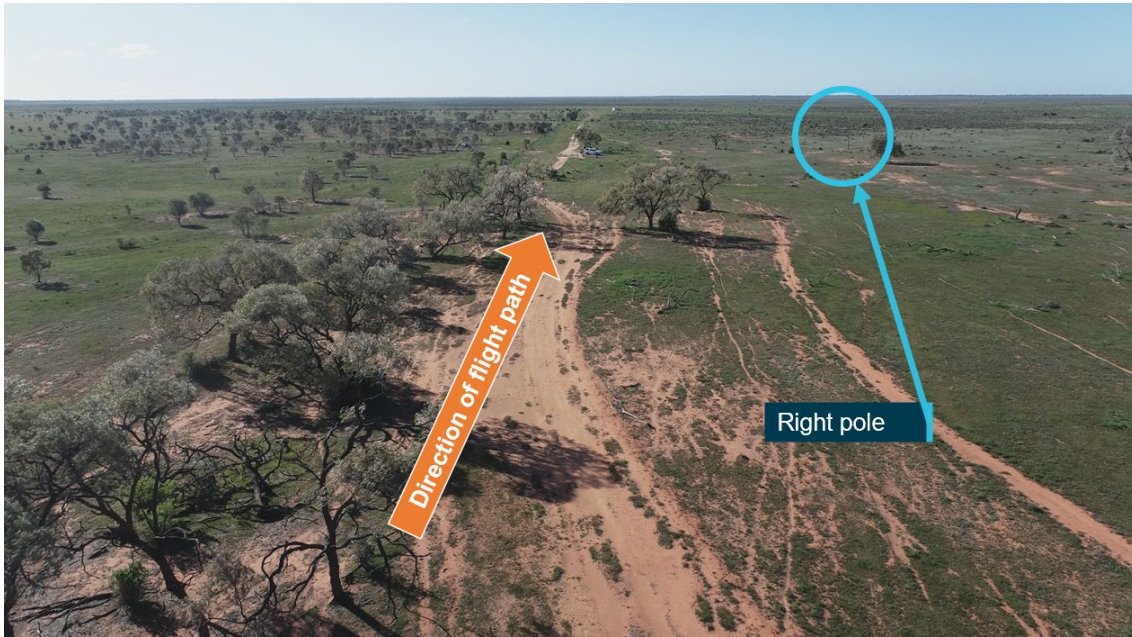
Figure 15: RPA footage of reconstructed flight path showing right pole from about 240 m
