Runaway and derailment of loaded ore train M02712

Near the 211 km mark south of Port Hedland, Western Australia, on 5 November 2018

ATSB Transport Safety Report

RO-2018-018

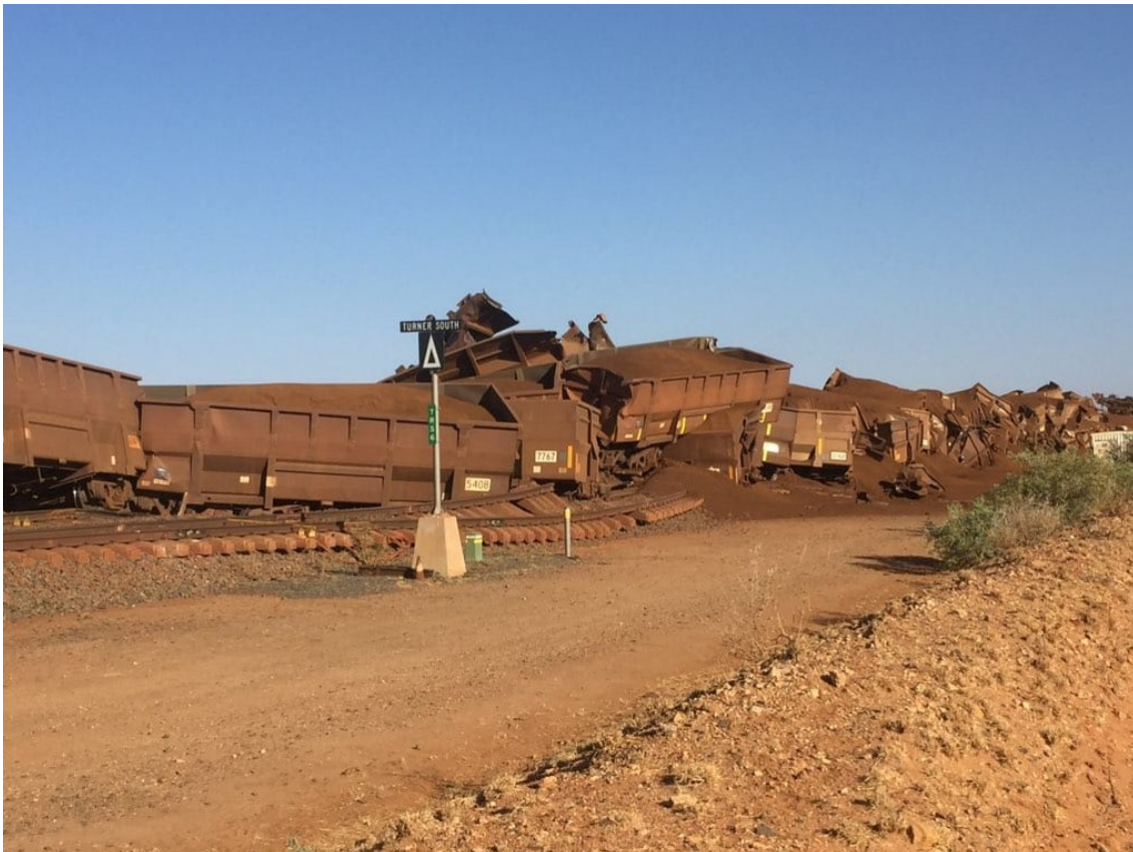
Cover photo: Wreckage of derailed train M02712 near Turner South. Source: BHPWAIO

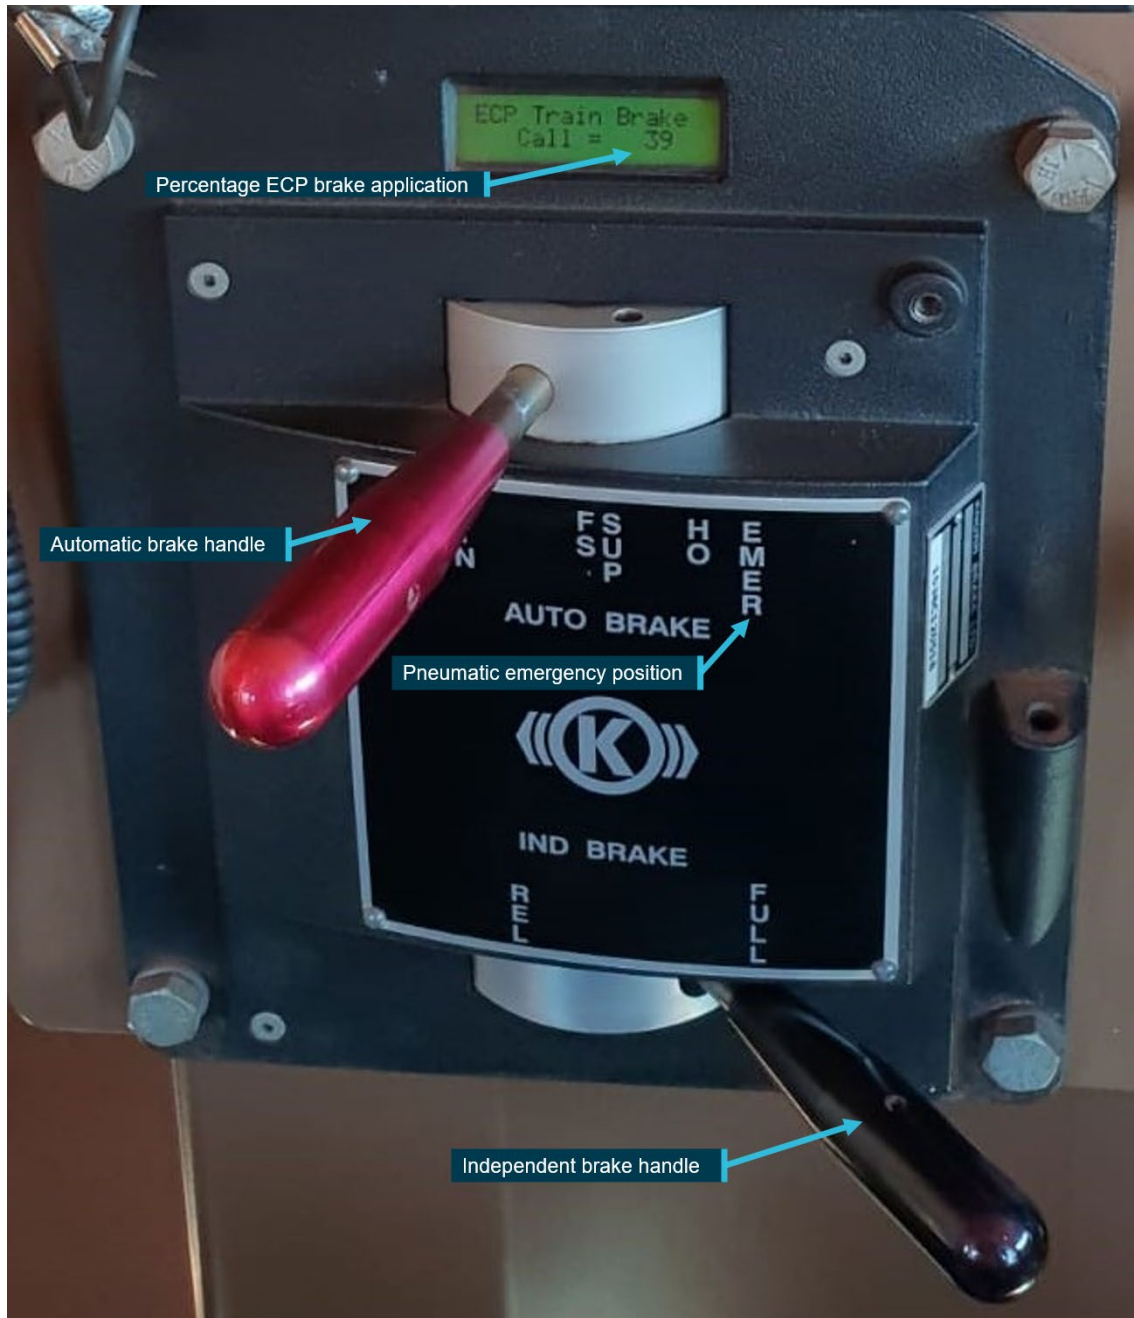
Figure 7: Drivers electronic brake control unit

*Position of the automatic brake handle equates to a 39% TBC brake application.
Source: BHP, annotated by the ATSB*

Figure 7 shows the position of the brake handles at the time of the runaway and derailment. The driver positioned the automatic brake handle in the service zone to the position equating to a 39% ECPB TBC at 0337, prior to the loss of trainline communications at 0338. The independent brake handle was moved to the FULL position at 0353.

In the case of M02712 approaching Garden on 5 November 2018, the driver had positioned the automatic brake handle for a 39% train brake call to the EP-60 brake controller, prior to the emergency (Figure 7).

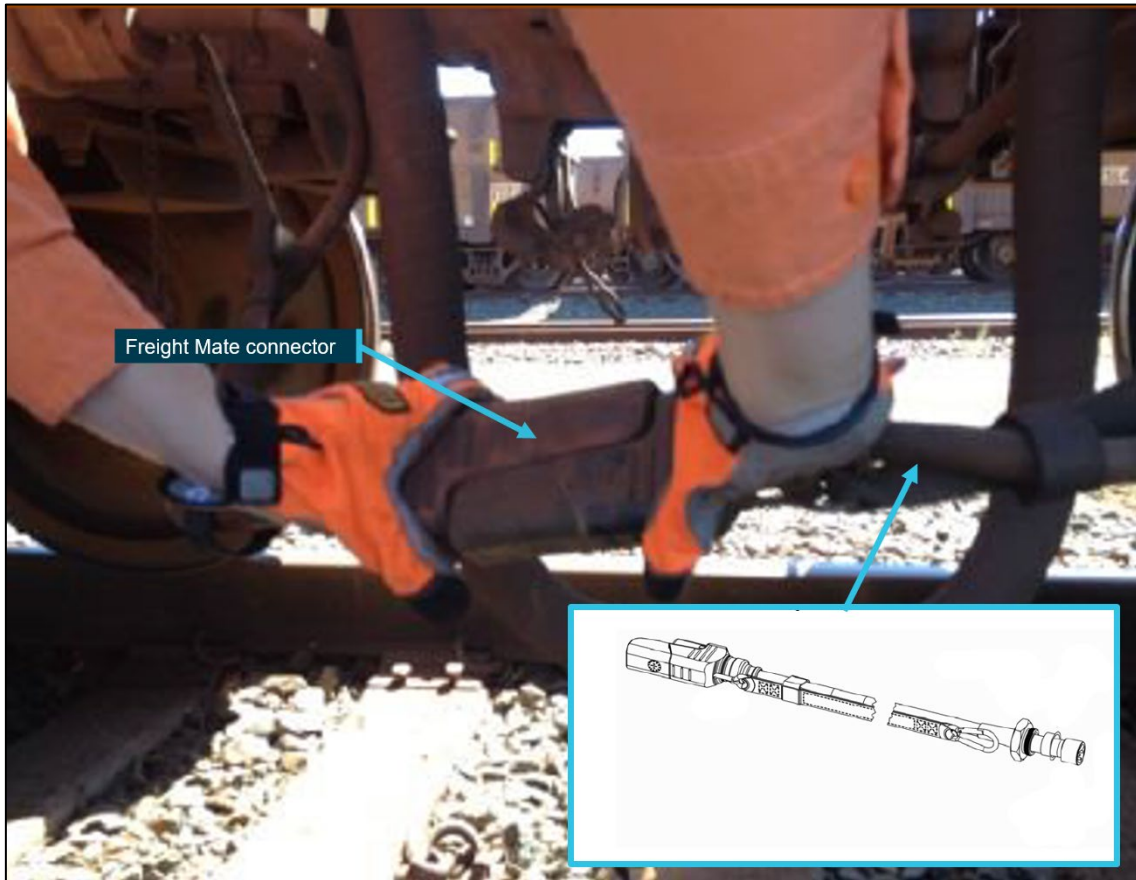
Figure 12: NYAB Freight Mate inter-car connector

*Image showing typical plug-type device connecting the trainline cable between ore cars.
Source: BHP, annotated by the ATSB*

In mid-2018, BHP initiated a trial of a Wabtec type connector (Figure 13) to address repeated service delays associated with trains receiving a 120% TBC brake application due to a loss of trainline power and communications from continuity faults within the existing connector. Associated with the service delays, BHP also noted that, depending on the track location, the failure required the application of handbrakes to secure the train. Undertaking this task increased exposure of the train crew and support personnel to a potential injury.
