Department of Transport
Bureau of Air Safety Investigation

INVESTIGATION REPORT
9401043

Douglas DC3 VH-EDC

24 April 1994

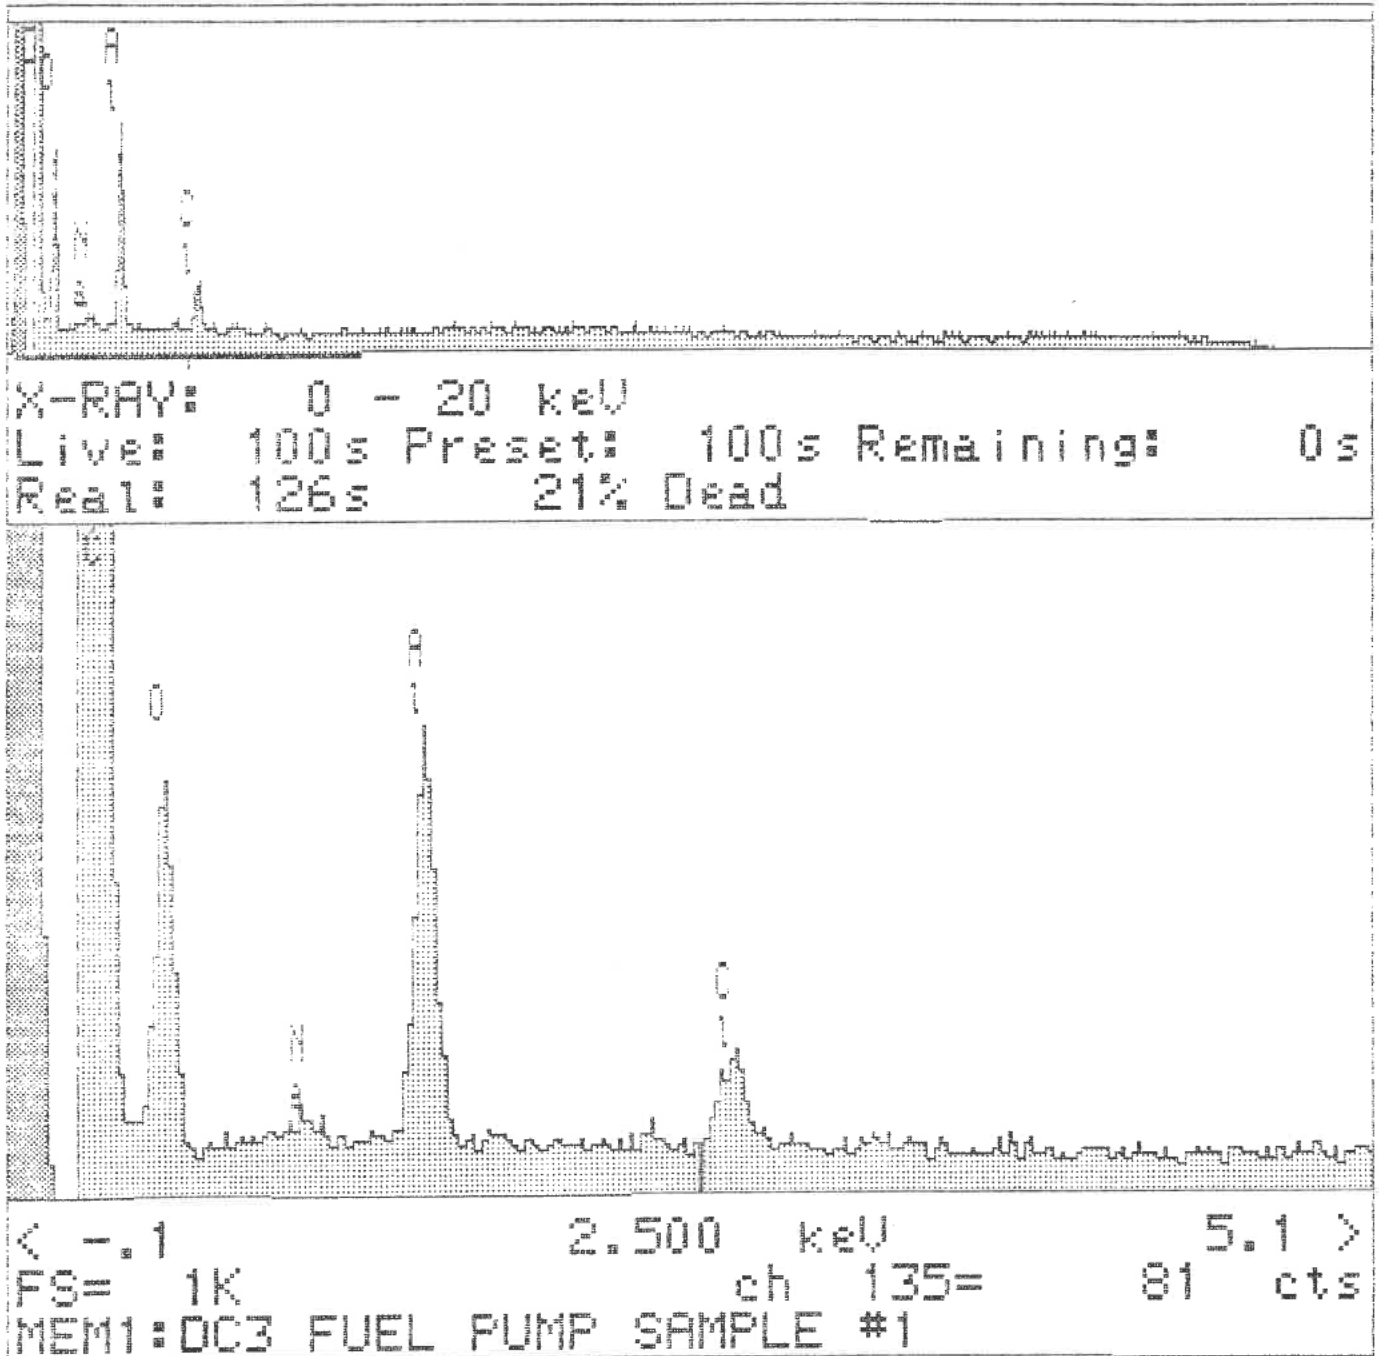
*Inside
Surface* Cover of the diaphan

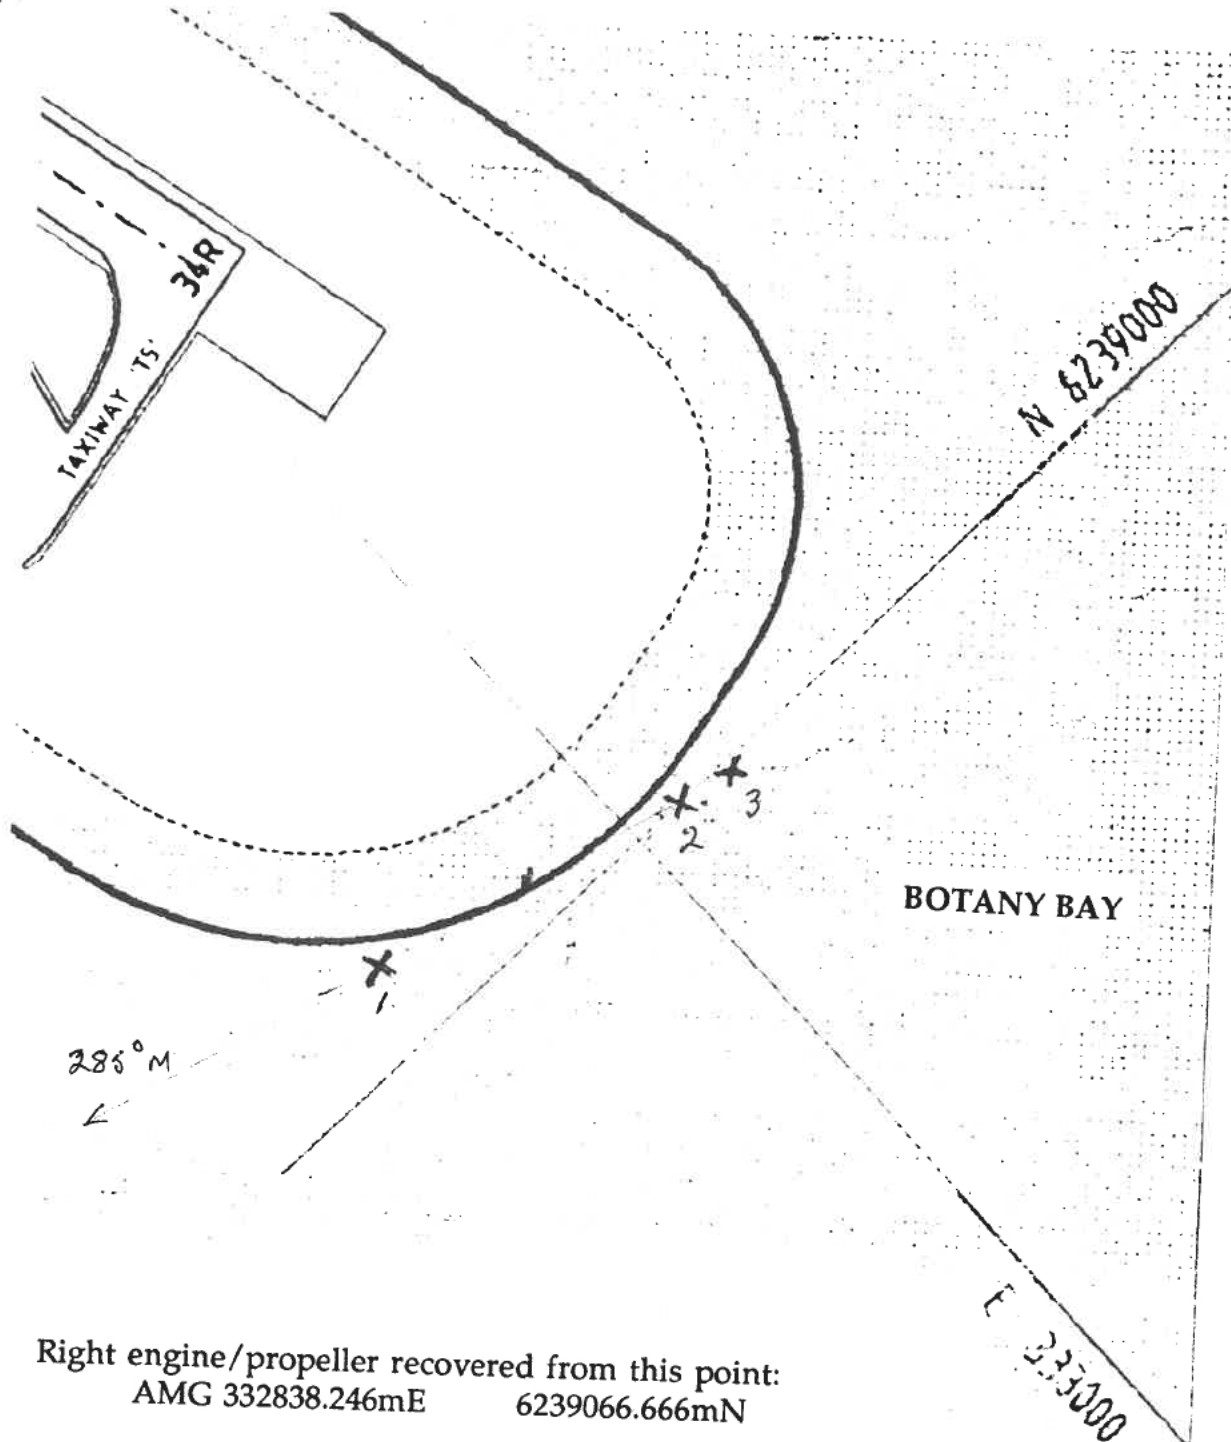
1. Right engine/propeller recovered from this point:
 AMG 332838.246mE 6239066.666mN

This location is 215 metres on a bearing of 285° 17' 14.15 secs from the South Cardinal Buoy, and 56 metres from the seawall (at water level).

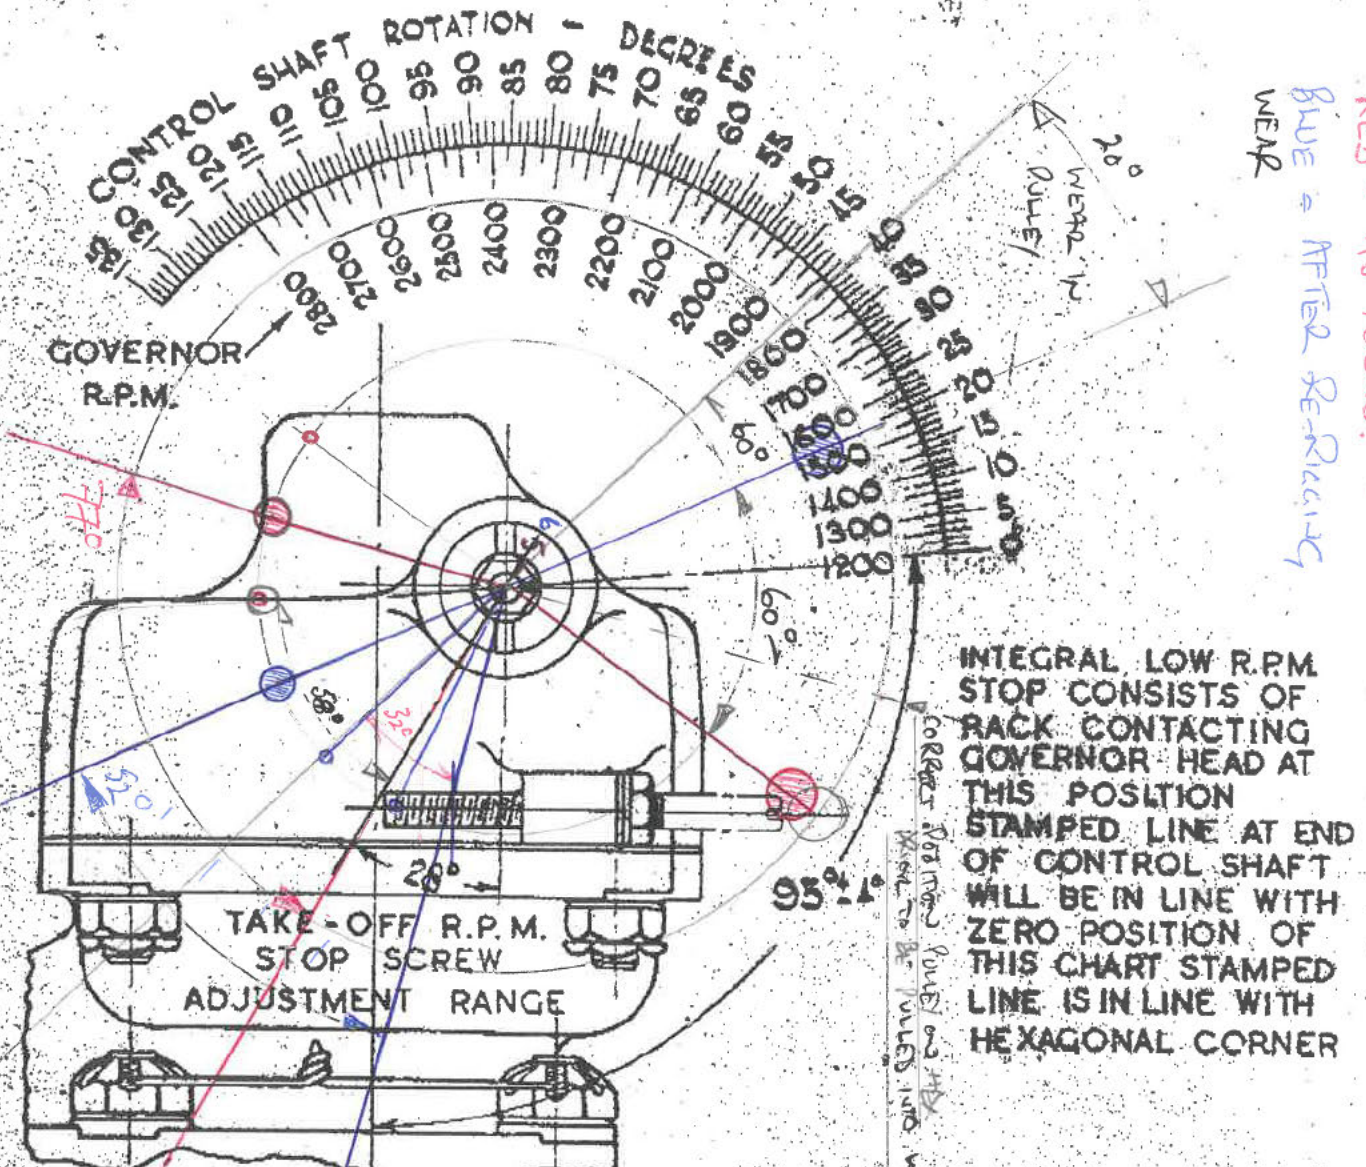
RED = AS FOUND. (NUMBER APPROX 20° OF WERNER 1/2" OF RULE)

BLUE = AFTER RE-RIGGING WEAR

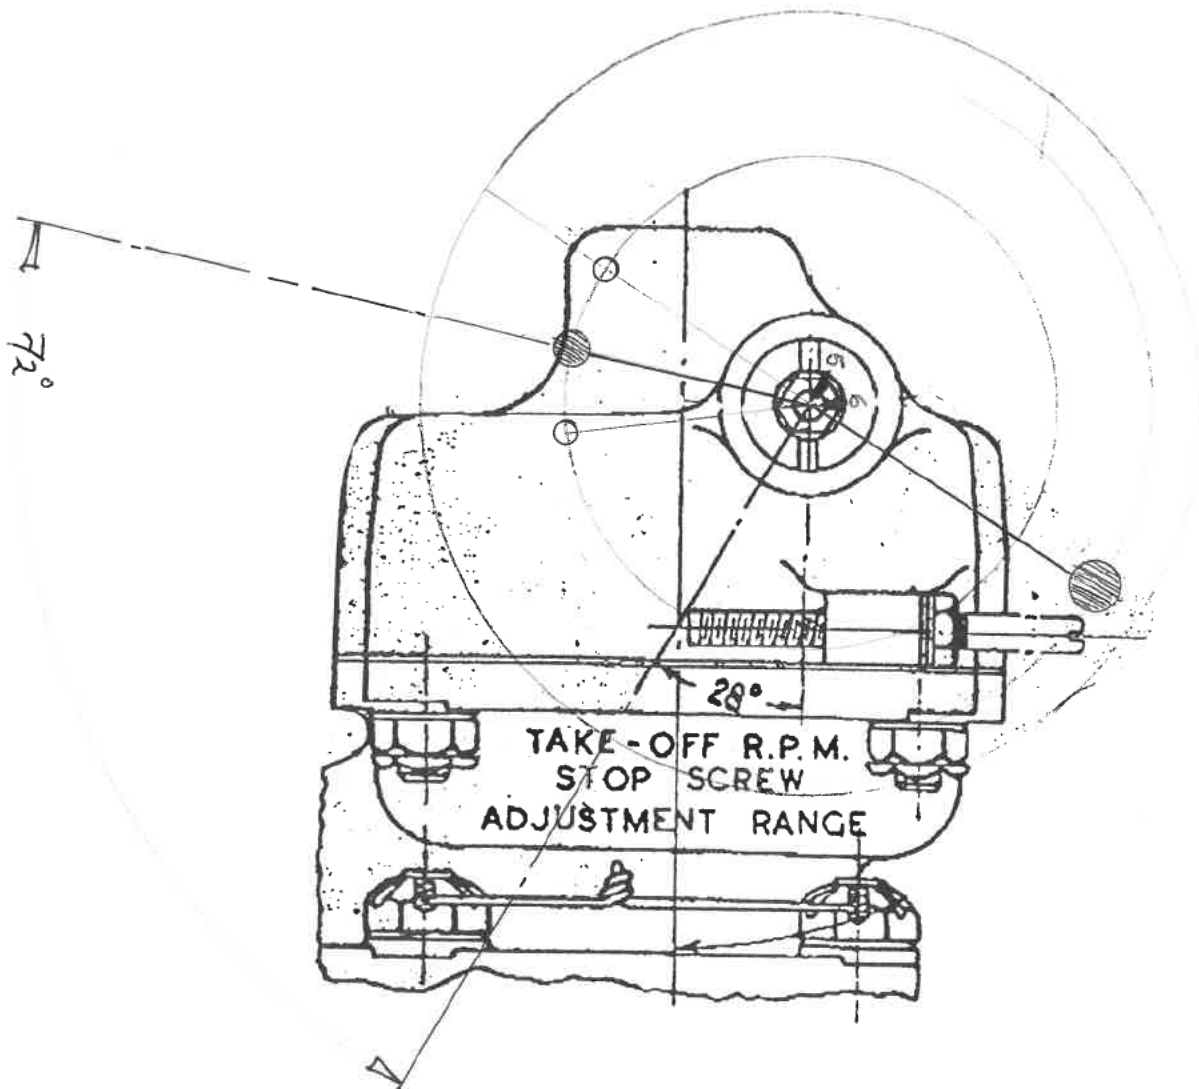
At Round - (PULLEY) SITTING IN NULL POSITION BETWEEN LOCK & R/W

TO CORRECT RIGGING ① ROTATE PULLEY 60° ON HEX SHAFT (1 FEET)
ALIGN SERIS MARK WITH NO 6.

- ② MOVE STOP SCREW 1 HOLE CW TO POSITION 1.
- ③ SCREW STOP SCREW ANTI-CW 8 TURNS TO NO POSITION.

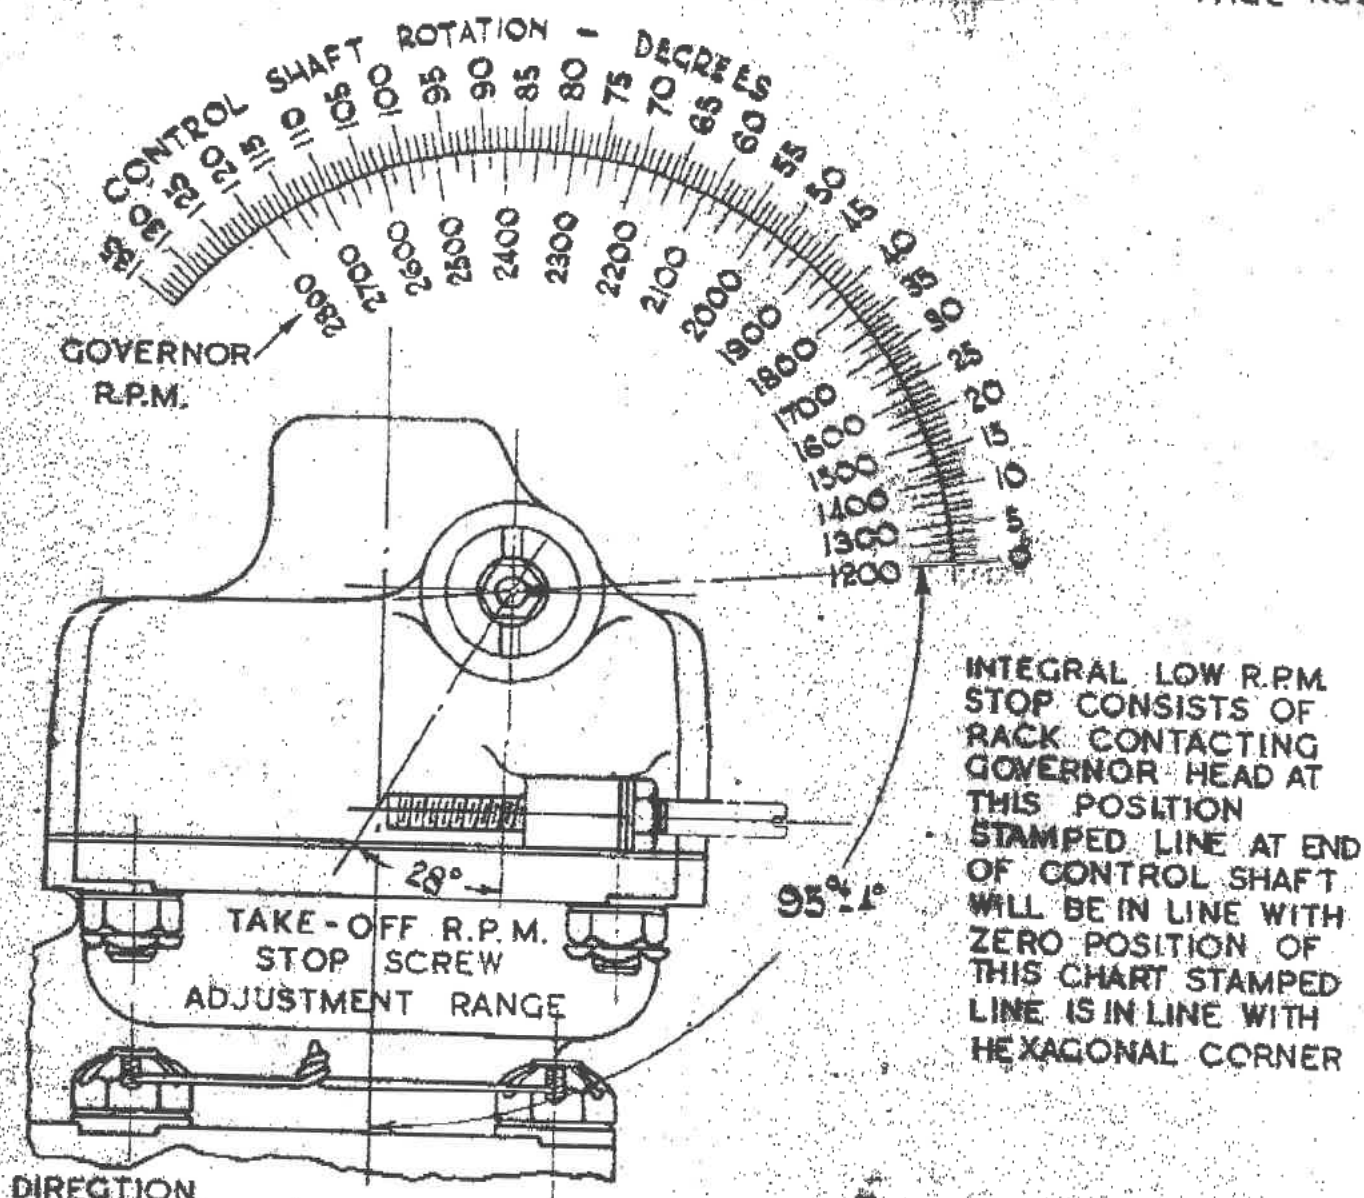
With the governor set as found on the test rig and with the pulley rotated until the stop peg was on the adjusting screw the equivalent max RPM was greater than the test rig could monitor.

When the pulley was then removed from the hexagon ended shaft the following was noted:-

- . Although the retaining nut was split pinned, there was little more than finger pressure required to loosen the nut.
- . With the retaining nut and washer removed the pulley was loose on the hexagon of the shaft. Excessive wear within the hexagon of the pulley allowed approximately 10-15 degrees of rotational movement.
- . The scribed index line on the hexagon shaft end aligned with the No 5 position stamped on the pulley face.
- . Although worn, it is considered that the wear was insufficient to enable the pulley to be rotated around the hexagon of the shaft. i.e. during disruption of the cables when the engine was torn from the aircraft.

With the governor pulley in the as found position this control check should have identified a gap between the stop peg and the screw stop with the lever in the Propeller lever fully forward in the increase RPM position.
