Derailment of freight train 9281

Near Charters Towers, Queensland, on 30 December 2020

ATSB Transport Safety Report

RO-2020-023

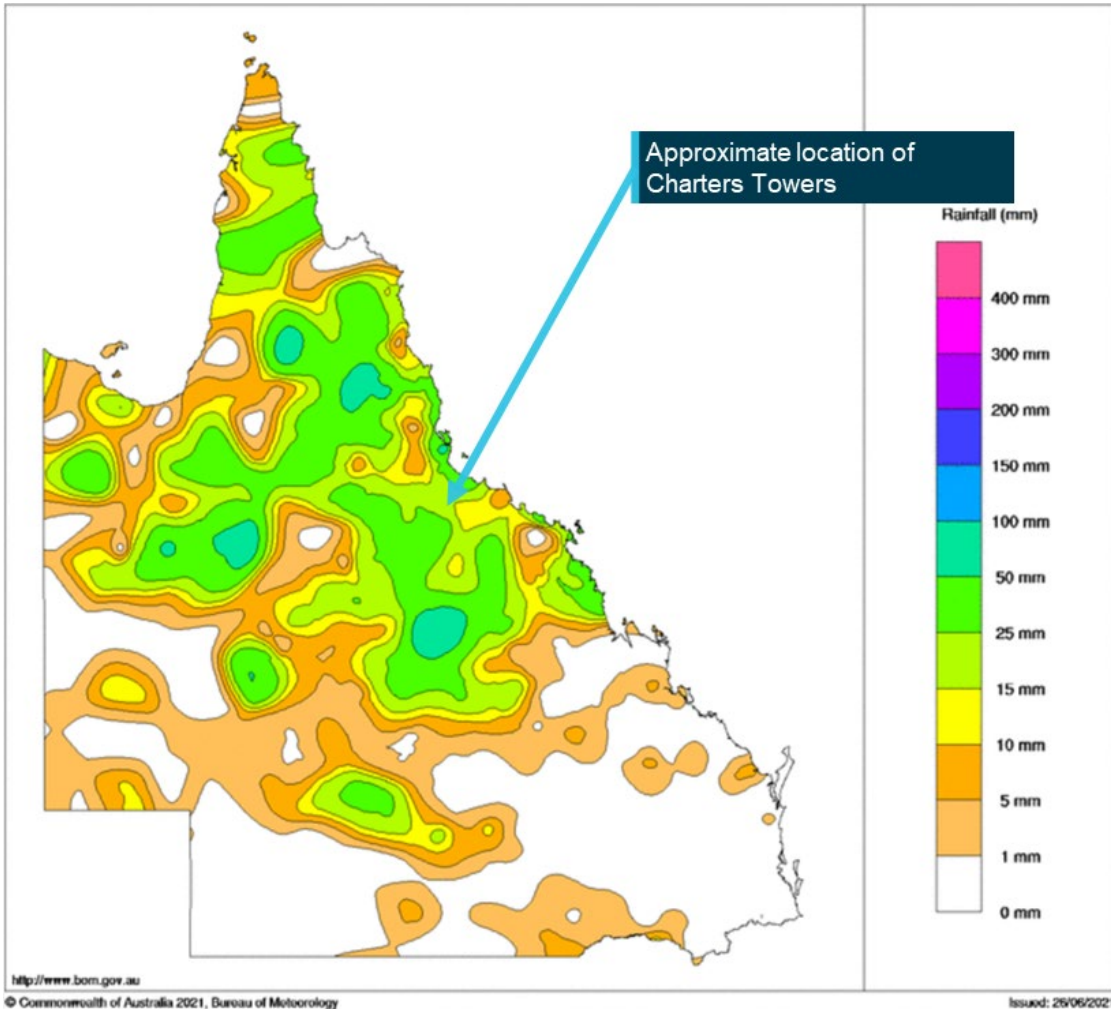
Figure 3: 29 December 2020 Rainfall Total

The BoM record of total rainfall for 29 December 2020, indicated that near the site of the derailment, the intensity of rainfall from a series of rain events was in the range of 25–50 mm over the 24-hour period. (Figure 3).

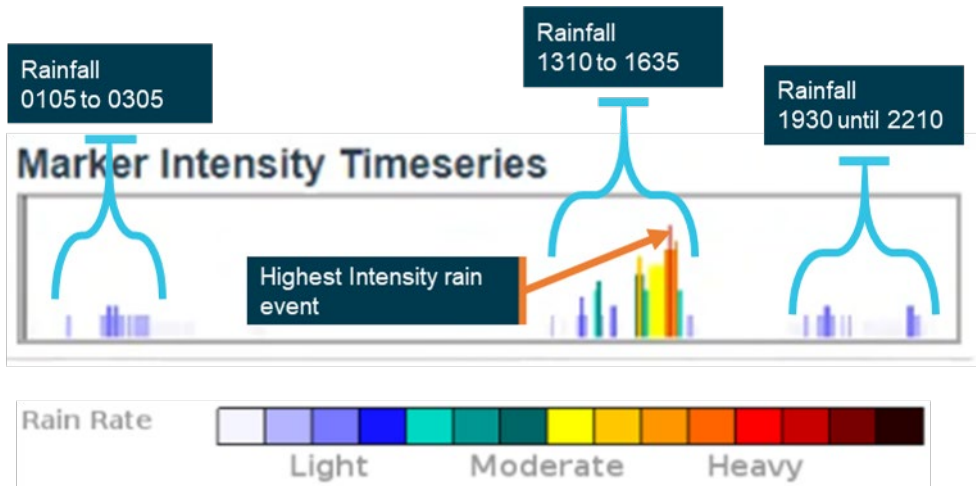
Figure 4: Weather radar rainfall intensity at derailment site over 24 hours

Weather radar data recorded a series of rainfall events at the derailment site in the 24 hours preceding the accident. They were during the periods 0105–0305 (light rainfall), 1310–1635 (moderate to heavy rainfall) and 1930–2210 (light rainfall) (Figure 4).

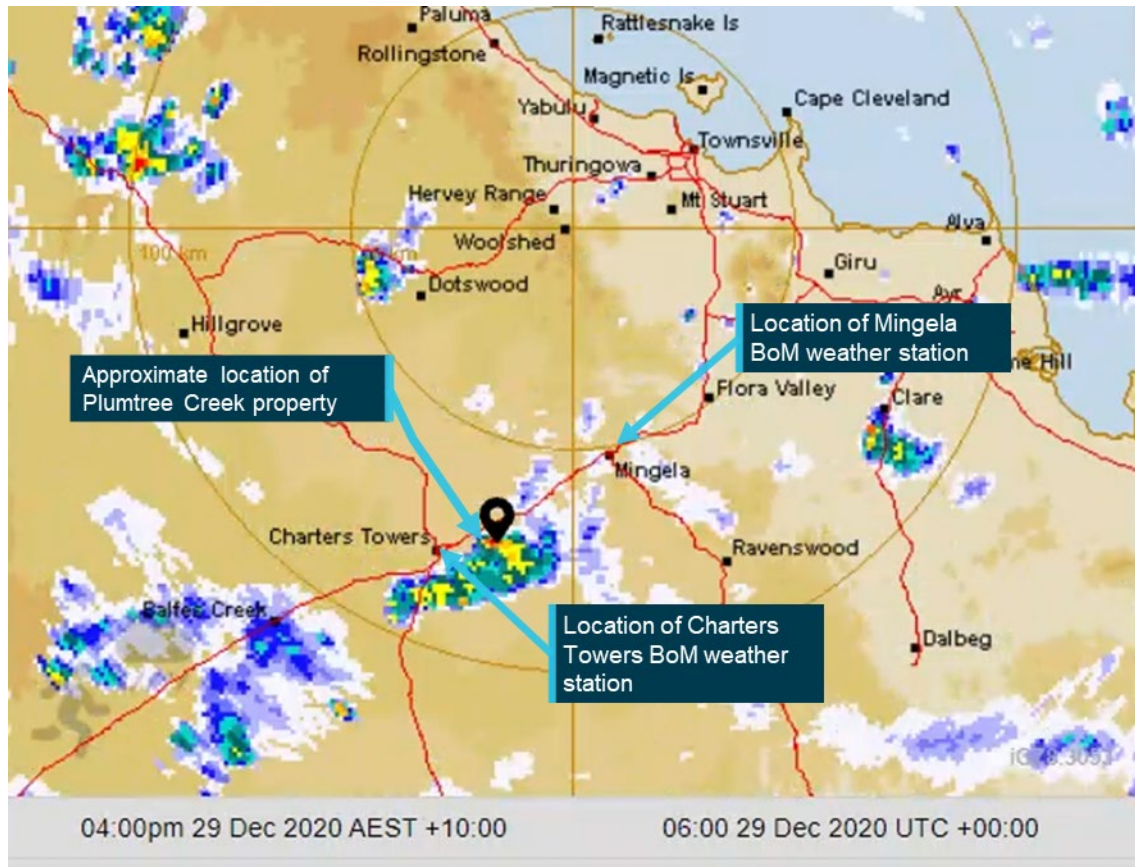
Figure 5: Weather radar rainfall intensity at derailment site

The ATSB noted that there was a period of consistent moderate to heavy rainfall at the derailment site from about 1510-1615. The 1600 weather radar data depicted a heavy rainfall event over the accident site, which passed between the weather stations at Charters Towers and Mingela (Figure 5).

A rainfall of 84 mm from 1510–1615 equates to 78 mm/h rainfall intensity.

The 78 mm/h observed was greater than a once in 20-year event (71.9 mm/h), but less than 50-year event (83.5 mm/h) for the Charters Towers weather station.⁵
