Collision with terrain involving Cessna A150M, VH-CYO

5 km west-south-west of Peachester, Queensland, on 23 June 2021

ATSB Transport Safety Report

AO-2021-025

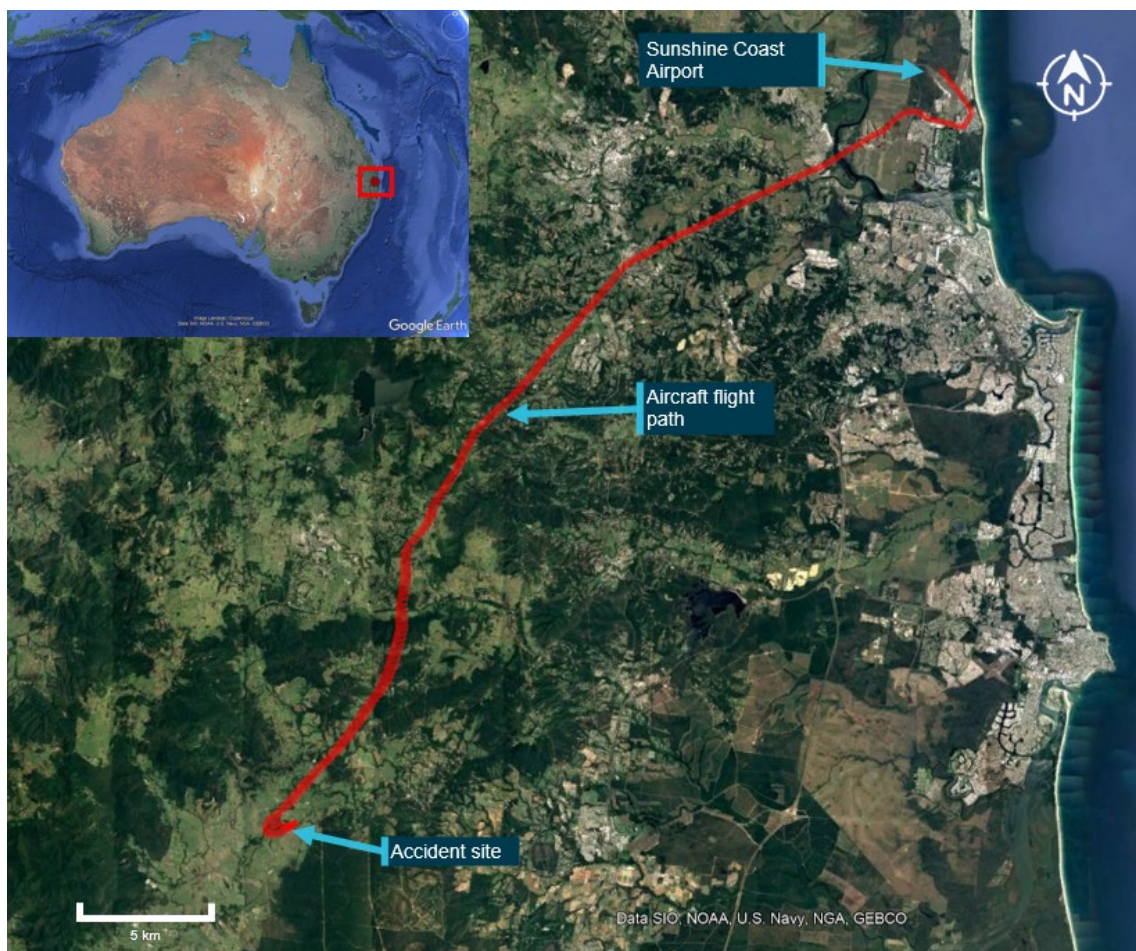
Figure 1: VH-CYO flight track radar data showing take-off point and accident site

The aircraft departed to the south-west and climbed to about 6,000 ft above mean sea level (AMSL). Radar data showed that the aircraft arrived at the area intended to conduct aerobatics about 20 minutes after departure (Figure 1).
