Hard landing involving Kavanagh Balloons B-350, VH-BSW

2 km south of Lilydale Airport, Victoria on 31 December 2021

ATSB Transport Safety Report

AO-2022-003

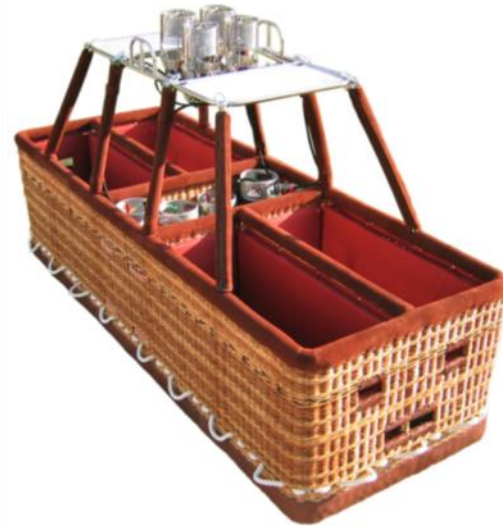
Figure 3: Double-T partitioned basket (example)

VH-BSW was a Kavanagh B-350 balloon which included an envelope, double T-partitioned basket with 32 rope handles (Figure 3) and 4 passenger compartments, a three burner system and 3 propane fuel tanks.

The depicted basket has a four-burner system
 Source: Kavanagh Balloons

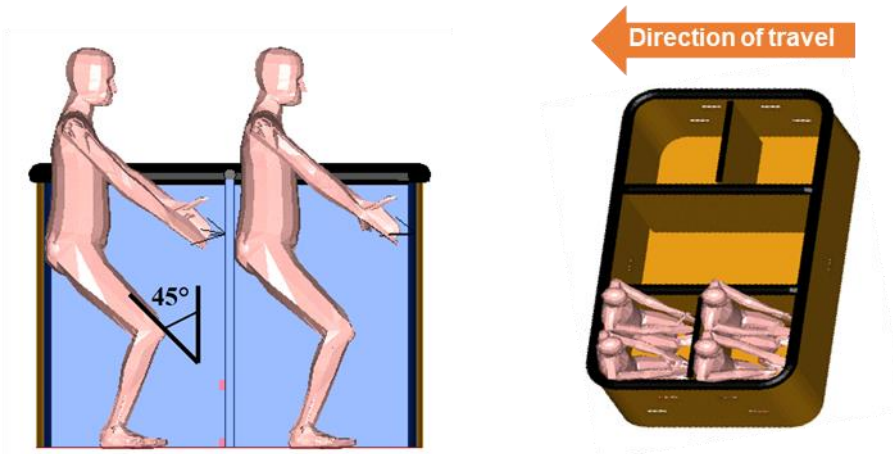
Figure 5: Recommended landing position (double T-partitioned basket)

The landing position on the operator’s safety briefing cards was a similar position to that recommended by the United Kingdom Civil Aviation Authority (CAA)⁵ for the double T-partitioned basket and required a passenger’s back to be facing the direction of travel with knees bent at an angle of less than 90 degrees (Figure 5). The research conducted to support the CAA recommendation⁶ found the backwards facing landing position reduced the risk of injury compared to the sideways facing position (Figure 6) during heavy and tip-over landings.⁷
