ATSB TRANSPORT SAFETY INVESTIGATION REPORT
Rail Occurrence Investigation Report 2006005
Final

Derailment of Train 5MB7

Benalla, Victoria

2 June 2006

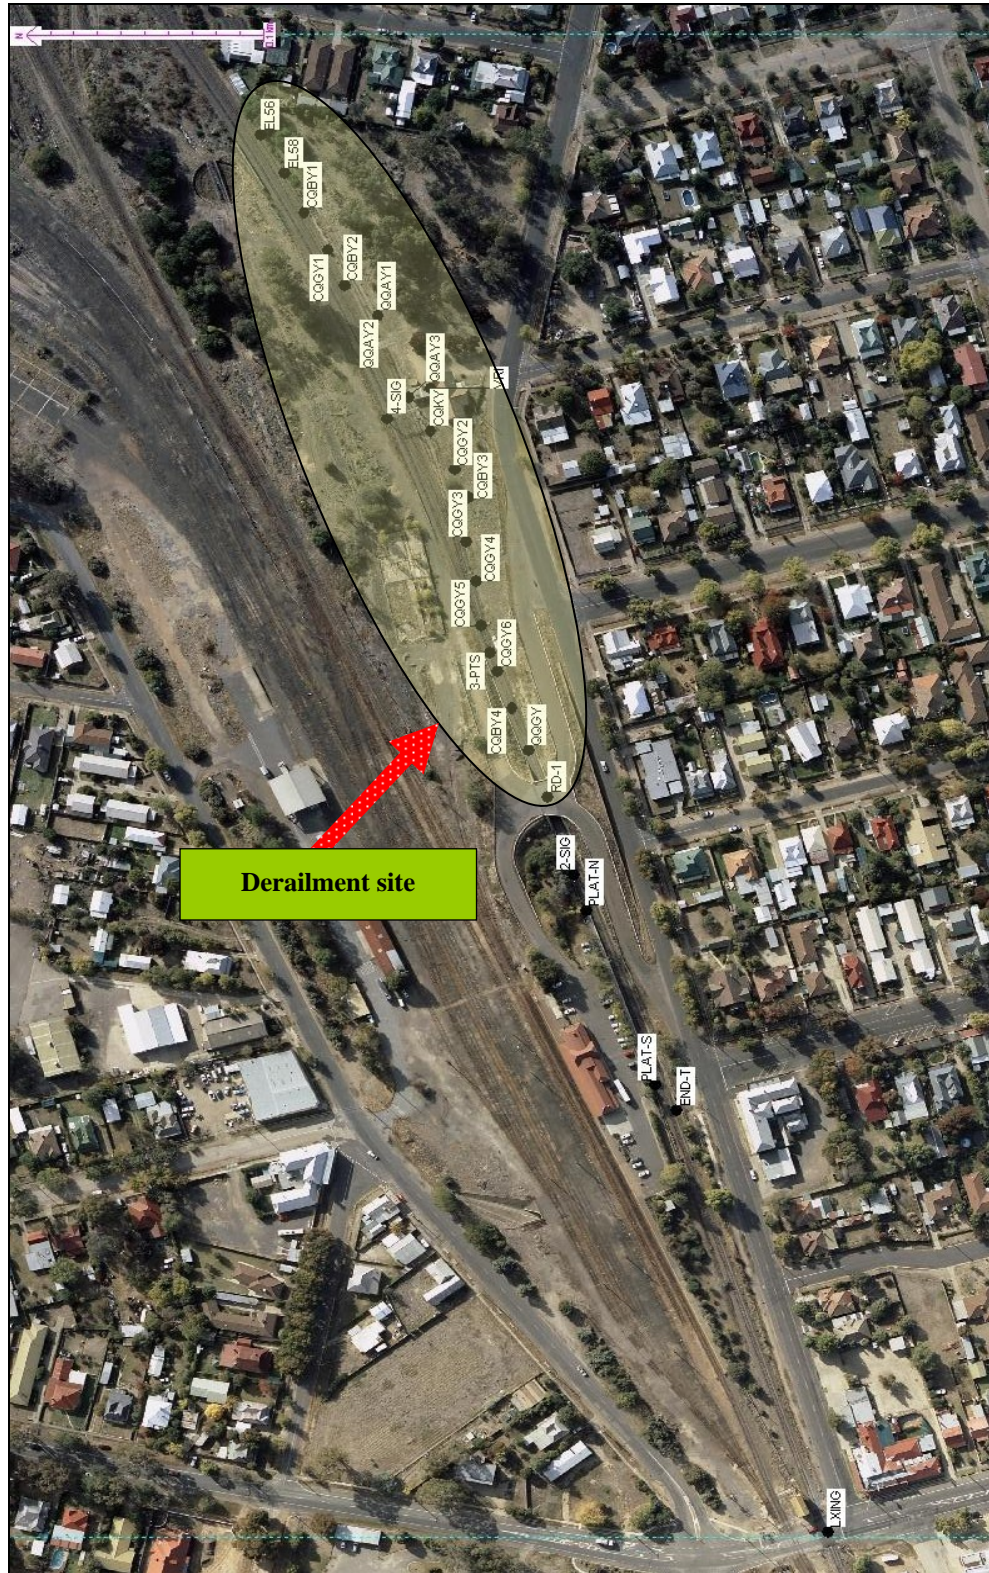
Figure 2:: Aerial photograph Benalla derailment site (S36°32.6' E145° 59.3') with position of locomotives/wagons superimposed on image.

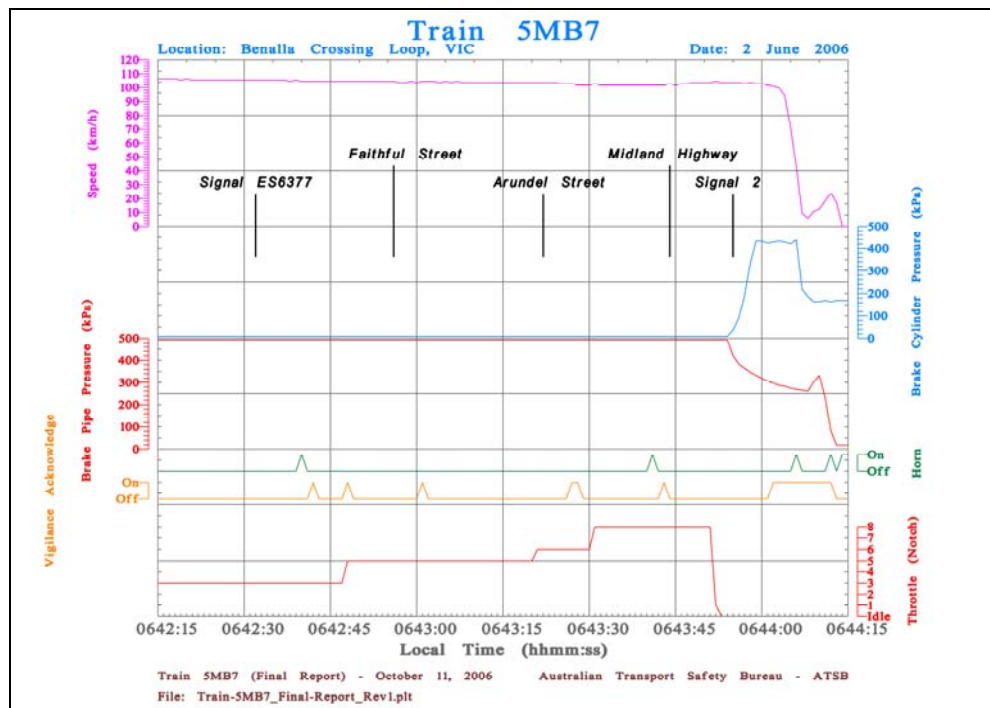
Figure 11: Data download from Fischer locomotive data logger.

Testing of the Benalla signalling hardware and circuits was undertaken over the period 2 to 3 June 2006. Information available from these tests was examined in conjunction with recorded CTC data and locomotive data (Fig. 11) and combined into a sequence of events list, section 5.1 of the Appendixes.

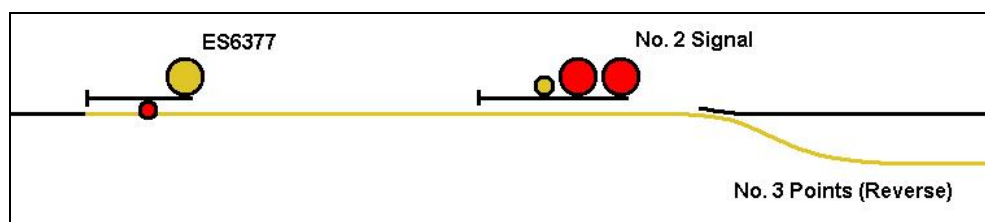
At 0629:54 the train controller in Adelaide set the Benalla crossing loop for an 'auto-cross'⁷. This was to allow train 5MB7 and train 5SM5, a Melbourne bound Pacific National (PN) freight train, to cross at Benalla. Train 5MB7 was being routed into the crossing loop and 5SM5 onto the main line. For this crossing configuration, No. 3 points was set to the reverse position, No. 2 Signal cleared to a 'Caution (low speed)' aspect and signal ES6377 (Fig. 12) should correspondingly have cleared to a 'Caution (normal speed)' aspect.

Figure 12: Signal ES6377 displays 'Caution (normal speed)' with No. 2 Signal displaying 'Caution (low speed)'.

The train controller in Adelaide selected Benalla for an ‘auto-cross’, with No. 3 points set reverse. For this configuration, the signal system is designed to clear No. 2 Signal to a ‘Caution (low speed)’ and signal ES6377 should correspondingly only ever clear to a ‘Caution (normal speed)’, Fig. 12.

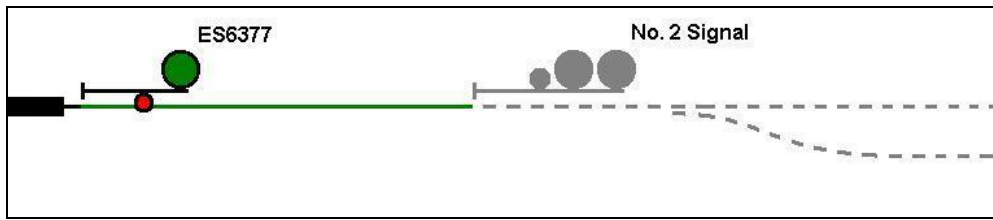
In his statement, the driver indicated that he was sure that signal ES6377 was displaying a 'Clear (normal speed)' aspect (Fig. 15). Had he seen this aspect it would be natural to interpret this indication to mean that the route was set for the main line, ie No. 3 points was set normal and the train could proceed at full line speed, 115 km/h.

Figure 15: Train driver stated that signal ES6377 was displaying a 'Clear (normal speed)'

The driver of train 5MB7 stated that signal ES6377 was displaying a ‘Clear (normal speed)’ aspect (Fig. 15) and he interpreted the indication as a route set for the main line. The driver also stated that when he saw No. 2 Signal it was displaying a ‘Caution (low speed)’ aspect (Fig. 17) and as he traversed No. 3 points they were set reverse.

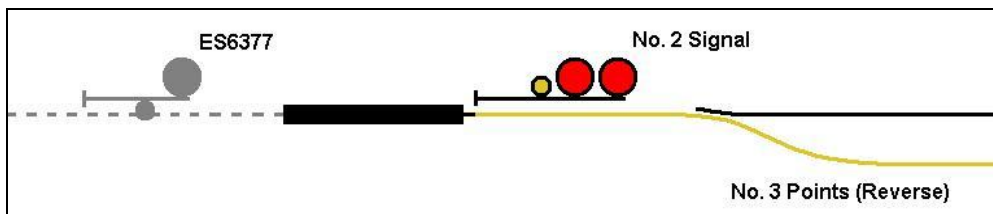
Figure 17: Train driver stated that signal No. 2 was at 'Caution (low speed)'.

The final reset of the vigilance system occurred at 0643:43 when the train was just in advance of the Midland Highway level crossing and 350 m from No. 2 Signal (Fig. 16). At 0643:51 the train was 120 m from the signal and just in front of the Benalla passenger platform when the driver reacted to the 'Caution (low speed)' aspect displayed by No. 2 Signal (Fig. 17).

The train driver throttled off immediately and made an emergency brake application.

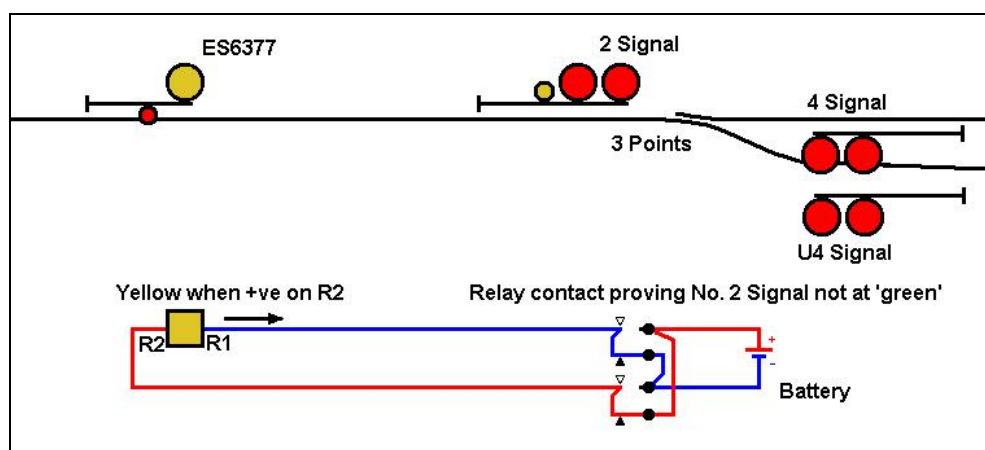
Figure 21: Simplified circuit - ES6377 showing pole changing circuit. Mechanism at 'yellow' when No. 2 Signal top arm at 'red'.

The simplified circuit diagram at Fig. 21 illustrates that when No. 2 Signal is not displaying a 'green' indication that signal ES6377 can only be energised to display a 'yellow' aspect. Similarly the circuit diagram at Fig. 22 illustrates that when No. 2 Signal displays a 'green' indication that signal ES6377 is energised to display a 'green' aspect.

Testing of the circuit established that it was functioning correctly, all wiring was electrically sound and the signal mechanism responded freely and correctly to the applied battery polarity.

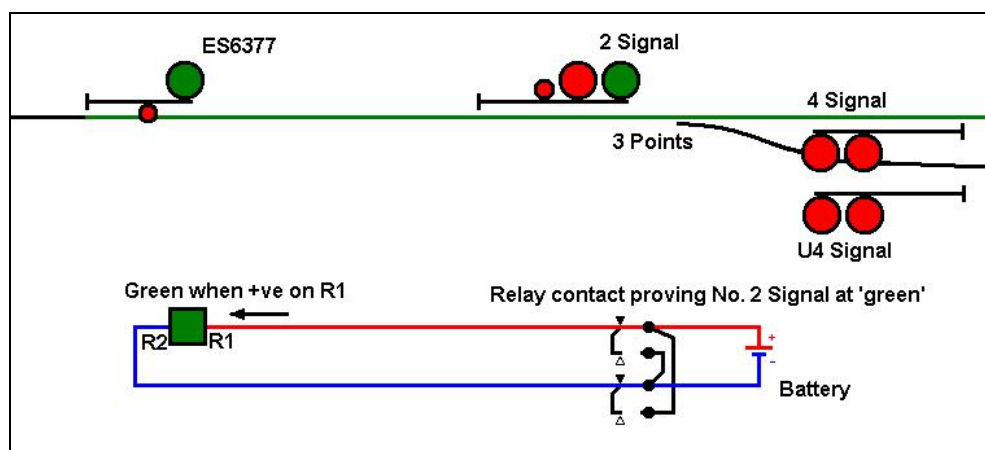
The operation of ES6377 could not be electrically faulted.

Figure 22: Simplified circuit - ES6377 showing pole changing circuit. Mechanism at 'green' when No. 2 Signal top arm at 'green'.

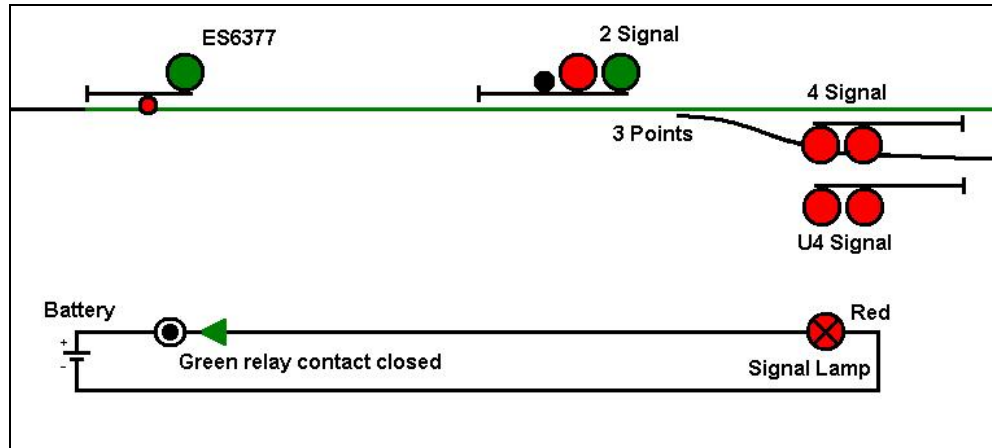
However, searchlight signals contain moving parts and there have been some rare instances where the rotary movement has become stuck and displayed a false green or yellow indication instead of red. To guard against this undesirable event, the design of the Benalla signal circuits electrically prove the position of the rotary movement for signal ES6377 (Fig. 23 and Fig. 24).

If the rotary movement is detected in the wrong position, ie displaying a green or yellow instead of red, the opposing signals, 'Up Starter' signals No. 4/U4, are prevented from clearing, ie retained at stop.

Figure 23: Simplified circuit – 4/U4 Signal is held at ‘red’ if signal ES6377 is displaying a ‘green’ aspect.

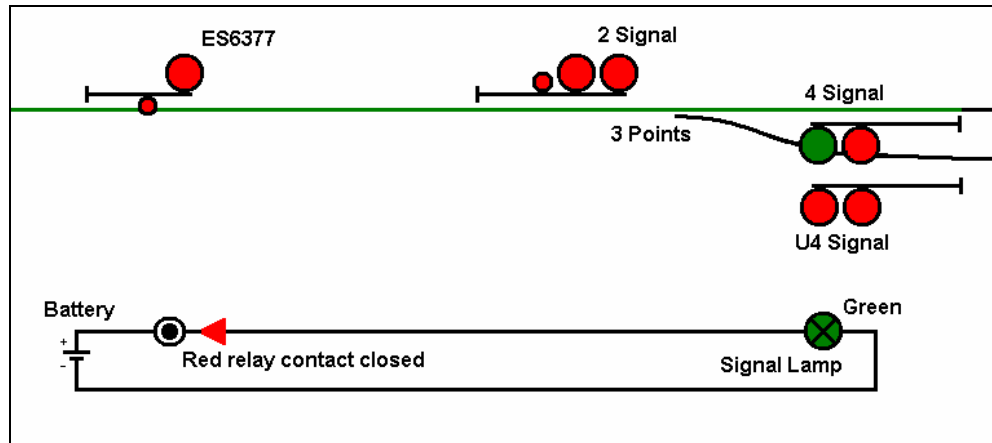
Figure 24: Simplified circuit – 4/U4 Signal proves that ES6377 is displaying a ‘red’ aspect before it can clear to ‘green’.

When considering train movements, Table 3 shows that the previous three movements through Benalla were all travelling in the up direction which requires 4/U4 signals to be cleared. As all three movements passed through Benalla under the appropriate signal indication, this verifies that the mechanism in signal ES6377 was displaying a ‘red’ aspect. This confirms that signal ES6377 was not displaying a ‘green’ indication as train 5MB7 approached due to a mechanical fault (stuck rotary movement) in the signal mechanism.
