ATSB TRANSPORT SAFETY INVESTIGATION REPORT

Aviation Occurrence Report – 200505311

**Crosswind Landing Event
Melbourne Airport, Vic. - 26 October 2005
HS-TNA
Airbus A340-642**

At 1200 Eastern Standard Time on 26 October 2005, the outboard bead heel of the number-1 wheel tyre on the left main landing gear (MLG) of an Airbus A340-642 (A340) aircraft, registered HS-TNA, separated from the outboard rim of the wheel assembly during a landing on runway 16 at Melbourne Airport, Vic. The landing was conducted during gusting crosswind conditions.

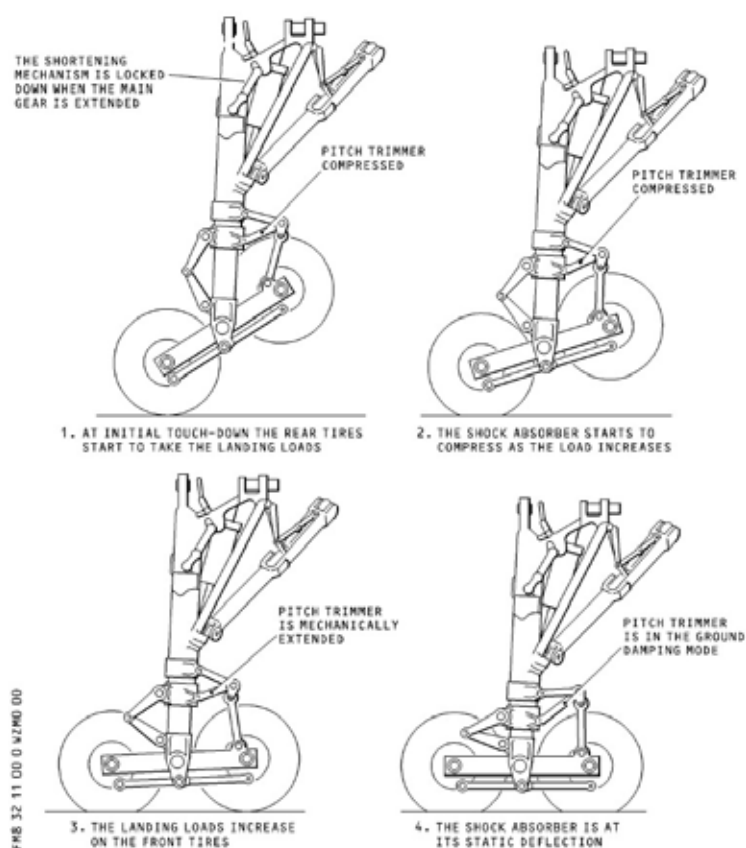
Figure 4: Main landing gear bogey alignment – direction of travel left to right

The main landing gear bogeys of the A340 tilted rearwards when the aircraft was airborne with the landing gear extended. During landing, the rear tyres on the MLG contacted the ground first. As the aircraft weight settled onto the MLGs, the MLG bogey arms 'derotated', and the front tyres lowered onto the ground (figure 4).

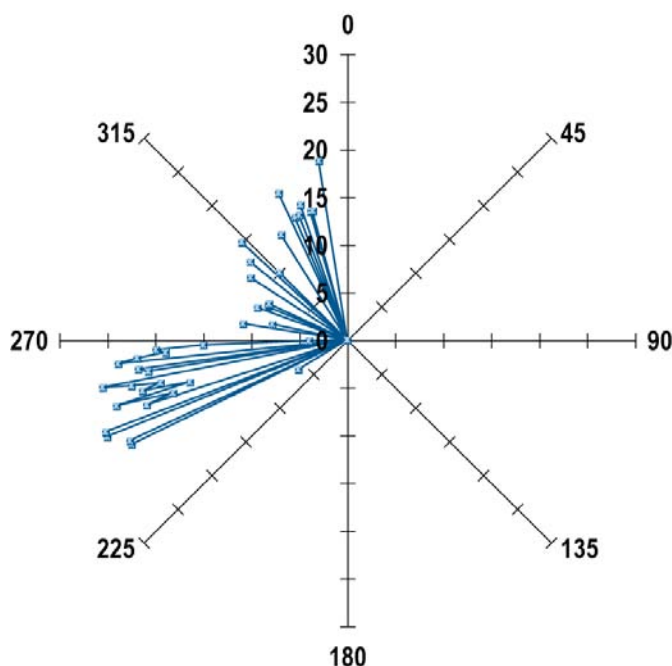
Figure 6: MLW1 anemometer wind rose for period 1100 to 1200

The recorded data from the MLW1 anemometer revealed that, during the period between 1100 and 1200, the mean wind direction ranged from between 245 to 352 degrees true. During that same period, the maximum wind speed ranged from 6 kts to 27 kts, and was greater than 15 kts for a total of 34 minutes.

A wind rose providing information about the 1-minute distribution of maximum wind speeds and the frequency of the varying wind directions that were recorded by the MLW1 anemometer between 1100 and 1200 is depicted at figure 6.

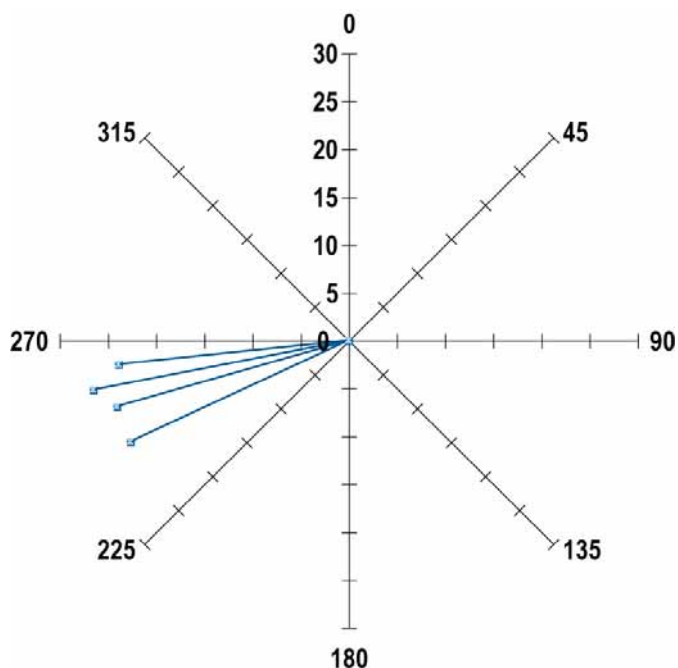
Figure 7: MLW1 anemometer wind rose for period 1156 to 1200

A wind rose providing information about the 1-minute distribution of maximum wind speeds and the frequency of the varying wind directions that were recorded by the MLW1 anemometer between 1156, when the aircraft contacted the tower controller, and 1200, when the aircraft landed, is depicted at figure 7.

During that period, the maximum wind speed and direction recorded by the anemometer confirmed that the crosswind conditions on runway 16 exceeded 12 kts. However, the Melbourne Tower Aerodrome Controller did not pass information to the crew about the significant crosswind conditions.

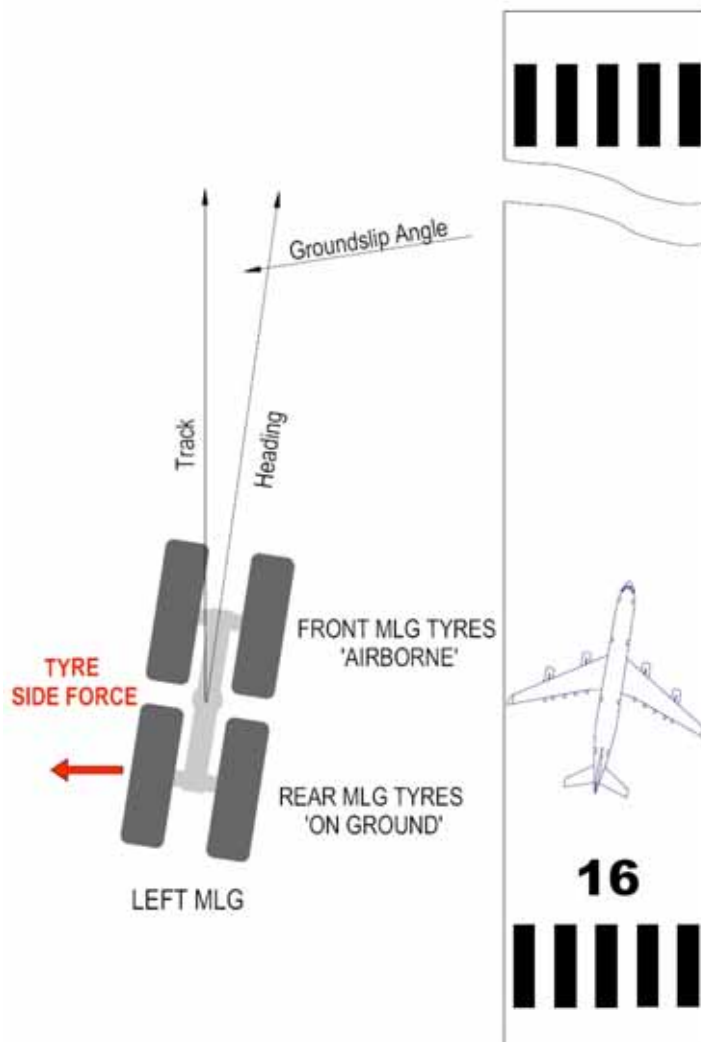
Figure 9: Touchdown MLG groundslip angle

That angle is the angular displacement between the plane of rotation of the tyre (generally approximating the aircraft heading), and the tyre's direction of motion or track over the ground (figure 9).

Large groundslip angles result if an aircraft lands with a large drift or ‘crab’ angle in strong crosswind conditions. Under those conditions, tyre side forces may reach a ‘saturation’ point at which stage the tyre will enter a fully-skidded state.

On dry runways, where good grip exists between the tyre and the runway surface, a fully-skidded condition will normally occur at a groundslip angle of about 15-degrees. On icy runways, a fully-skidded condition may occur at a groundslip angle of only 5-degrees. It is for that reason that crosswind landings on contaminated runways pose greater risk than on dry runways.

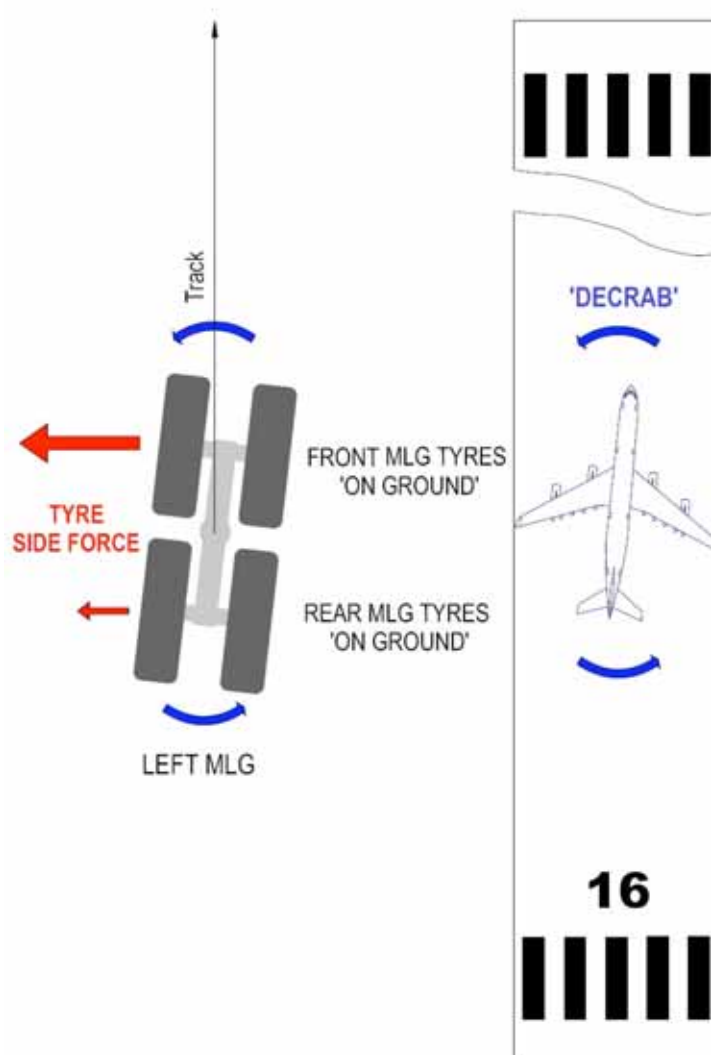
Figure 10: MLG tyre side forces during 'decrab' after touchdown

The MLG on an aircraft fitted with a conventional tricycle undercarriage is located aft of the aircraft centre of gravity. During a crabbed landing in crosswind conditions, the MLG tyre side forces tend to ‘decrab’ the aircraft into alignment with the vector of its forward momentum as depicted in figure 10.
