ATSB TRANSPORT SAFETY INVESTIGATION REPORT

Aviation Occurrence Report – 200600563

Engine Failure

VH-KLP

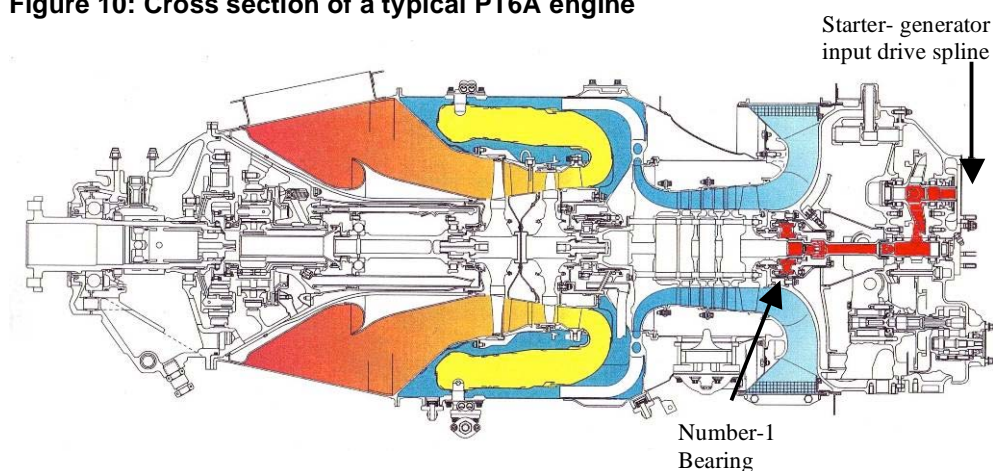
Figure 10: Cross section of a typical PT6A engine

Figure 10 illustrates the construction of the PT6A engine. The positions of the number-1 bearing and the starter-generator input drive spline are indicated by arrows. The typical starter-generator EDD electrical current path is highlighted in red between the two arrows.

There are two known ways starter-generator EDD can occur. The first type of starter-generator EDD, which is the type found in this event, is a hard short or low resistance to earth, caused by an insulation breakdown in the armature windings or lamination slots. This type of event allows a single high current transient discharge

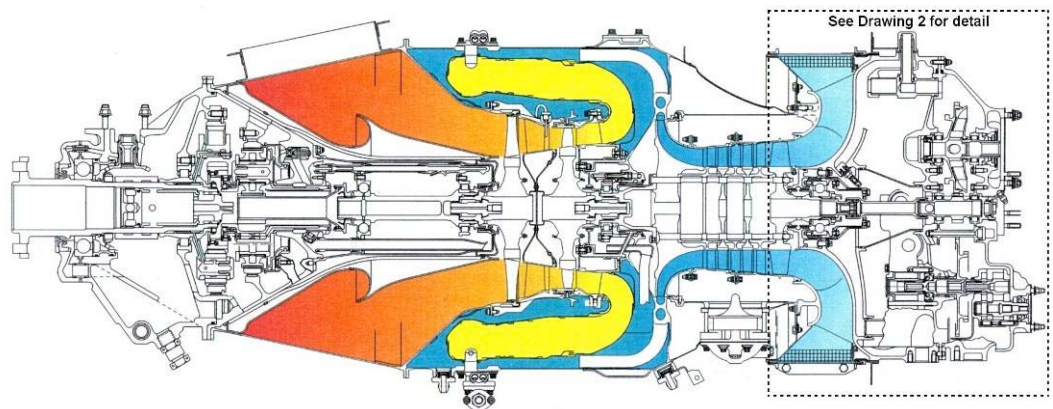
Drawing 1: Sectional view of a typical PT6A engine – accessory gearbox and number-1 main shaft bearing area enclosed

Drawing 1 presents a representative cross-sectional view of the PT6A engine, with Drawing 2 showing the arrangements of the components referred to above within the engine compressor inlet and accessory gearcase.

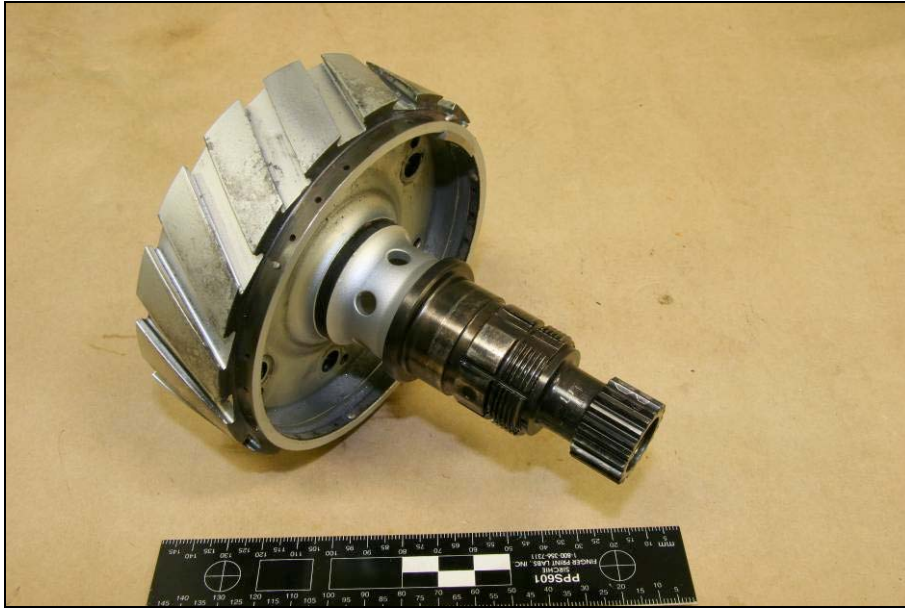
Figure 13: Compressor rear hub and coupling spline

Drive to the accessory gearcase of the engine was transferred from a splined coupling integrated into the stage-1 compressor hub, see Figure 13. The coupling splined connection adjacent to the number-1 bearing mount showed a small circular region of localised pitting damage on the face of a single spline tooth, see Figure 14. The surrounding surfaces showed no other anomalous features or damage associated with service or maintenance. The uniform, circular and isolated nature of the pitted region was consistent with the effects of localised surface re-melting, produced by a transient electrical discharge event, with current flow across the coupling connection.

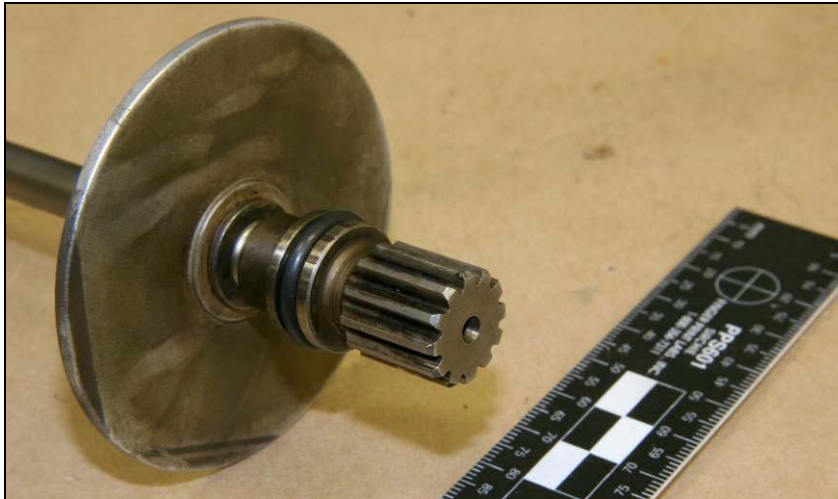
Figure 24: Starter-generator drive shaft and coupling spline

The starter-generator unit that had failed while in service on VH-KLP, was an APC model 200SGL, part number 200SGL119Q, serial number 2870XL. To support the engine failure mode investigation, the SG central splined drive shaft, see Figure 24, and the armature assembly were received and examined to identify and characterise any anomalous damage or unusual appearance. Under low power examination, the drive spline teeth showed several areas of pitting and surface re-melting, again typical of EDD, see Figures 25 and 26. Otherwise, the drive shaft appeared sound and showed no evidence of premature breakdown or damage.
