ATSB TRANSPORT SAFETY INVESTIGATION REPORT  
Rail Occurrence Investigation 2006006  
Final

Level crossing collision between  
**XPT Passenger Train ST24  
and Passenger Car**

Thurgoona Road, Albury, NSW

5 June 2006

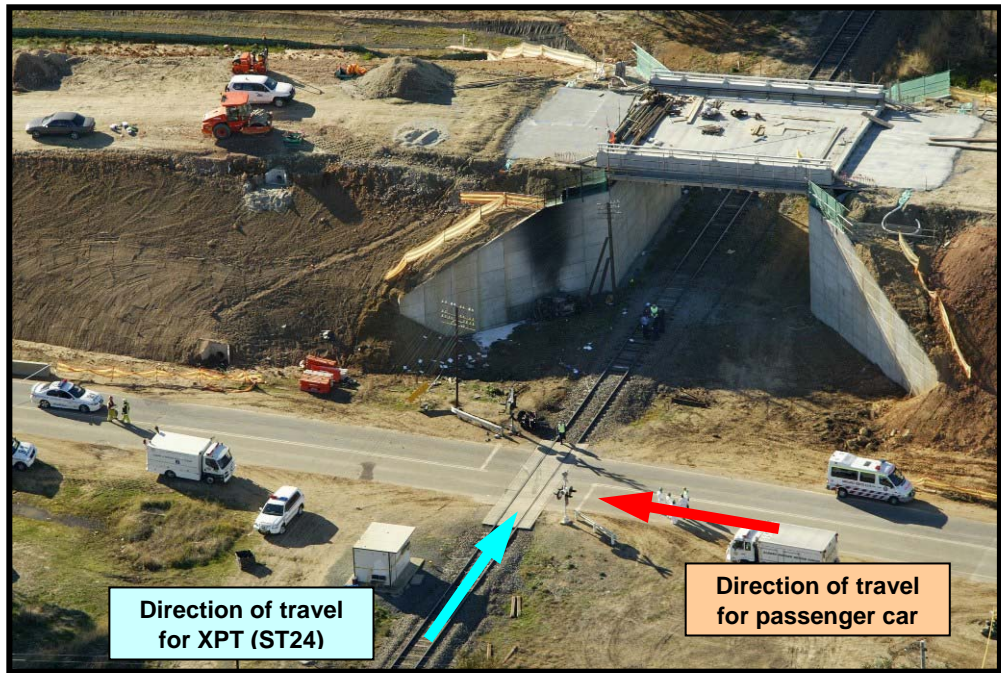
**Figure 2: Thurgoona Road level crossing and road bridge construction**

Thurgoona Road is located on the northern outskirts of Albury and links the Hume Highway to the smaller township of Thurgoona. At the time of the accident, Thurgoona was considered a growth front, projected to service a sub-regional population of up to 30,000 people. Consequently, the road junction between the new Hume Highway and Thurgoona Road was to become a major freeway interchange, incorporate a road bridge over the DIRN and the subsequent closure of the ‘at-grade’ level crossing.

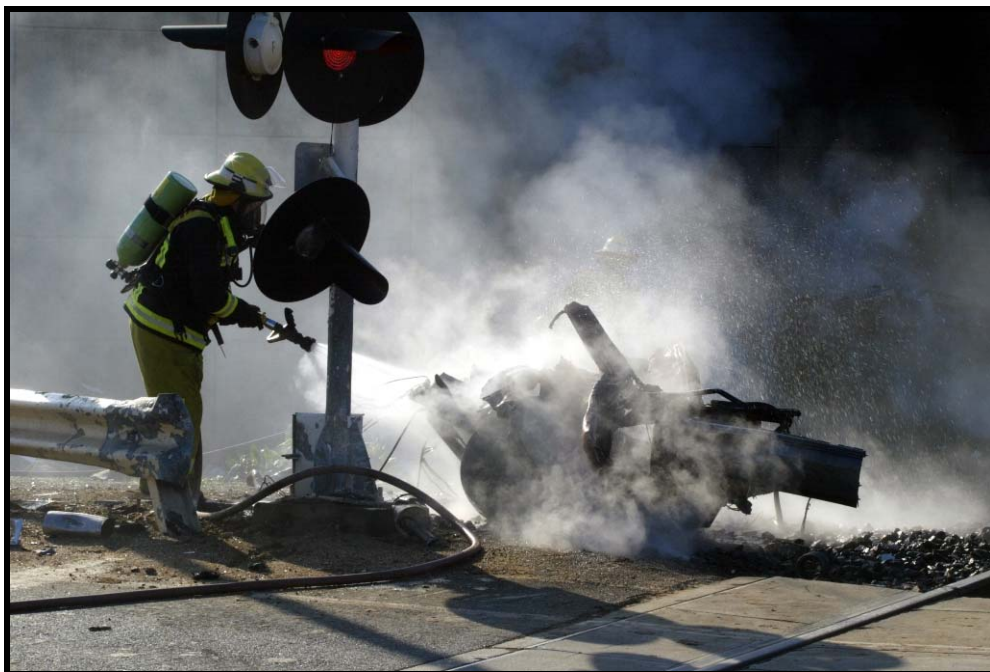
**Figure 7: Emergency Services**

CountryLink staff liaised with the passengers of train ST24, firstly ensuring there were no injuries, and then attending to passenger comfort until evacuation processes could begin. With the assistance of emergency services personnel and CountryLink staff, passengers were safely transferred to alternative transport for completion of their journey.

In general, the emergency response was conducted in an efficient and professional manner, including the actions of train crew, train control staff, witnesses and emergency services personnel.
