Bureau of Air Safety Investigation

# Wire strikes

A technical analysis

June 1991

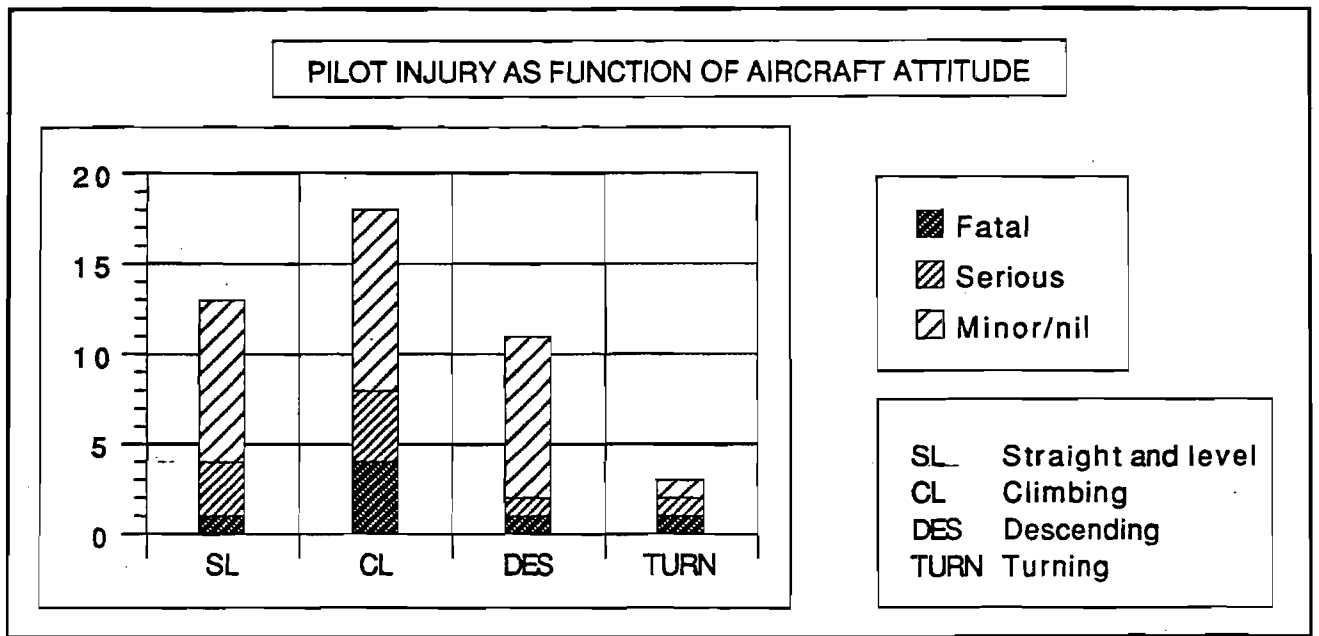
FIGURE 4

The attitude of the aircraft when it made contact with the wire was classified as follows: straight and level (sl), descending (des), climbing (cl), and turning (turn). It can be seen from Figure 4 that accidents which occurred whilst flying straight and level or in descent provided the lowest degree of injury for the pilot (69% and 55% without significant injuries respectively).

Striking powerlines with the landing gear whilst in a climb attitude was responsible for 18 accidents of which four were fatal.

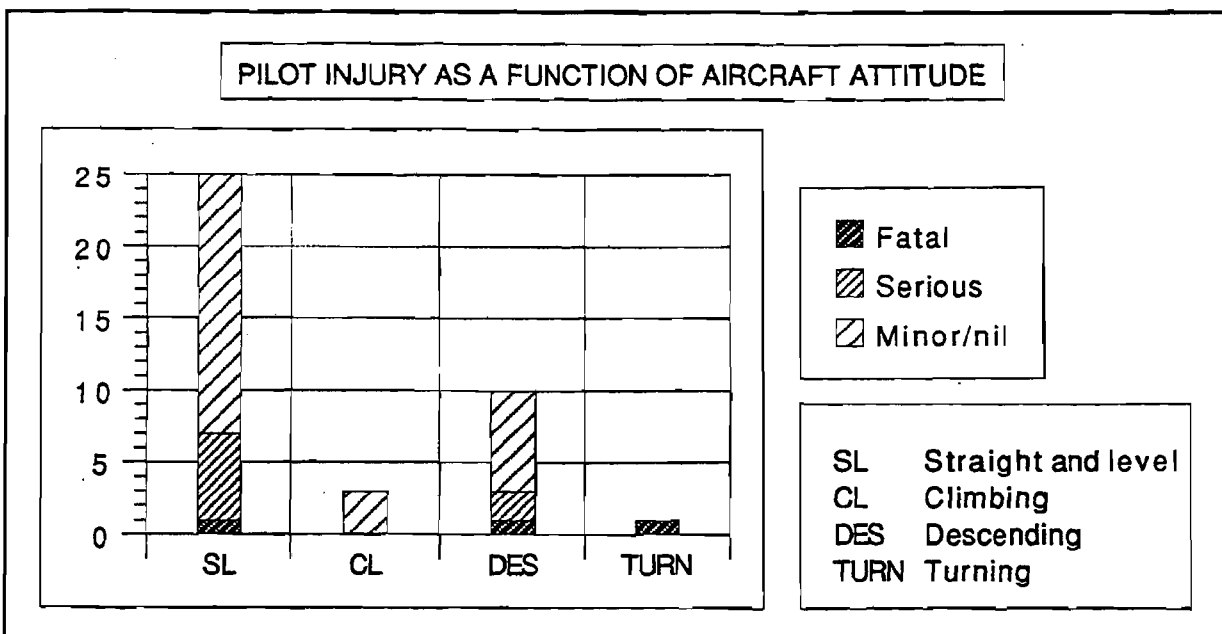
FIGURE 9

Figure 9 depicts the breakdown of accidents according to aircraft attitude at the time of contact with the fin and/or deflector.

Of all the accidents involving straight and level flight, in 49% of the cases the contact was with the fin and/or deflector. Nearly half of these pilots escaped relatively uninjured (41%).

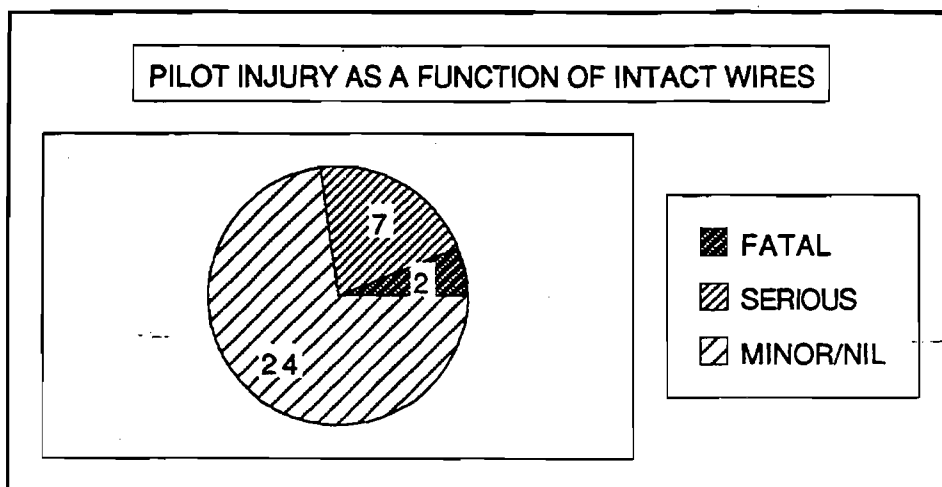
FIGURE 10

In the majority of the fin and/or deflector strikes, the wire remained intact (33 out of 39 cases). The majority of these led to minor or no injuries to the aircraft occupant (see Figure 10).

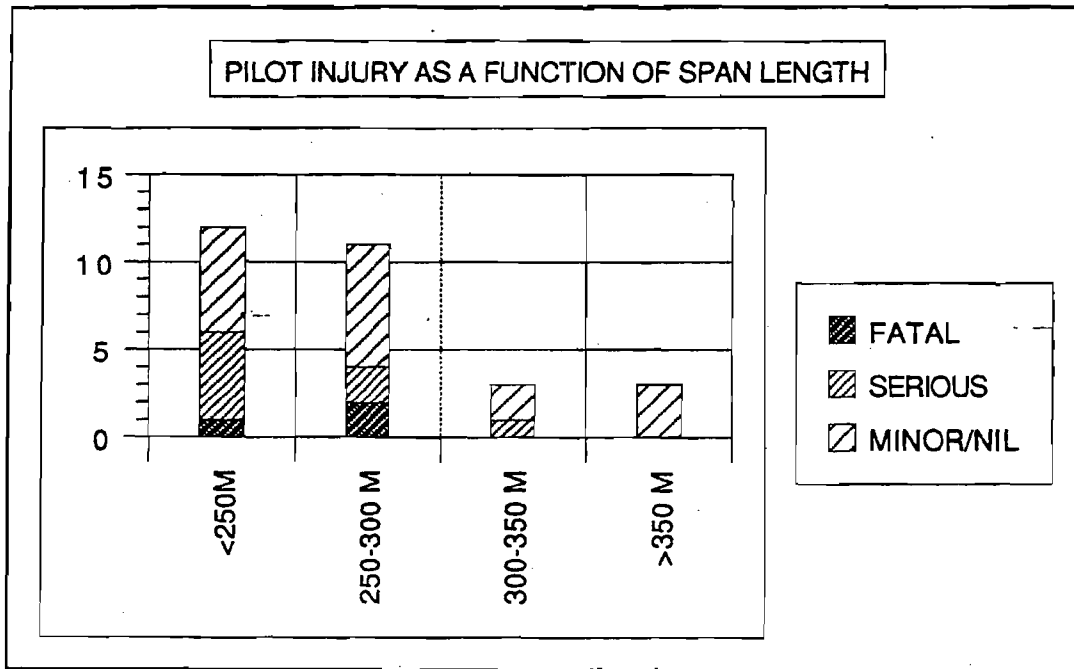
FIGURE 11

Figure 11 tends to indicate that a greater number of accidents occurred following strikes with wires of shorter span lengths.

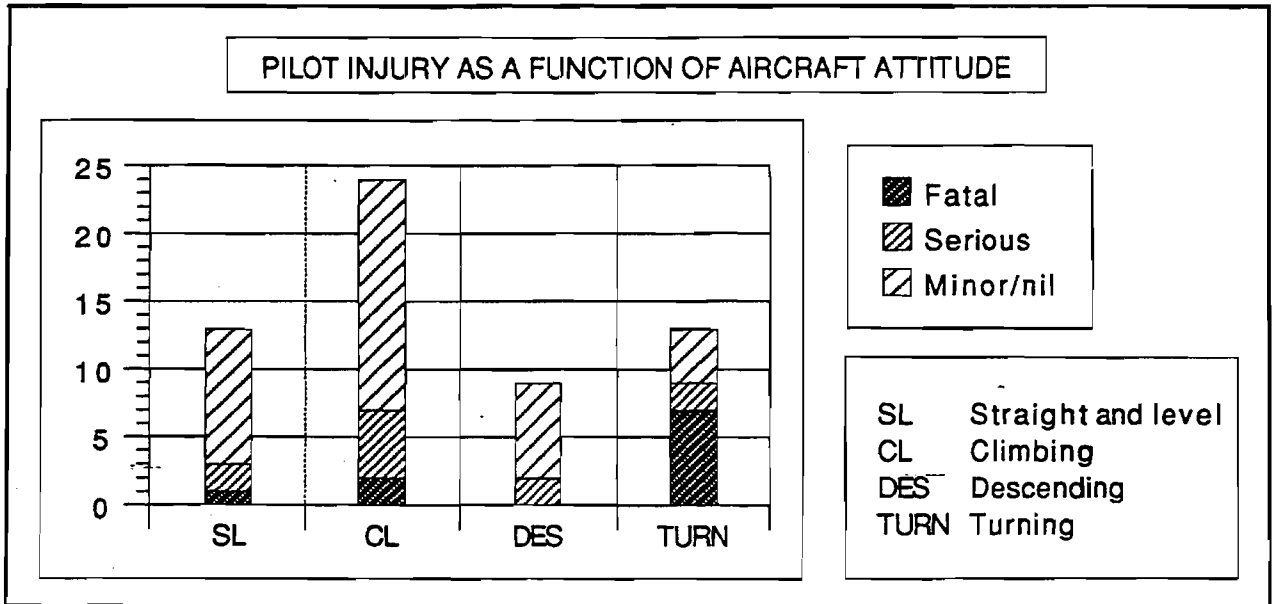
FIGURE 12

Figure 12 gives the breakdown of accidents according to aircraft attitudes. The results show that the greatest number of accidents involving strikes by parts of the aircraft other than the landing gear, fin or deflector occurred whilst the aircraft was in a climb (40%). Analysis of injury according to the attitude of the aircraft at the time of the accident indicated that similar proportions were killed, seriously injured, minimally injured or uninjured when the aircraft was in climb or in straight and level flight.

Accidents which occurred whilst the aircraft was turning resulted in a higher proportion of deaths and accounted for 35% of all fatal accidents.

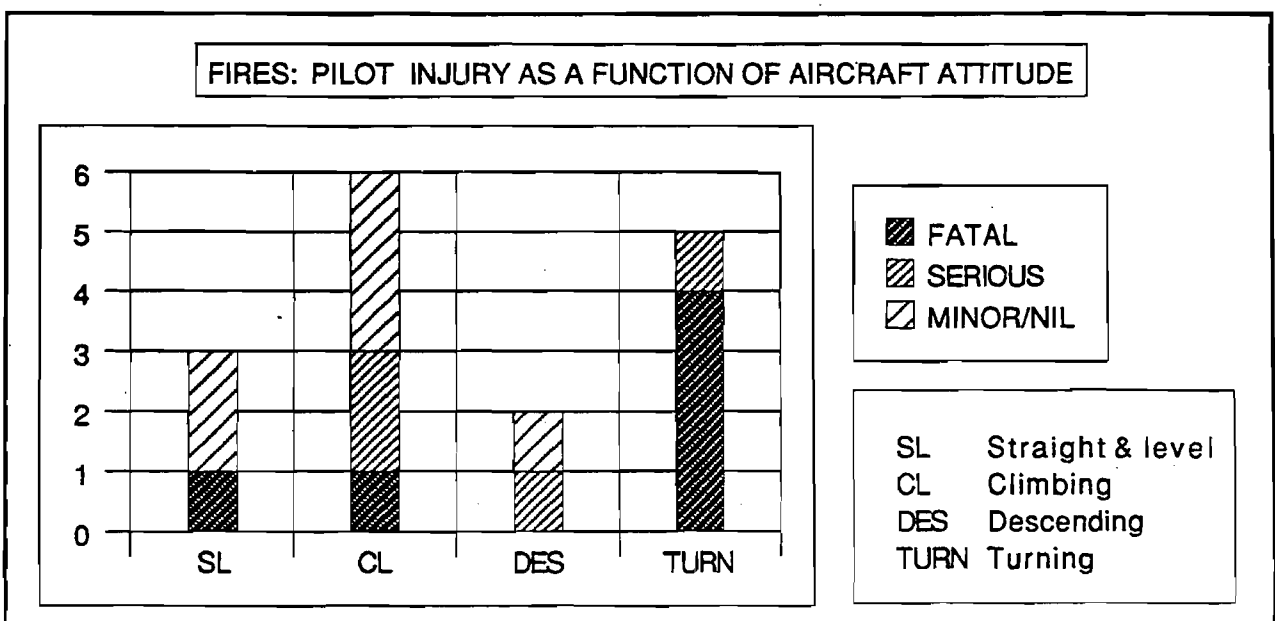
FIGURE 13

A total of 16 occurrences involving contact with part of the aircraft termed 'other' resulted in fire. Of these, six were fatal accidents, four culminated in serious injuries and six in either minimal or no injuries. When considering each aircraft attitude at the time, results indicated that the greatest incidence of fire was associated with the aircraft striking powerlines in a climb attitude or following a turn (see Figure 13). It is noteworthy that the incidence of fire was similar when accidents occurred during descent or in straight and level flight, with no fatalities in the case of descending aircraft.

Fire was present in 71% of the fatal accidents following wire strikes occurring whilst the aircraft was in a turn and in 46% whilst climbing.

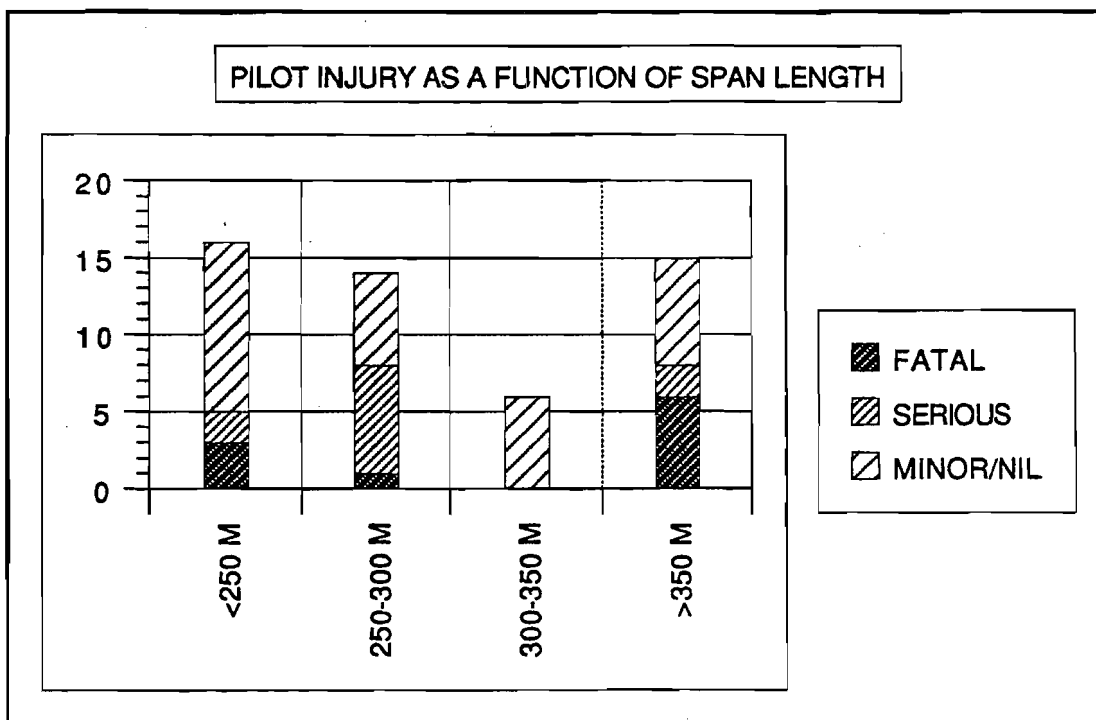
FIGURE 16

Figure 16 indicates that the most favourable outcome for the pilot was achieved when the aircraft struck wires whose span varied between 250 and 350 metres.

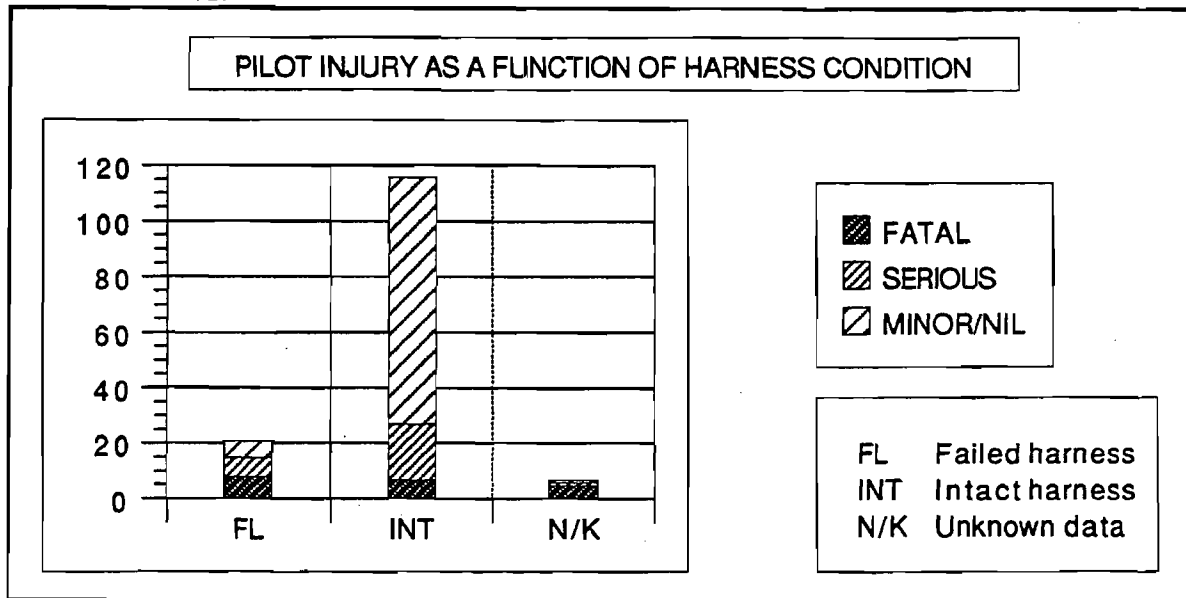
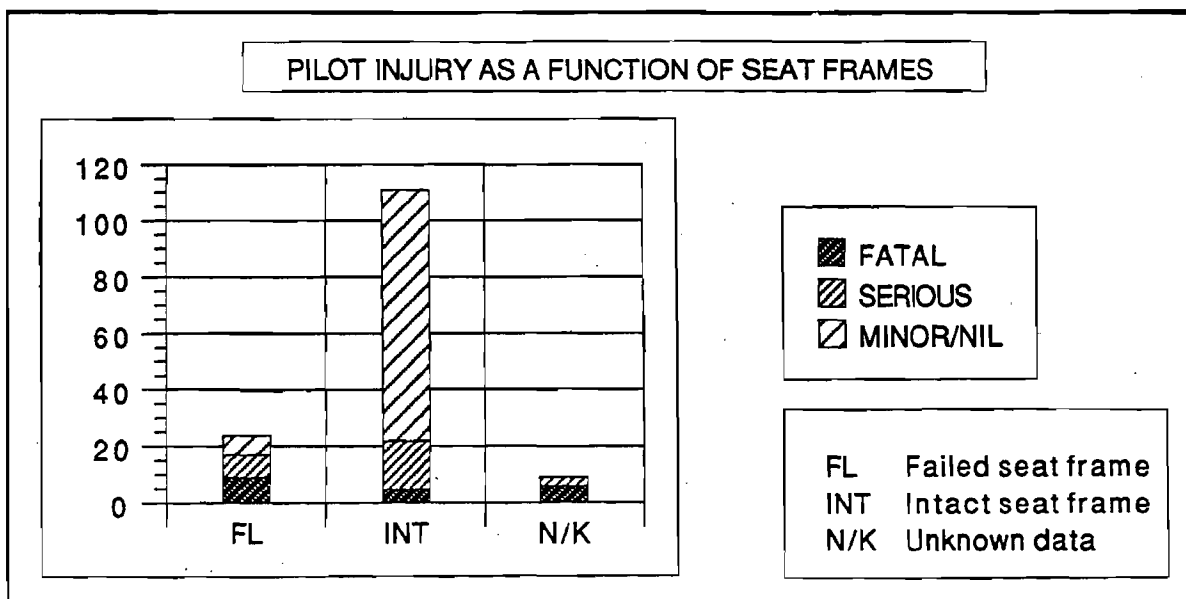
The harness and seat frames were considered in a similar manner to that of the cockpit structure. Failures included stretched webbing, shoulder strap failure, buckle failure, toggle failure and attachments failure. The seat frame failures included seats being forced off rails, collapsed, buckled, broken seat legs and fractured frames. Figure 18 and 19 display the status of the restraint system and seat frames for each category of injury respectively. A breakdown of pilot injury as a function of harness condition according to aircraft type is given in Appendix G. Appendix H provides similar data relating pilot injury to seat frame condition.

The above tables show that in the majority of accidents the harness or seat frame did not fail.

Generally, a slightly smaller failure rate was found with PA-25 series aircraft. Seats failed in 21% of accidents, and harness failure also occurred in 21% of the accidents. The figures for the C-188 series were 31% and 26% respectively. This was excluding the aircraft that were able to land. However, PA-25 series seat failures were associated with more fatal injuries.

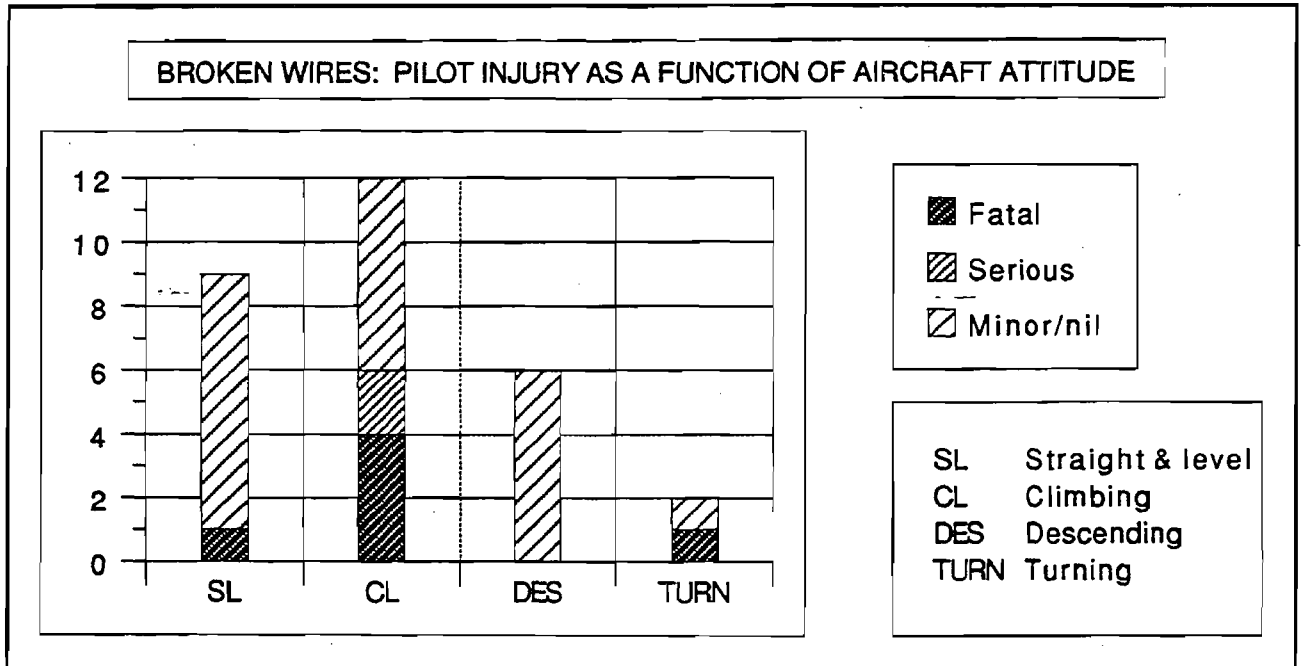
Breakdown of accidents in which the cables were broken as a function of aircraft attitude:

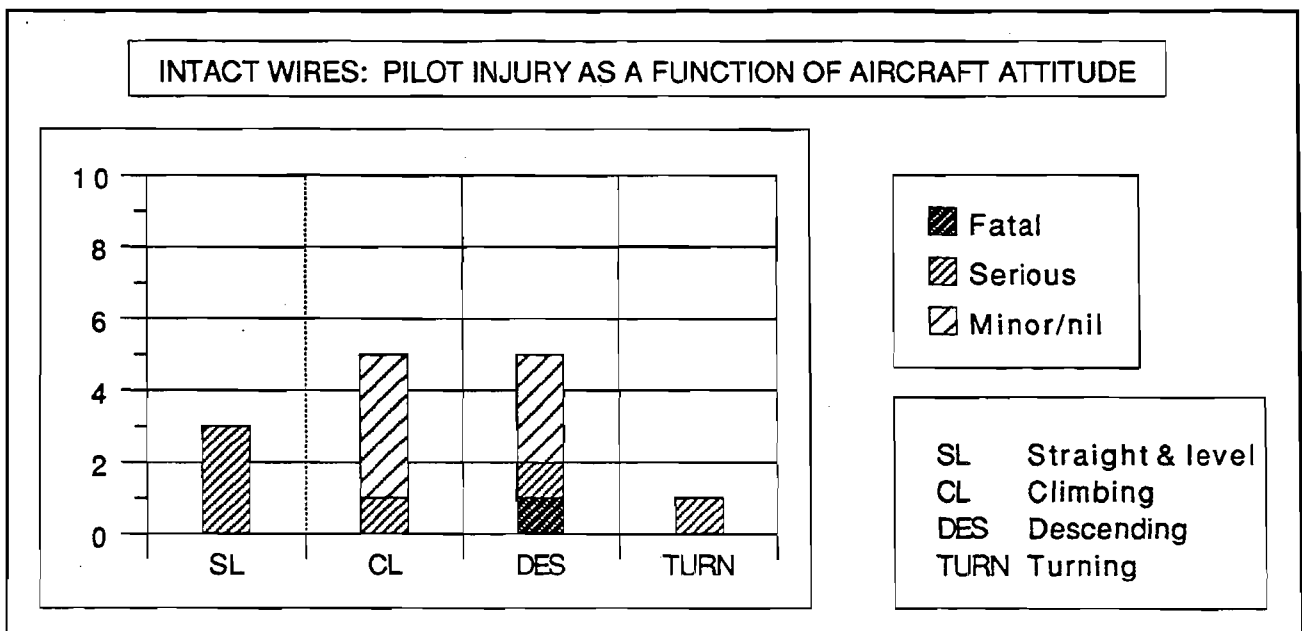
Breakdown of accidents in which the wires remained intact as a function of aircraft attitude:

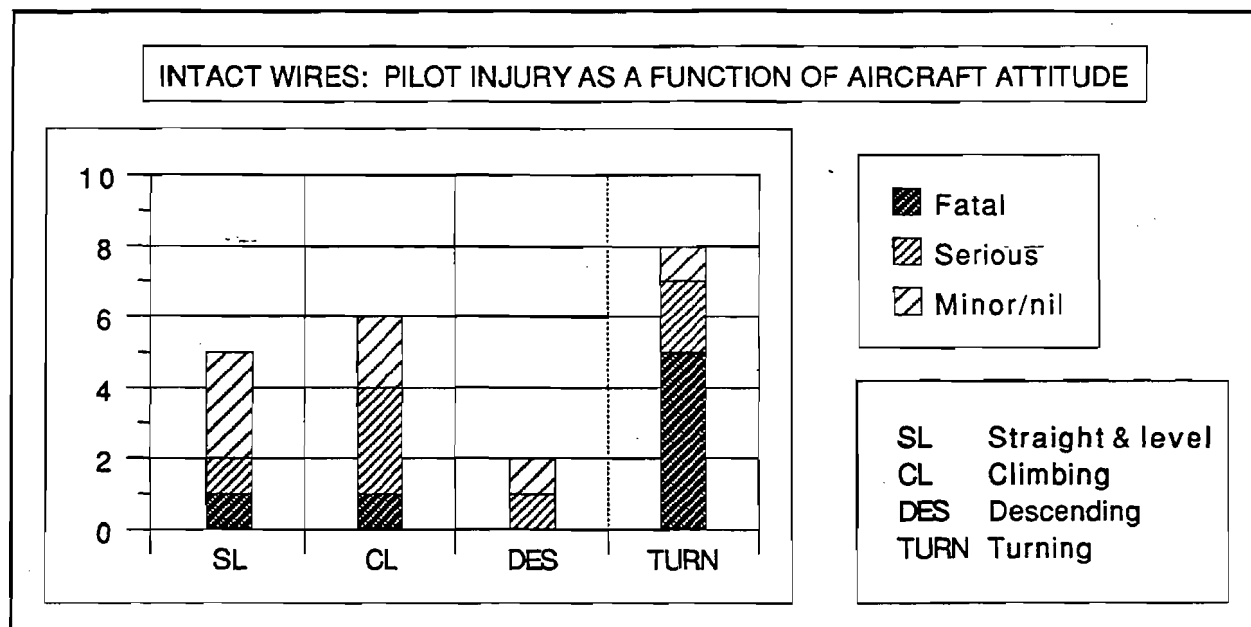
Breakdown of accidents occurring on parts of the aircraft termed as other, in which the wires remained intact, as a function of aircraft attitude:

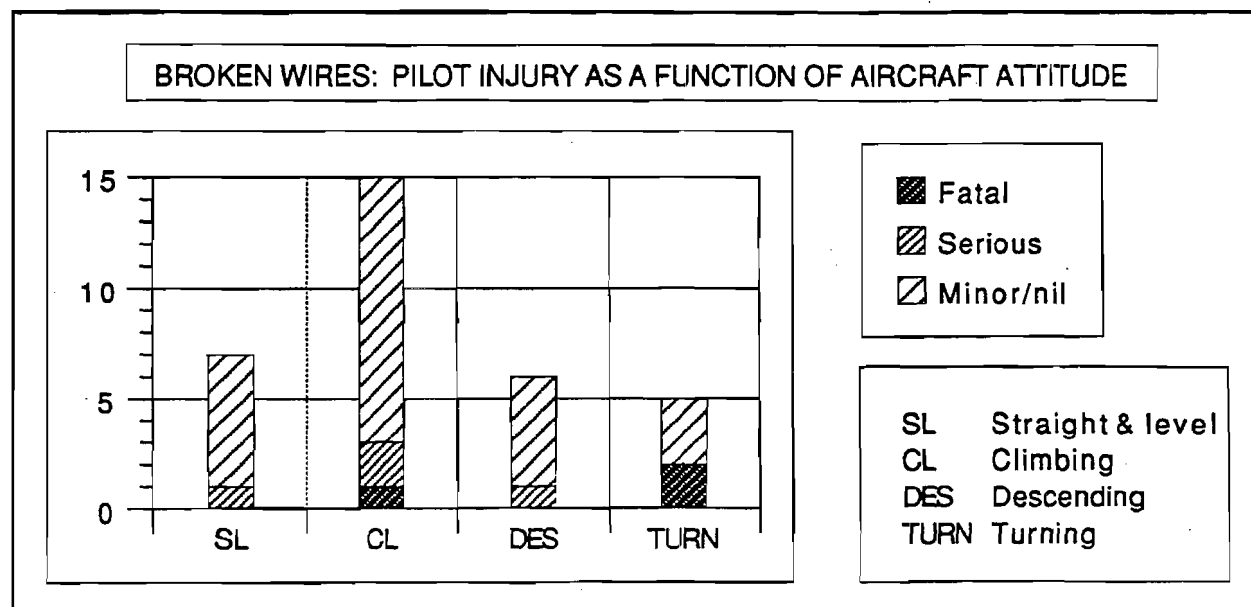
Breakdown of accidents occurring on parts of the aircraft termed as other, in which the wires were broken, as a function of aircraft attitude:

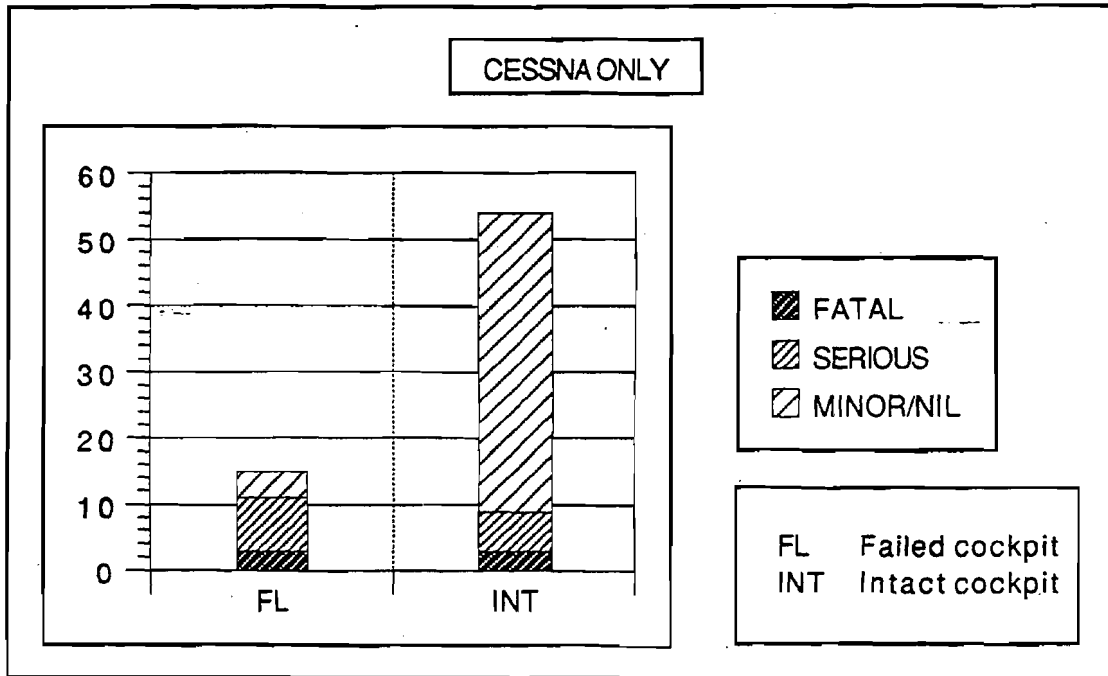
Status of the cockpit for each category of injury for the Cessna C-188 series:

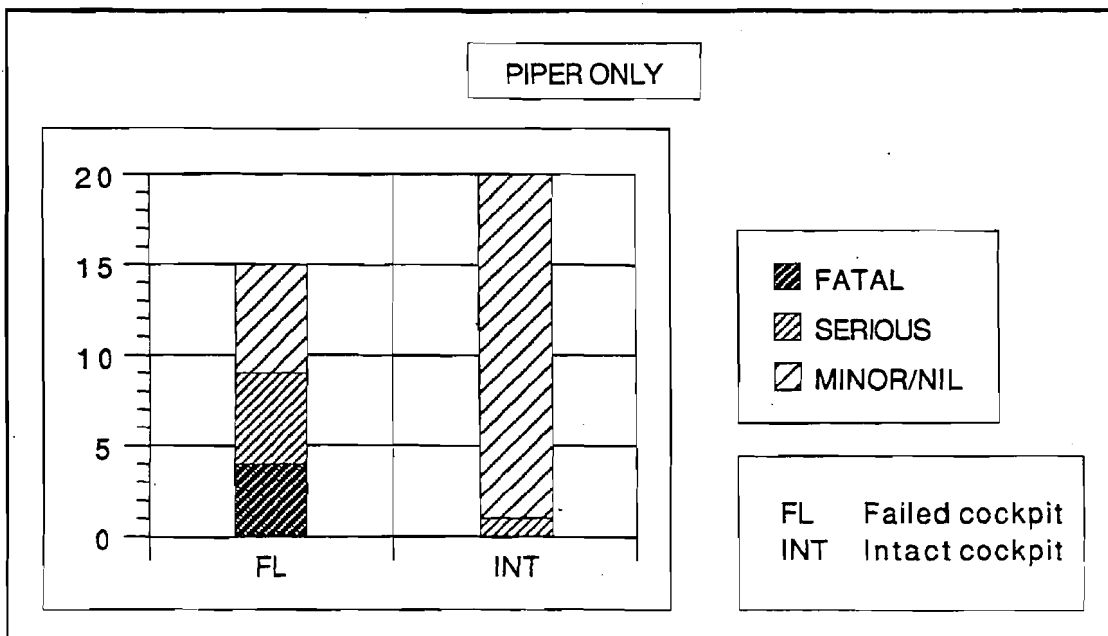
Status of the cockpit for each category of injury for the Piper PA-25 series:

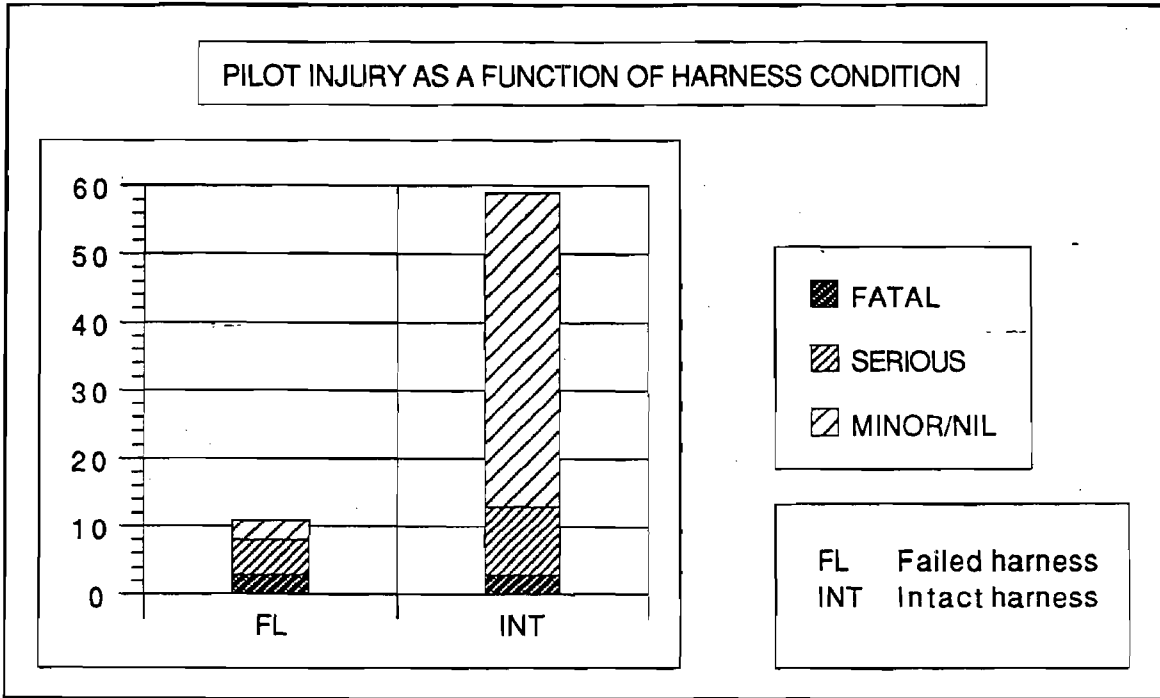
Status of the restraint system for each category of injury for the Cessna C-188 series:

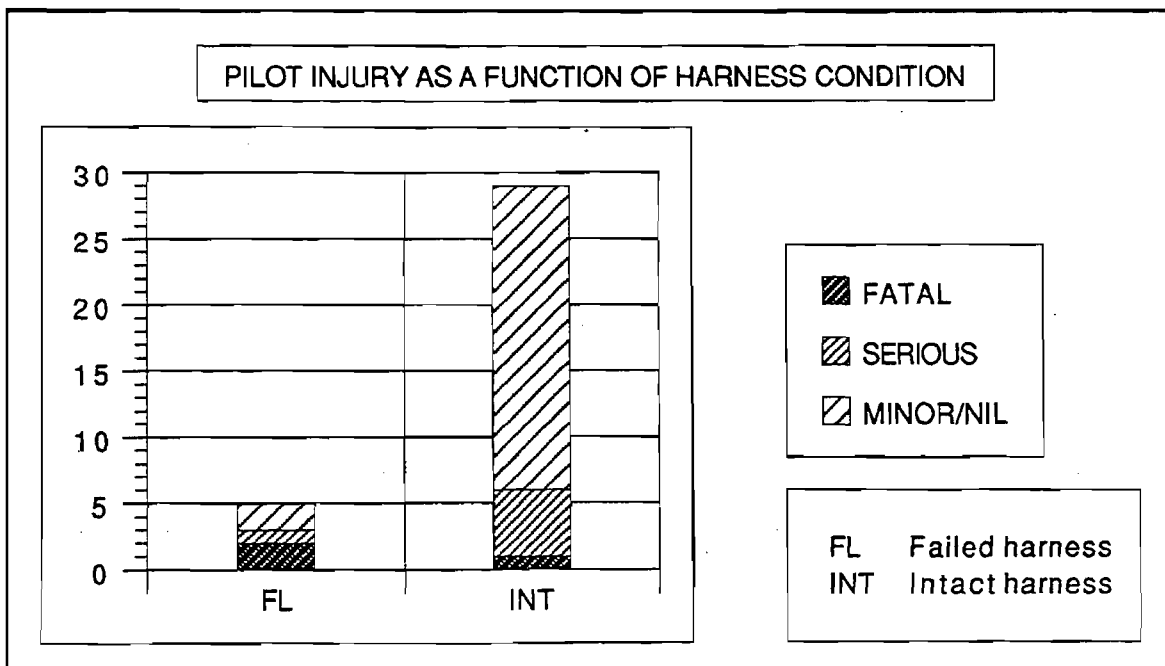
Status of the restraint system for each category of injury for the Piper PA-25 series:

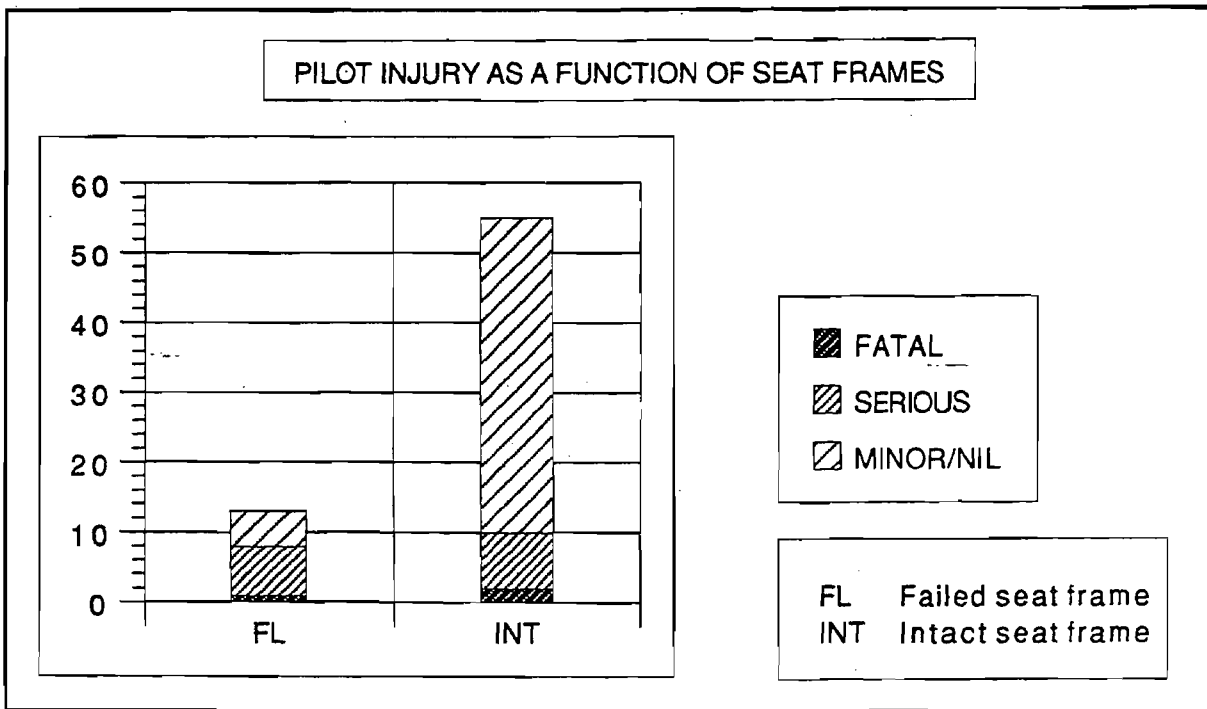
Status of the seat frames for each category of injury for the Cessna C-188 series:

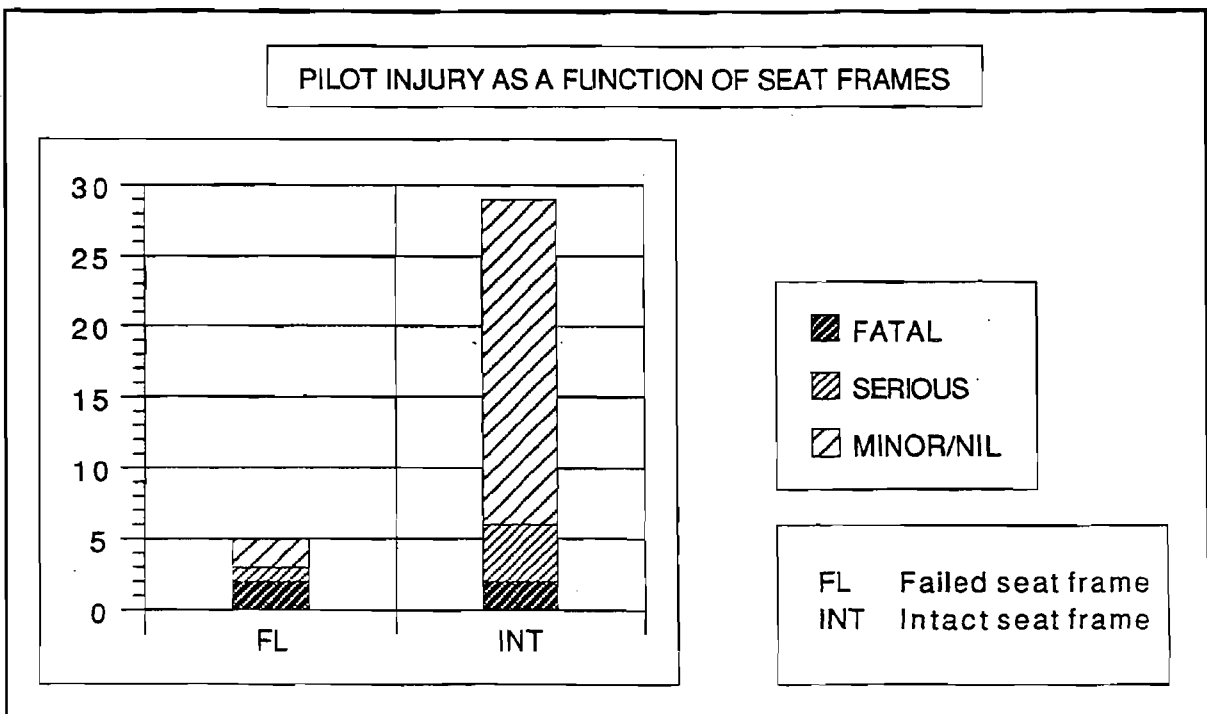
Status of the seat frames for each category of injury for the Piper PA-25 series:
