**ATSB TRANSPORT SAFETY REPORT**  
Occurrence Investigation Report AO-2009-002  
Final

**Main rotor blade skin debonding**  
**29 December 2008**  
**135 km NE Alice Springs, NT**  
**VH-HZB**  
**Robinson Helicopter Company**  
**R22 Beta**

**ATSB TRANSPORT SAFETY REPORT**  
Aviation Occurrence Investigation  
AO-2009-002  
Final

**Main rotor blade skin debonding**  
**29 December 2008**  
**135 km NE Alice Springs, NT**  
**VH-HZB**  
**Robinson Helicopter Company R22 Beta**

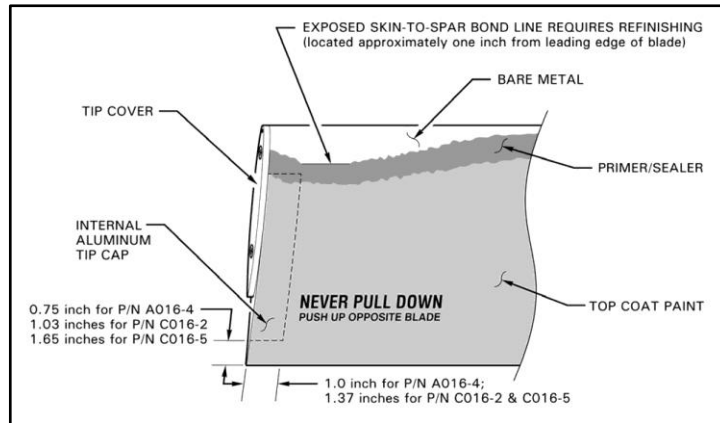
**Figure 2: Overview of the Robinson Helicopter main rotor blade features**

Main rotor blade part number A016-4 was introduced in 2004 and replaced earlier designs (Part number A016-1 & A016-2), which had a thicker 0.025 in / 0.635 mm aluminium alloy skin. The new design, A016-4, was similar to part number C016-2 and C016-5 blades fitted to RHC R44 and R44 II model helicopters.
