ATSB TRANSPORT SAFETY REPORT
Rail Occurrence Investigation RO-2008-005
Final

Derailment of Train 5PS6

Bates, South Australia

19 April 2008

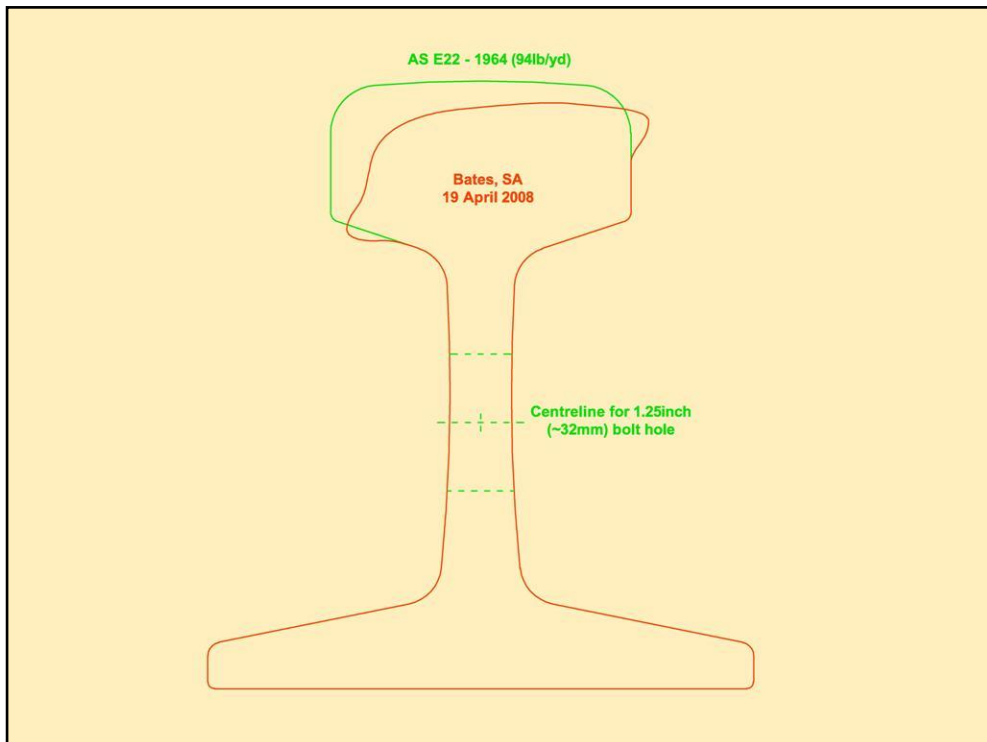
Figure 2: Rail profile

The rail was manufactured in January 1970 by Australian Iron & Steel (Port Kembla). The applicable standard at the time of manufacture was the *Australian Standard Specifications for Railway Permanent Way Materials, AS E22- 1964 Steel Rails*. Figure 2 illustrates the level of wear that was present in the high rail (outer rail) of the curve. While there was some evidence of metal flow, the level of wear did not exceed the allowable rail wear limits documented in the ARTC Track and Civil Code of Practice (CoP) (refer to Table 1). In general, the track appeared to be well maintained and in good condition.

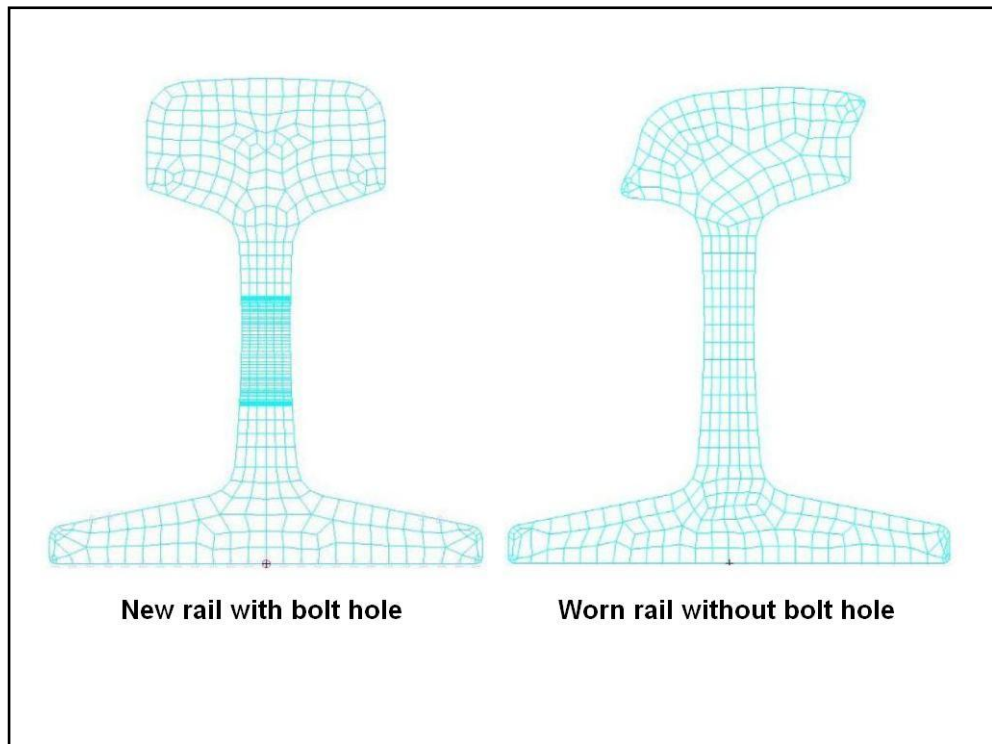
Figure 8: Cross sectional finite element mesh

Linear static stress analysis indicated that the highest tensile stresses occurred at the edge of the bolt-hole, at an angle of approximately 45 degrees from the vertical. This is consistent with the bolt-hole crack observed in the rail recovered from the Bates derailment site (Examination of the track near the point of derailment found evidence of rail fracture. The pieces of rail were recovered and placed in their original configuration, allowing investigators to conduct an initial on-site examination of the fracture surfaces and determine a likely sequence of failure.). The magnitude of the calculated stresses was almost three times greater than the stresses calculated in the web of the rail that did not have bolt-holes. It is evident that a bolt-hole in the web of a rail introduces a stress concentrating effect under cyclic loading typical of actual rail traffic¹⁴.

Crack initiation analysis was conducted to examine rail steel's response to cyclic loading typical of actual rail traffic. The analysis indicated that a crack would initiate at the outside edge of the bolt-hole for both the new and worn rail profiles. This is consistent with the fracture surface on the rail recovered from the Bates derailment site (Figure 6) where the crack appeared to be about 5 mm longer on the outer edge of the bolt-hole, implying that it was likely to have initiated at the outer edge as reflected in the theoretical analysis. It should be noted that the rail models used for the theoretical analysis assumed a 'perfect' hole through the web of the rail. In practice, bolt-holes exhibit imperfections (machine marks, surface scoring, corrosion etc.) all of which act as stress concentrators and are likely to significantly vary the time taken for a crack to initiate at a specific bolt-hole. However, it can be concluded that a crack is likely to develop at an unused bolt-hole (in the web of a rail) under cyclic loading typical of actual rail traffic.

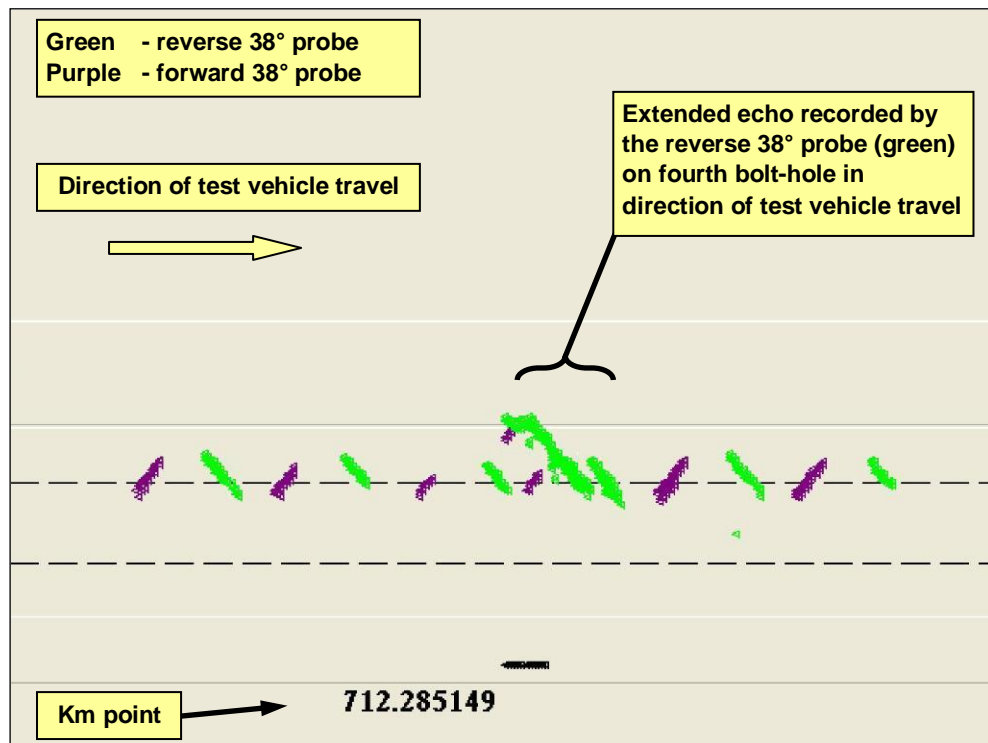
Figure 10: Extract from recorded ultrasonic test data

There were no suspected bolt-hole defects reported by the test vehicle operator in the vicinity of the point where train 5PS6 derailed. However, post derailment examination of the recorded test vehicle data showed echo patterns that were consistent with a series of six bolt-holes, one of which showed an extended echo recorded by the reverse 38 degree probe on the right rail¹⁸ (Figure 10). The location of this echo pattern is consistent with the bolt-hole crack observed in the broken rail following the derailment of train 5PS6 (sizing this echo pattern is discussed in Section 2.5.3 Standards).
