**ATSB TRANSPORT SAFETY REPORT**  
Occurrence Investigation Report AO-2007-070  
Final

**Leading edge device failure**  
**Norfolk Island**  
**29 December 2007**  
**VH-OBN, Boeing 737-229**

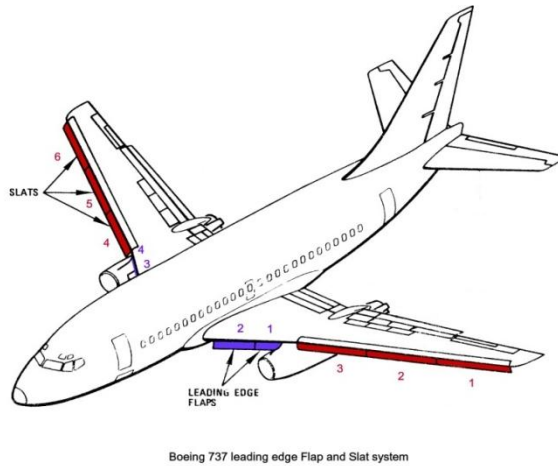
**Figure 1: Leading edge flap/slat system**

The leading edge flap/slat system formed part of the aircraft's high-lift devices, which changed the camber of the wing to increase lift during low-speed flight. Three leading-edge slats were installed on each wing outboard of the respective engine, with two leading edge flaps installed inboard of the engine on each wing. The slats were numbered 1 through 6 from left to right. The number-4 slat was directly outboard of the right engine (Figure 1). Each slat was attached to the wing by two main tracks and two auxiliary tracks (Figure 2).

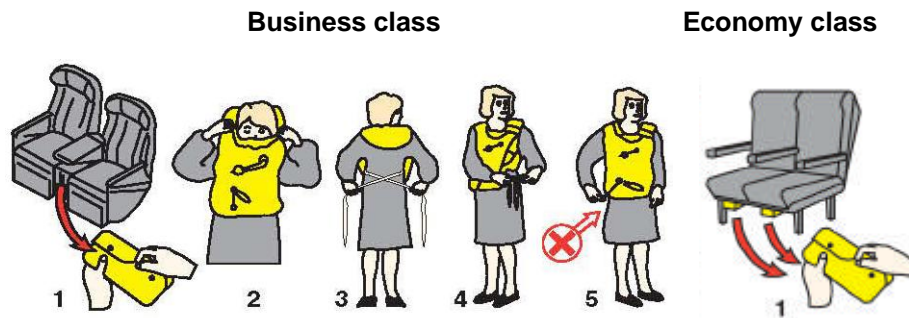
**Figure 7: Lifejacket instructions from the business class passenger safety card (left) and step 1 from the economy class safety card (right)**

The cabin crew reported that a number of passengers found it difficult to locate their lifejackets under their seat or armrest, and that some passengers in business class (rows one and two) needed assistance locating them. It was noted that in business class, the lifejackets were at floor level under the armrest, which may have contributed to them being difficult to find (Figure 7).

There were a number of passengers that put on their lifejackets incorrectly, but that were subsequently corrected by the cabin crew. The most common problems were putting them on backwards, or tying the cord over the top of the jackets instead of under them (see Figure 7, business class diagram number 4). Tying the cord over the top of a jacket would restrict or modify its inflation.

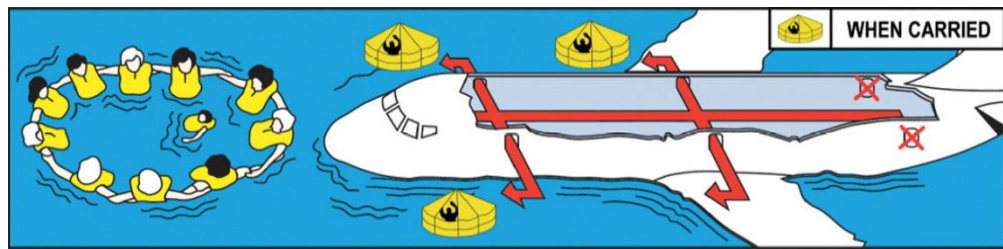
**Figure A1: Excerpt from the passenger safety card directing passengers not to use the rear exits and to alight the wing in the forward direction.**

The passenger safety card indicated that, once the aircraft landed on the water, only the forward and over-wing exits were to be used, and that passengers should leave the aircraft in the forward direction from the wings (Figure A1).

The majority of respondents did not know which direction they should have exited the wing (68%). Only 8% indicated they should exit in the forward direction. One respondent indicated that, although they were advised which exits to use, they were not told which direction to alight from the wing. Of the three passengers sitting in the over-wing exit row who responded, two indicated they did not know which direction to move off the wing, while the third indicated they should exit rearwards.

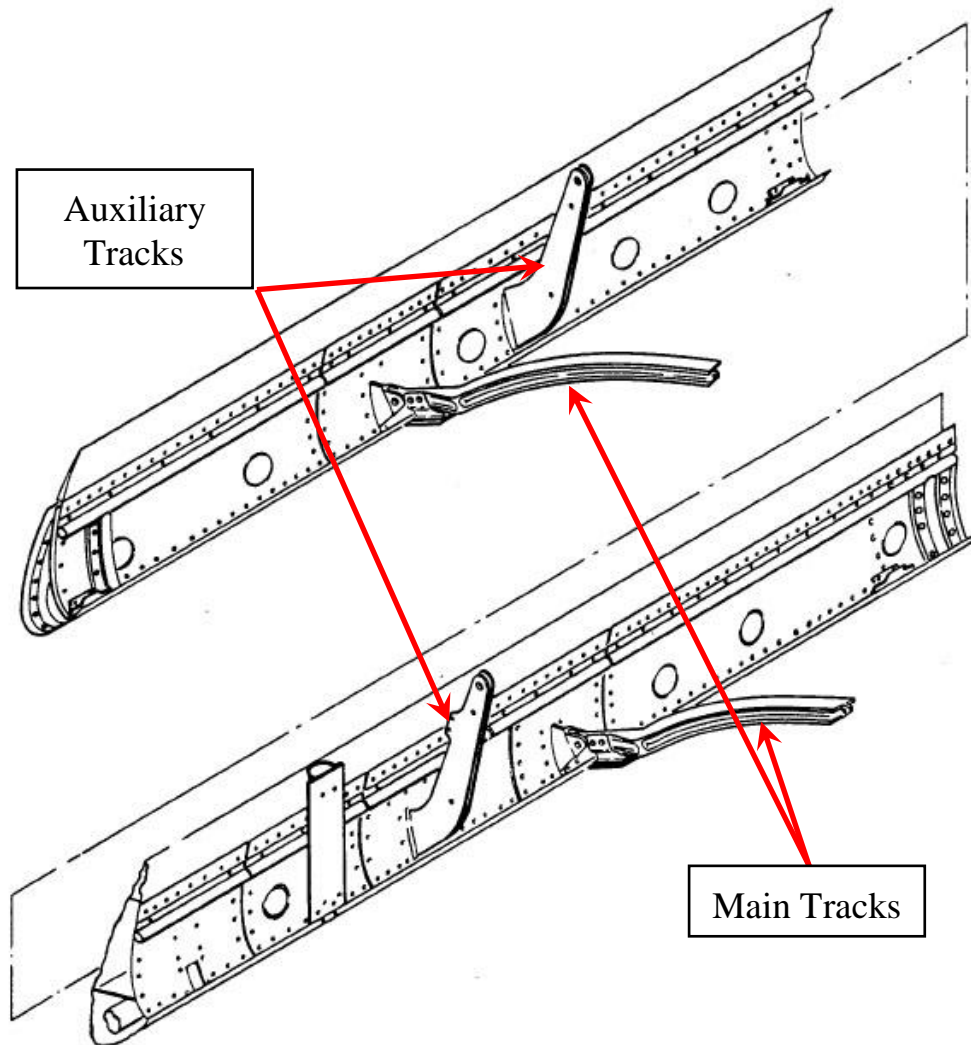
Figure 1. Leading edge slat\*

The slats consist of ribs attached to a beam, inner and outer clad aluminium skins and a honeycomb trailing edge. A void between the inner and outer skins provides a path for thermal anti-icing. Anti-icing ducts installed in the slat leading edge connects with hot air supply lines through a telescoping tube. A three position hydraulic actuator is attached to the centre of all leading edge slats (1 thru 6). Each slat has two main tracks and two auxiliary tracks which ride on rollers in the wing leading edge. A third auxiliary track is installed at the outboard end of slats No. 1 and 6. Structural stops are provided in both the extended and retracted slat positions. The downstops are attached to the slat tracks and contact with track guides in the extended position. The upstops consist of three adjustable plates which contact with the slat beam when the slats are retracted. All slats (1 thru 6) are stabilised at the intermediate position by a torsion rod and support arm assembly attached to the front spar between the auxiliary slat tracks.
