ATSB TRANSPORT SAFETY REPORT
Aviation External Investigation AE-2009-046
Final

**Aircraft instrument and fuel system detritus
examination
Bell 206L4, P2-HBC
Collision with Terrain in the
vicinity of Lake Murray PNG
25 September 2008**

On 25 September 2008, the pilot of a Bell 206L4 helicopter, registered P2-HBC, was conducting sling loading operations in the vicinity of Lake Murray, Papua New Guinea. While conducting a vertical lift, a witness reported hearing a 'different noise' from the helicopter's engine, before observing the pilot jettison the load. The witness then observed the helicopter oscillating from side to side, yawing to the left and then descending through the tree canopy to impact the ground. The pilot was fatally injured and the helicopter seriously damaged.

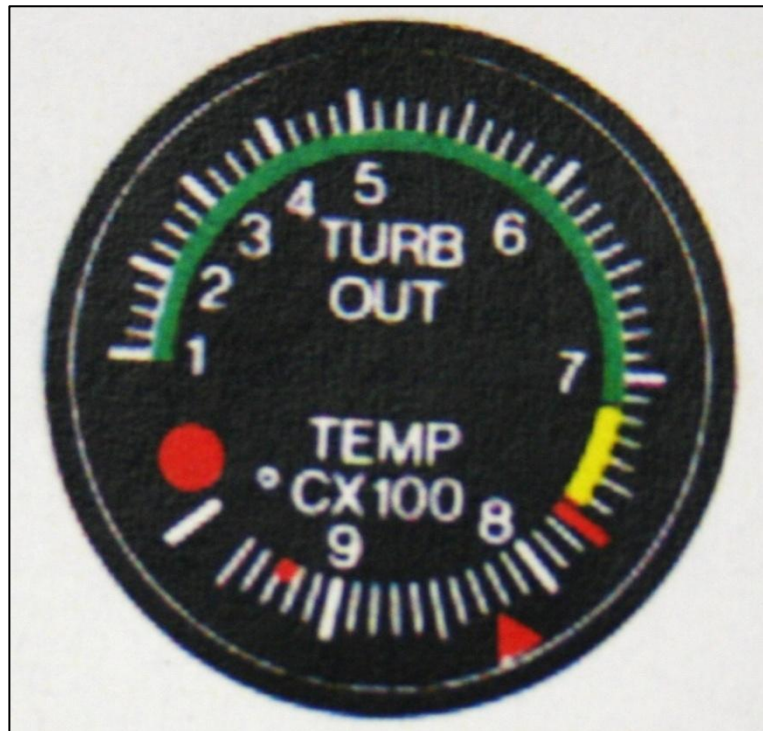
Figure 13: Turbine out temperature gauge diagram

Warning light	Illuminates when TOT between 826 and 927°C more than 10 seconds or TOT above 927°C.

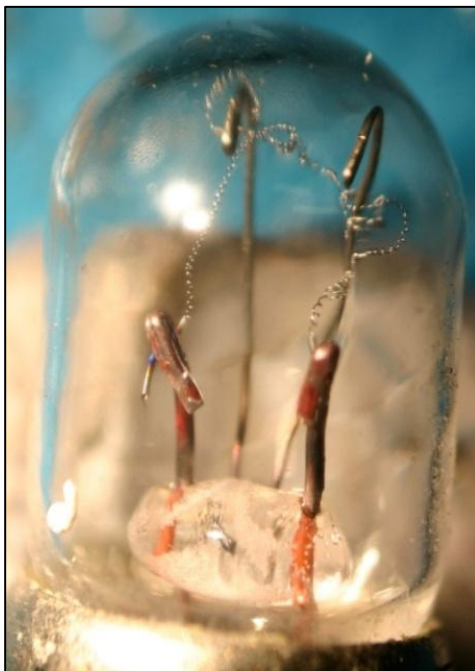
Figure 14: Confirmed filament stretch example from another accident

Figures 14 and 15 compare an exemplar lamp showing confirmed filament stretch, with one of the light globes from the annunciator panel examined.
