ATSB TRANSPORT SAFETY REPORT
Marine Occurrence Investigation No. 251
MO-2008-003
Final

Independent investigation into the disablement and subsequent grounding
of the Sierra Leone registered products tanker

Breakthrough

at the Cocos (Keeling) Islands

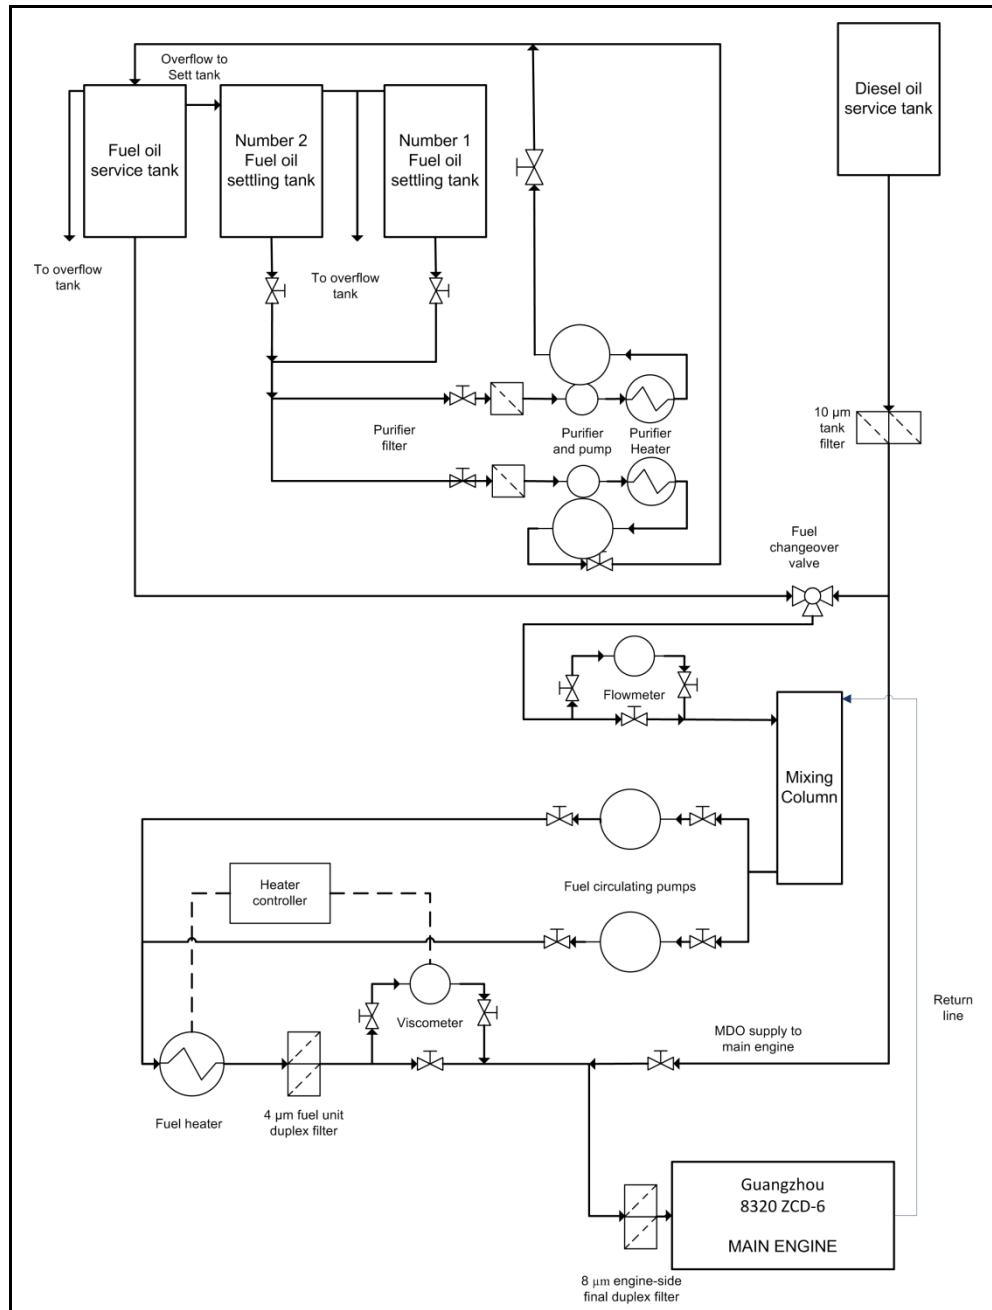
Figure 2: Main engine system schematic diagram

One of the ship's Chinese engineers examined the writing on the side of the fuel unit filter and told the chief engineer that the 'filter was specified for MDO and not for IFO'. It was a fine, 4 µm filter whereas the main engine final filter was 8 µm (Figure 2) and the MDO tank outlet filter was 10 µm. The engineers exchanged the fine filters with the larger mesh MDO tank filters. However, they still needed to be cleaned about twice per watch. The chief engineer believed that the engine could not operate using the contaminated MDO and that the only solution to the ship's problems was to obtain clean MDO bunkers which would need to be delivered to the ship.
