ATSB TRANSPORT SAFETY REPORT
Marine Occurrence Investigation No. 256
MO-2008-008
Final

Independent investigation into the grounding of the
Isle of Man registered bulk carrier

Iron King

at Port Hedland, Western Australia

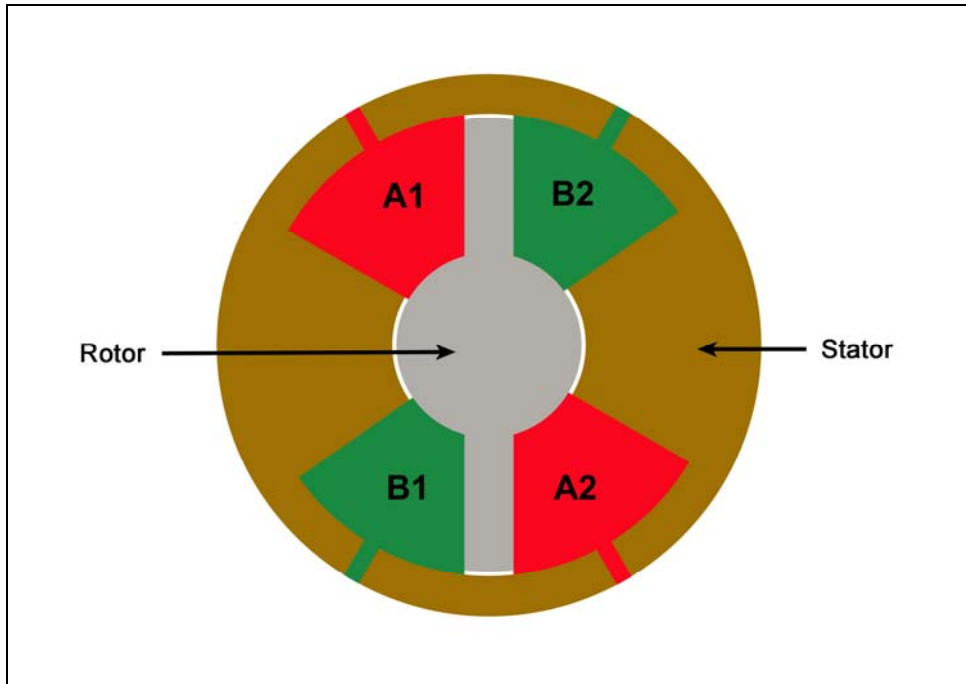
Figure 3: Conceptual diagram of a rotary vane unit

Iron King is fitted with a Porsgrunn hydraulically operated rotary vane steering gear (Figure 2). The rotary vane unit (actuator) consists of a rotor, mounted directly on the upper section of the rudder stock, which is enclosed in a circular housing (stator) that is secured to the ship's structure (Figure 3). A set of nitrile rubber seals provide an oil seal between the rotor and stator.

When hydraulic fluid is supplied under pressure, via the directional control valve(s), to chambers A1 and A2 (the chambers are common due to internal drillings in the actuator) and the directional valve(s) allow chambers B1 and B2 to drain, the rotor, and hence the rudder, moves in a clockwise direction, turning the ship to port (Figures 3 and 4). Similarly, when hydraulic fluid is supplied under pressure to chambers B1 and B2 and chambers A1 and A2 are allowed to drain, the rudder moves in an anti-clockwise direction, turning the ship to starboard.

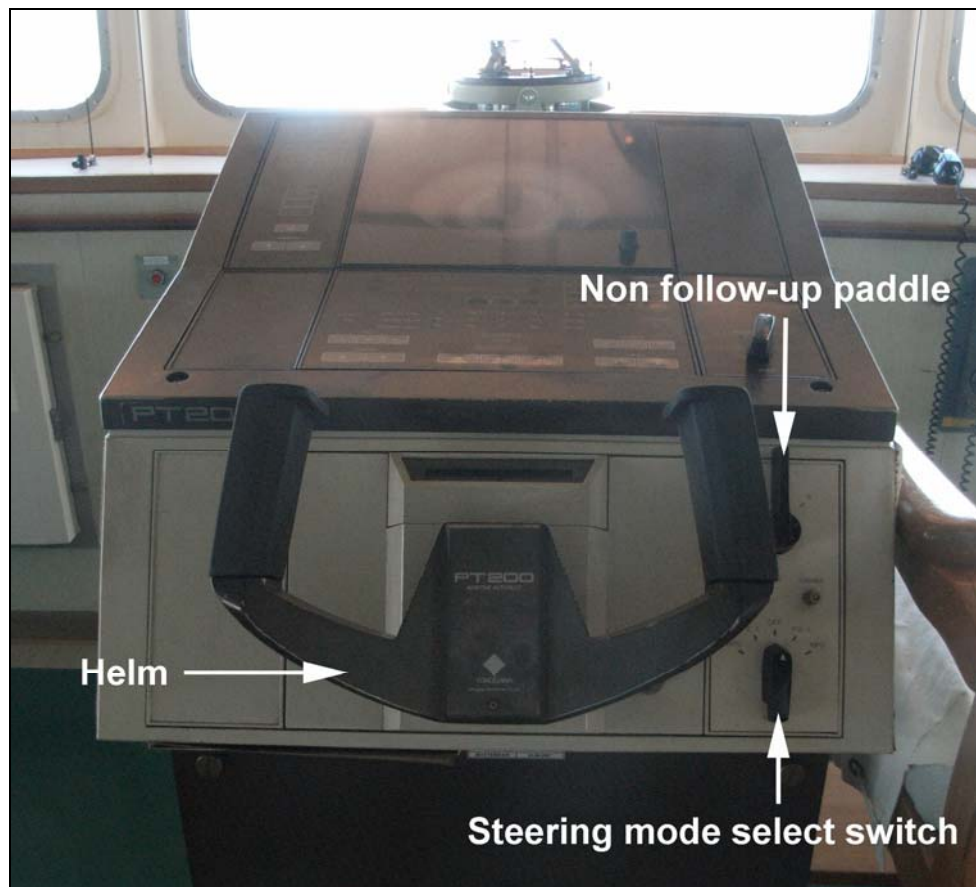
Figure 5: Yokogawa PT200 steering control stand

When either control system follow-up steering mode is selected (Figure 5), the operator controls the ship's steering by turning the control stand mounted steering wheel (helm) to a desired rudder position (e.g. port 20°). The follow-up control system constantly compares the electronic input signal from the helm with the signal received from a position transmitter mounted on the rudder stock. If the

signals are not the same (i.e. the rudder stock is in a different position to the helm), the control system applies an output signal that energises the relevant solenoids on the pilot valves. As a result, the rudder moves in the desired direction. When the 'desired' helm signal matches the output from the rudder stock position transmitter, the solenoids are de-energised and the rudder stops moving and remains in the desired position (e.g. port 20°).
