**ATSB TRANSPORT SAFETY BULLETIN**  
Aviation Level 5 Investigations AB-2010-020  
Final

# **Level 5 Factual Investigations:** **1 December 2009 to 30 March 2010**

AB-2010-020

**Level 5 Factual Investigations:  
1 December 2009 to 30 March 2010**

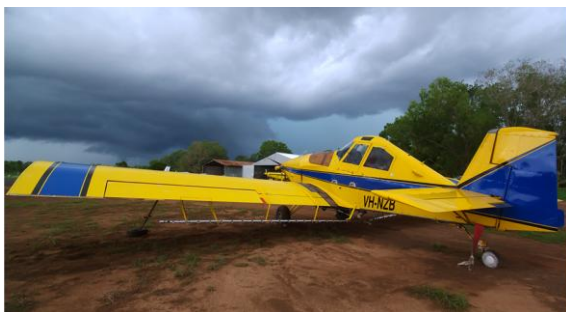
Figure 1: VH-NZB

On 25 November 2009, an Ayres Corporation S2R-T34<sup>1</sup> aircraft, registered VH-NZB (Figure 1), was being operated on a ferry flight from Parkes, New South Wales (NSW) to Batchelor, Northern Territory (NT), with an initial intermediate stop at Longreach, Queensland (Qld). While on final approach to Longreach, without warning, the aircraft's nose pitched upward and an aerodynamic stall resulted. The pilot, the sole occupant, regained control and the aircraft landed safely.

A subsequent engineering investigation by the aircraft's maintenance provider determined that the elevator push rods had been fitted in the reverse order during recent maintenance, thus
