ATSB TRANSPORT SAFETY REPORT  
Marine Occurrence Investigation No. 260  
MO-2008-012  
Final

Independent investigation into the rupture of a  
submarine gas pipeline by the Hong Kong registered container ship

# APL Sydney

13 December 2008

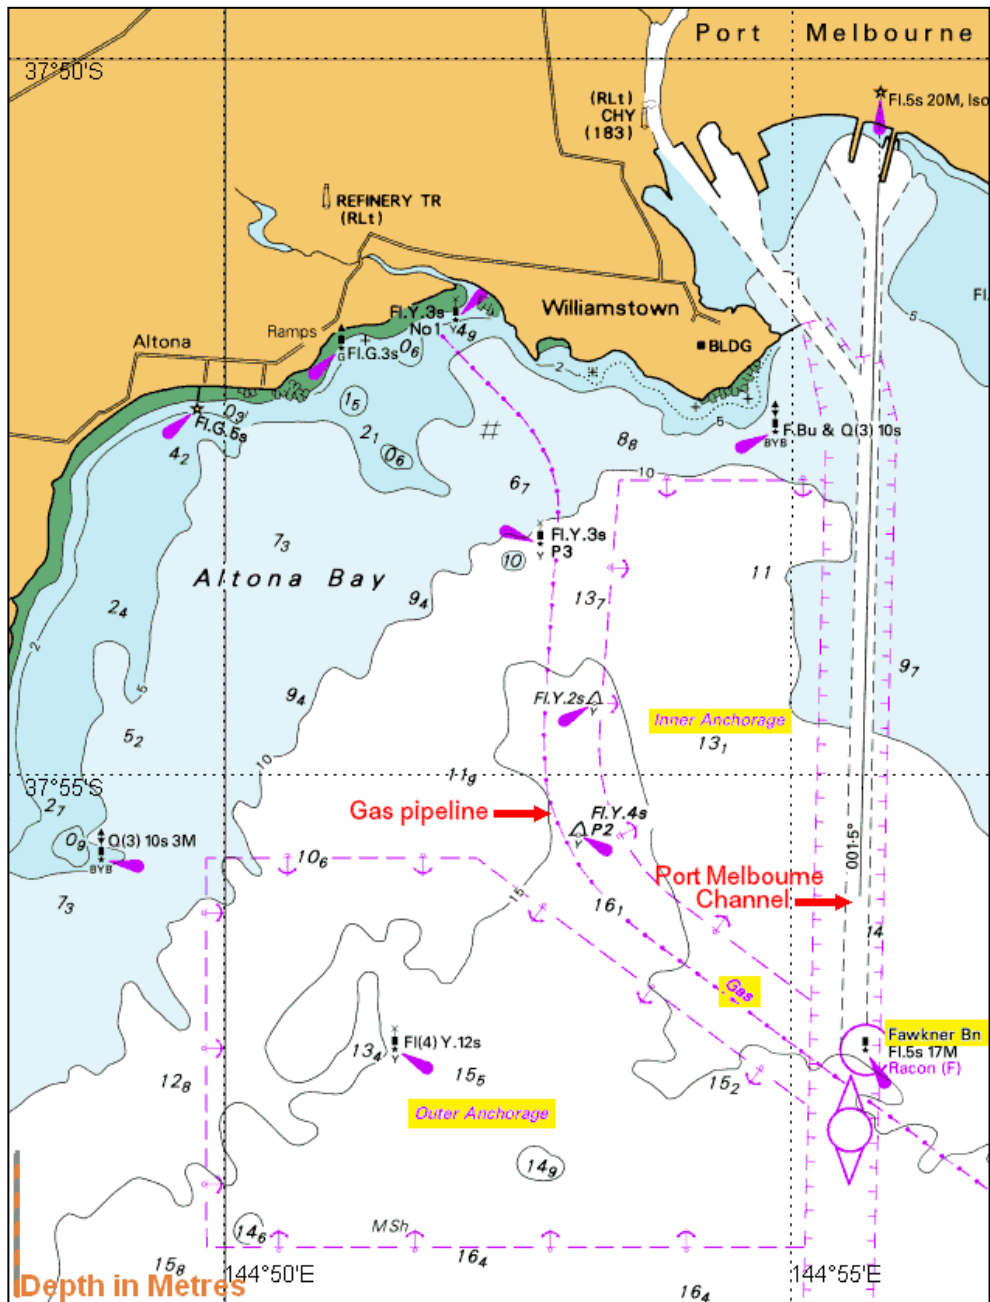
**Figure 3: Section of navigational chart Aus 143 showing anchorages off Melbourne at the time of the incident (yellow highlighting by ATSB)**

At the time of the incident, the name Melbourne anchorage generally referred to two charted anchorages to the west of the Port Melbourne Channel (Figure 3). Designated as the Inner Anchorage and the Outer Anchorage, they were separated by a narrow corridor in which lay a submarine gas pipeline. Adjacent boundaries of the anchorages were parallel to and about 3 cables<sup>13</sup> (approximately 550 m) on either side of the pipeline's charted location.

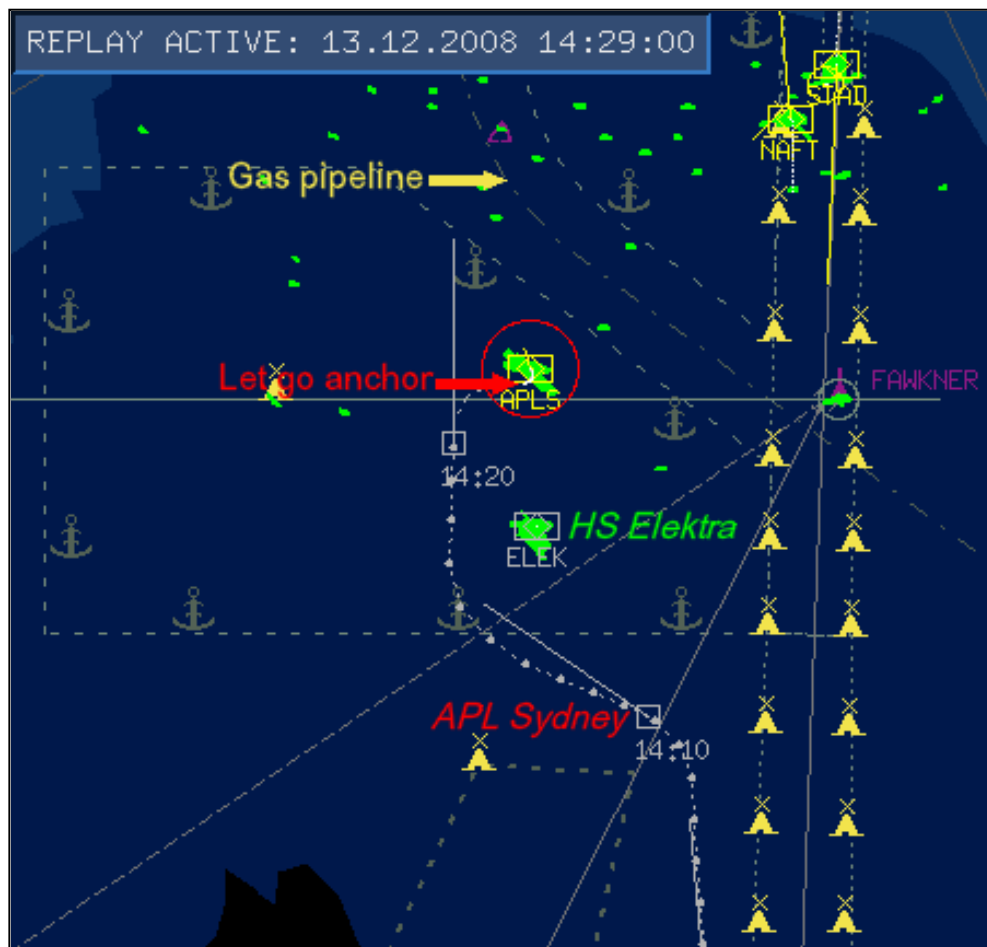
**Figure 4: Section of harbour control's radar display at 1429 on 13 December**

At 1428, when *APL Sydney*'s starboard anchor was let go, the ship's GPS unit indicated its position as 37°56.73'S 144°53.33'E, where the charted depth is about 16 m. The pilot advised the pilot boat's skipper that the ship had anchored 8 cables to the north of *HS Elektra*. At 1429, he reported to harbour control that the ship was anchored in a position 274° (T) x 1.8 miles from Fawkner Beacon (Figure 4).

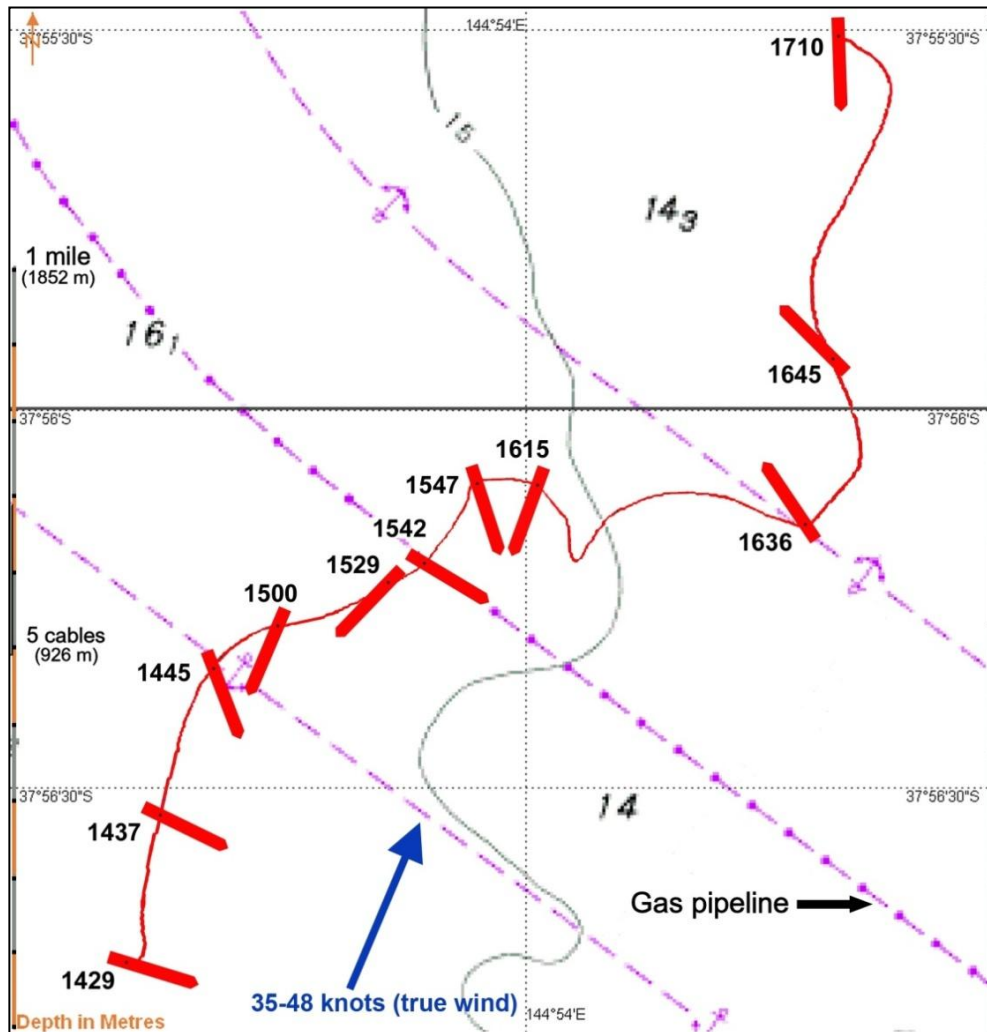
**Figure 5: Section of navigational chart Aus 155 with scale images of APL Sydney, aligned to its heading, at various times on 13 December**

At the time, the ship's heading<sup>17</sup> was about 108° and the 35 knot south-southwest wind, gusting to 48 knots, was on the starboard beam (Figure 5). The drizzle and light rain had continued.

cable direction and tension. At 1445, the ship was at the anchorage boundary and on a heading of 159° (Figure 5). It had still not ‘brought up’<sup>18</sup> to the anchor.

At 1542, the pilot asked the master to confirm that the anchor was aweigh. The master informed him that there were 2 shackles of cable in the water. On its heading of 120°, the ship was now located directly above the pipeline and moving at a speed of 1.8 knots in a northeast direction (Figure 5).

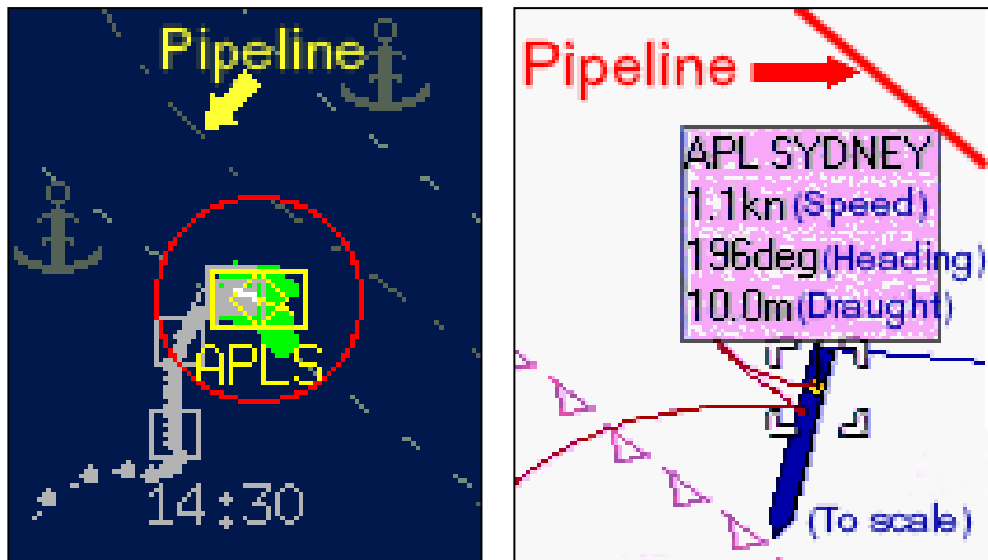
Figure 6: Sections of harbour control radar and AIS displays at 1506

At 1506, the control officer asked *APL Sydney*’s master if the ship was maintaining its position. The master advised that it was and he would wait there and report again ‘if there is a danger’. The control officer then spoke with the pilot who told him that the pilot boat’s AIS indicated the ship was near the pipeline and asked the control officer to check this on his equipment. Harbour control’s radar and AIS displays indicated that the ship was outside the anchorage boundary (Figure 6). The control officer checked the radar and advised the ship was near the anchorage boundary. He then checked the AIS display and told the pilot that it indicated that the ship was between the anchorage boundary and the pipeline. The pilot concluded that the ship must have dragged its anchor and it was agreed that he would return to the ship. It was 1511 and the pilot boat crew then prepared to depart the berth again.

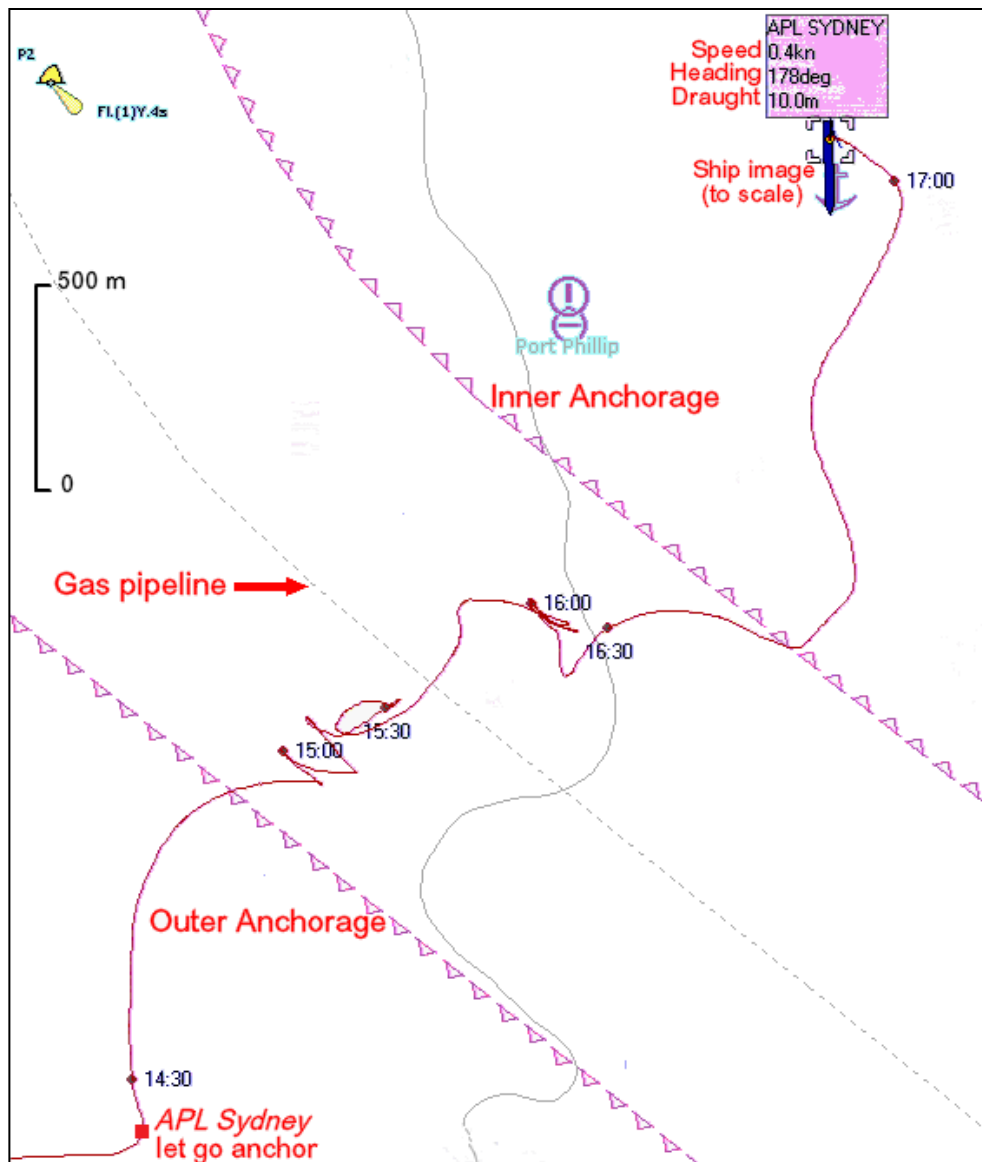
**Figure 12: Section of harbour control's AIS display showing *APL Sydney's* position and track from about 1420 to 1710 on 13 December**

Harbour control's equipment, the AIS in particular, allowed effective real-time ship traffic monitoring. The AIS display indicated *APL Sydney*'s GPS position, heading, speed and movement in relation to the pipeline (Figure 12). However, the control officer normally used AIS to monitor moving traffic and radar to monitor anchored ships. Shortly after 1501, he checked the radar and instructed the master to maintain position and wait for a pilot. At interview, he stated that he thought it was more prudent that the ship remain in its position rather than risk the anchor dragging

However, the control officer made a decision based on an assessment of a situation he had not been appropriately monitoring, whereas the master had monitored the situation and was well placed to assess it. Although pilotage is compulsory, the pilot had left *APL Sydney* about half an hour earlier and it would take time to send a pilot back to the ship, which was now outside the anchorage, and immediate action on board was required to resolve the situation. In following the control officer's instructions, the master suspended his plan to weigh anchor and shift the ship but took no action or precaution to maintain its position. While the control officer had concerns with regard to shortening the cable, he had not suggested deploying more cable to the master. Their interaction at this stage resulted in no action being taken, when immediate and effective action on board the ship was necessary.

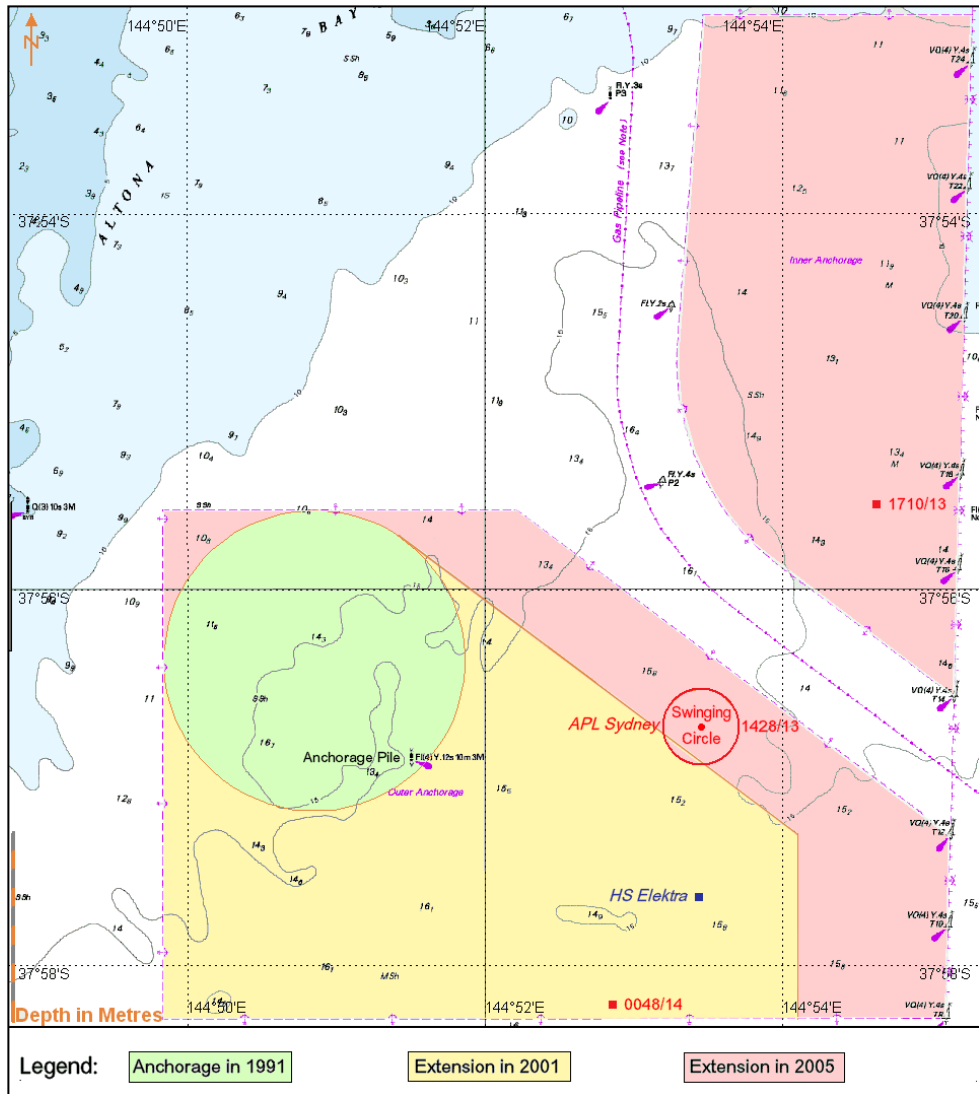
**Figure 15: Section of navigational chart Aus 155 showing changes to Melbourne anchorage between 1991 and the time of the incident**

*APL Sydney*'s swinging circle, centred on the position where its anchor was let go at 1428 on 13 December, had a radius of 2 cables (Figure 15). The circle lay within the Outer Anchorage and, at its closest, was 1.3 cables from the anchorage boundary and 4 cables clear of the gas pipeline.

Since the gas pipeline was laid in 1972, there have been a number of changes to the anchorages off Melbourne. Their names and limits have continued to evolve with the port’s changing needs and increasing ship size and traffic (Figure 15).

In 1970, a circular Outer Explosives Anchorage with a radius of 5 cables existed in the northwest part of what later became the Outer Anchorage. At the time, there was also an Inner Explosives Anchorage. Their limits were defined in nautical publications but not charted. Those anchorages evolved into three explosives anchorages until 1985, when changes were made and two anchorage areas again defined.

In 1991, the Outer Explosives Anchorage was renamed the Explosives Anchorage and its circular area was enlarged to a radius of 8 cables and charted. About 5 years later, its name was changed to the Outer Anchorage and in 2001, the anchorage was extended towards the south and east and became a polygonal shape. Its north-eastern boundary was parallel to and 8 cables from the gas pipeline. The Anchorage Pile beacon, which had been at the centre of the previously circular anchorage, was moved towards the middle of the new anchorage.
