# Operational event

## Brisbane Airport, Queensland

### 25 November 2007

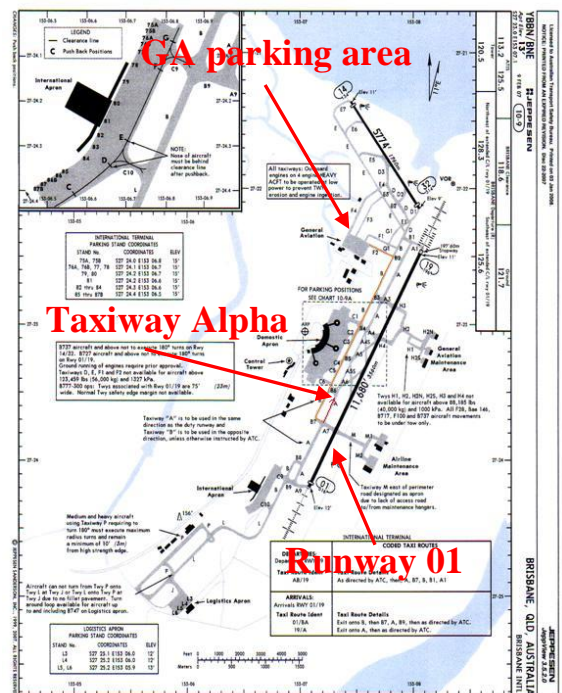
**Figure 1: Brisbane Airport chart<sup>2</sup>**

commenced a take-off run on taxiway Alpha, adjacent to the active runway 01 (Figure 1). The aerodrome controller (ADC) instructed the crew to cancel the take-off clearance. The crew stopped the aircraft on the taxiway.

The crew and aircraft arrived in Brisbane earlier in the day from Sydney. The aircraft had been parked in the general aviation (GA) parking area at the northern end of Brisbane Airport (Figure 1). Between the time of starting the aircraft's engines and prior to taxi, the PIC's electronic flight bag
