Australian Government
Australian Transport Safety Bureau

AVIATION SAFETY INVESTIGATION REPORT
200204328

Hamilton Island Aerodrome

Piper PA-32-300, VH-MAR
26 September 2002

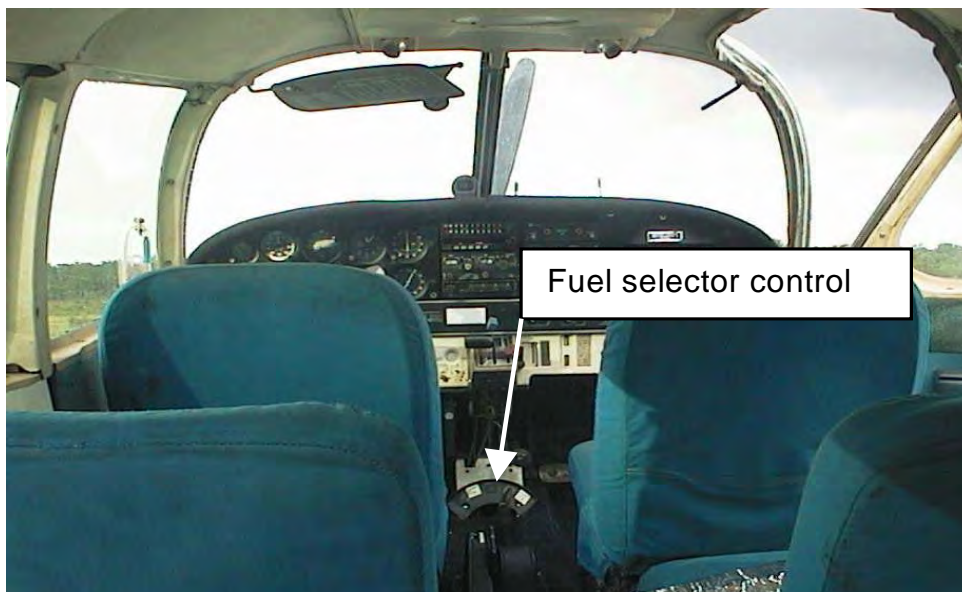
Figure 4: Occurrence aircraft cockpit photograph

Fuel lines connected each tank to an underfloor fuel selector valve. The fuel selector control was located on the floor beneath the centre of the aircraft's instrument panel. It had five positions, corresponding to: an OFF selection; followed by left tip; left main; right main; and right tip tanks when moving the selector from left to right. Those fuel selector control positions are indicated at Figure 3. The in-cockpit location of the fuel selector control is indicated in the occurrence aircraft cockpit photograph at Figure 4.
