Collision with terrain involving Lockheed Martin Stalker XE UAS

Avoca Race Track, Victoria, 25 October 2016

ATSB Transport Safety Report
Aviation Occurrence Investigation
AO-2016-141
Final – 9 February 2017

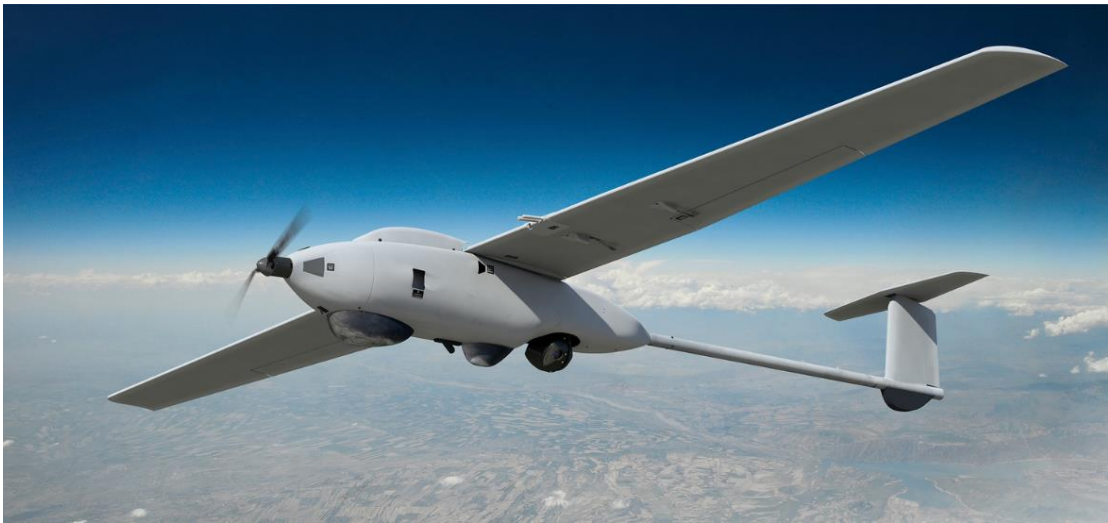
Figure 1: Typical Stalker XE aircraft

On 25 October 2016, an instructor was supervising students in the operation of a Lockheed Martin Stalker eXtended Endurance (XE) unmanned aerial system (UAS) (Figure 1) at the Avoca race track in Victoria.
