Australian Transport Safety Bureau

Amateur-built and experimental aircraft survey: The results

Investigation briefs

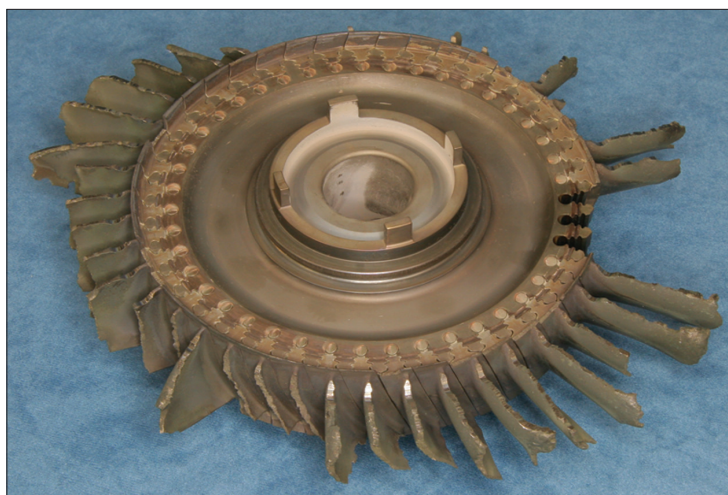
Ground personnel reported that there was visual evidence in the engine exhaust of catastrophic damage to the power, or hot section of the engine. The left engine was removed by the operator and shipped to an approved engine overhaul facility for disassembly and examination under the supervision of the ATSB. Examination of the left engine revealed that the initiator of the damage was

the release of a power turbine second-stage blade. Metallurgical examination determined that the failure of the second-stage turbine blade had occurred as a consequence of the initiation and growth of a high-cycle fatigue crack from the downstream trailing corner of the blade fir-tree root post. Damage to the crack origin prevented the identification of any features that may have contributed to the initiation of fatigue damage. At the time of blade fracture, approximately 25 per cent of the root cross-section had been compromised by fatigue cracking.

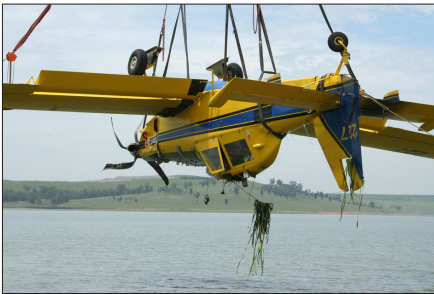
On 7 December 2007, the pilot of an Air Tractor Inc. AT-802 aircraft, registered VH-LIS, was conducting a test flight at Lake Liddell, NSW. The purpose of the flight was to test an experimental in-flight water collection system using skis attached to the aircraft's main landing gear. At about 0910 AEST, the pilot was conducting the second test run of the day. After the skis had been in contact with the surface of the lake for 36 seconds, witnesses observed the aircraft pitching nose down, about its right main landing gear while rotating to the right. The aircraft then overturned and sank. The aircraft was substantially damaged and the pilot was fatally injured.

The investigation concluded that the right experimental ski breached the surface of the water which caused a substantial amount of drag to act on the right side of the aircraft, rendering the aircraft uncontrollable. The circumstances of this accident highlight the need for due diligence and detailed risk assessments to be performed as part of experimental test programs. As a result of this incident, CASA has proposed amendments to Advisory Circular 21-10 - Experimental Certificates to provide updated guidance information to persons applying for the issue of experimental certificates, and advice on risk management for test pilots during experimental flight testing.
