ATSB TRANSPORT SAFETY REPORT  
Aviation Research and Analysis Report – AR-2009-016(3)  
Final

# Aviation Occurrence Statistics 1999 to 2009

AR-2009-016(3)

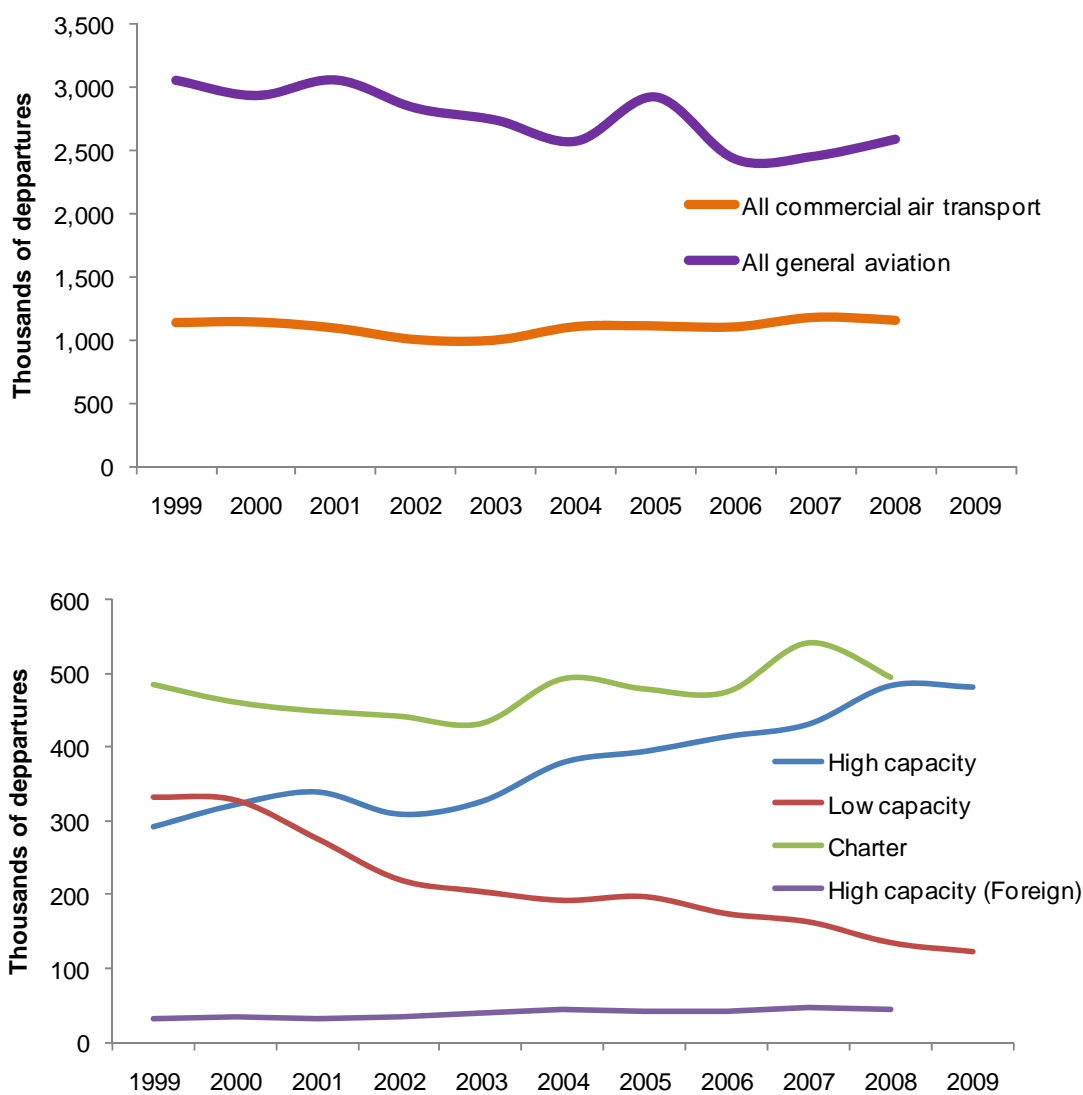
**Figure 1: Departures by operation type, 1999 to 2009**

Domestic high capacity departures have increased from 1999 to 2008 in a linear fashion by about 189,000 departures from 1999 to 2009. Low capacity aircraft departures have decreased in a linear fashion from about 208,000 departures from 1999 to 2009. Charter departures have remained relatively static with a slight increase since 2003. An increase in foreign registered aircraft departures has been observed over the reporting period.

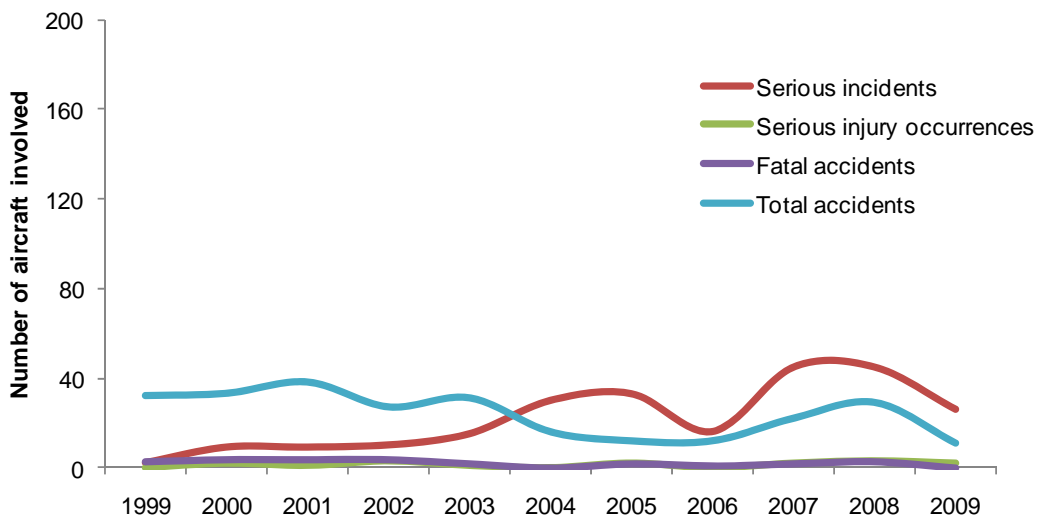
**Figure 3: Commercial air transport occurrences and injuries, 1999 to 2009**

The accident rate per million departures showed a U-shape line (Figure 3) from 2003 onwards. Charter aircraft account for the majority of accidents in commercial air transport and have an accident rate about five times higher than for high and low capacity RPT operations. Observation of the number of accidents in 2009, however, shows a steep decline to 11 accidents after the two consecutive years of increasing accidents. The fatal accident rate per million departures showed figures less than, or equal to four fatal accidents per million departures. No clear trend in fatal accident rates per million departures was observed, although some variability is observed between years. The fatal accident rate was at its highest in 2002 and lowest in 2004. An increase in serious incidents was observed from about 2003 onwards. This is when the *Transport Safety Investigation Act 2003* came into force. However, the number of serious incidents dropped from 45 (2007 and 2008) to 26 in 2009. Serious incidents are indicators of events that almost led to accidents. As such, they represent occurrences which could have had more serious consequences. In relation to serious injuries, there were generally less serious injuries than fatalities, although in 2008 and 2009, this trend was reversed.

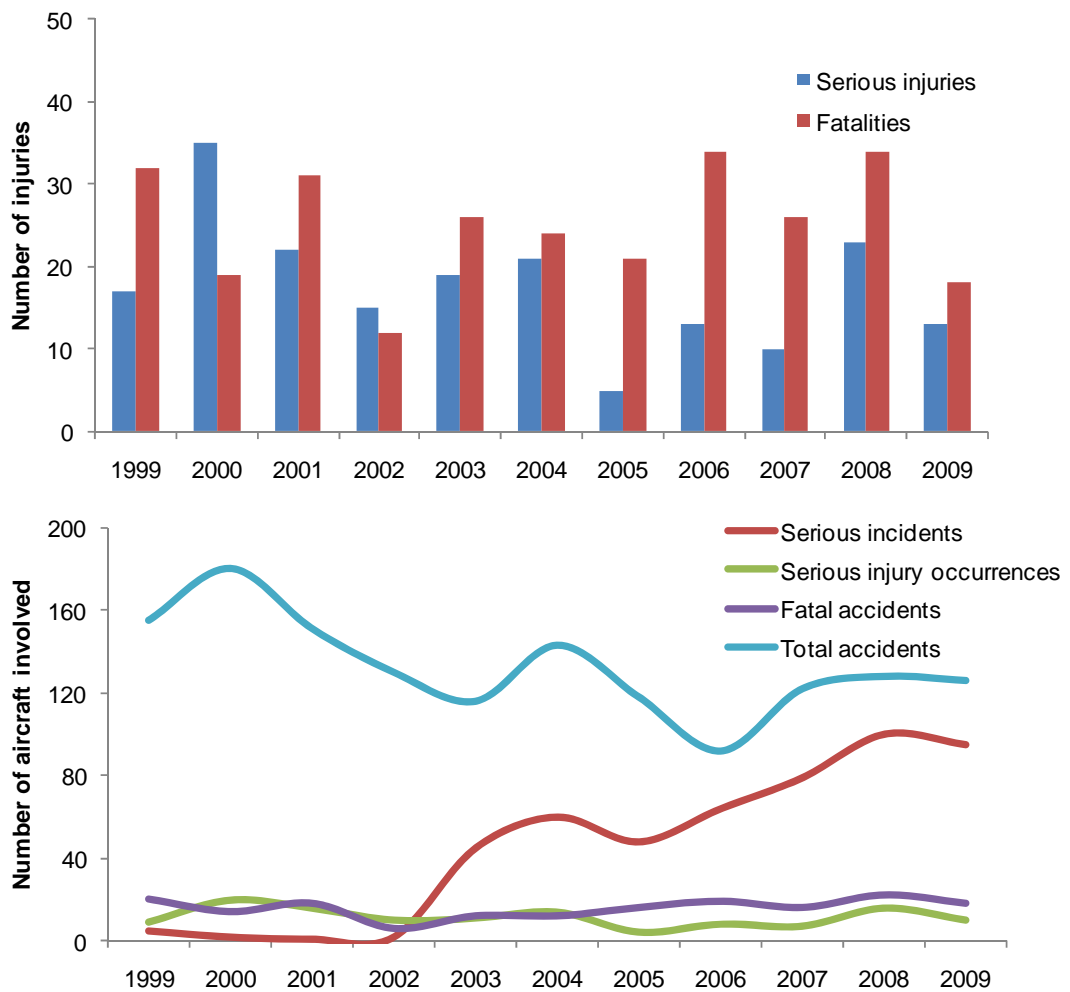
**Figure 7: General aviation (VH- and foreign registered) rates, injuries and occurrences, 1999 to 2009**

The general aviation accident rate per million departures is lower than for hours flown. In the most recent year where departures are available (2008), the accident rate (per million departures) was twice as large in general aviation as in commercial air transport, and the fatal accident rate was three-times as large.

Subcategories of general aviation have different accident and fatality rates. When the data is pooled over the report period, certain features emerge. Compared with flying training, aerial work has an accident rate per million hours that is two times higher and private/business has an accident rate that is 2.5 times higher. In terms of fatal accidents per million hours, the fatality rate in aerial work is three times higher than flying training, and private/business is at least six times higher. These rates are explored in the following tables. Note that accident rates are recorded per million hours flown, as departures in each subcategory are not known.
