Ground operations occurrences at Australian airports 1998 to 2008

This report examines occurrences involving ground operations and foreign object debris that occur at Australian airports which receive high capacity aircraft. It uses occurrence and investigation data reported to the Australian Transport Safety Bureau to create a picture of ground occurrences. This picture begins when an aircraft is being prepared for takeoff and ends when passengers and crew have disembarked from the aircraft. It explores contributing factors associated with each type of occurrence, with the objective of providing some insight into what happened and why various events occurred. The key to preventing ground occurrences appears to revolve around ensuring effective communication between pilots, ground crews and air traffic services through a process of checks and balances.

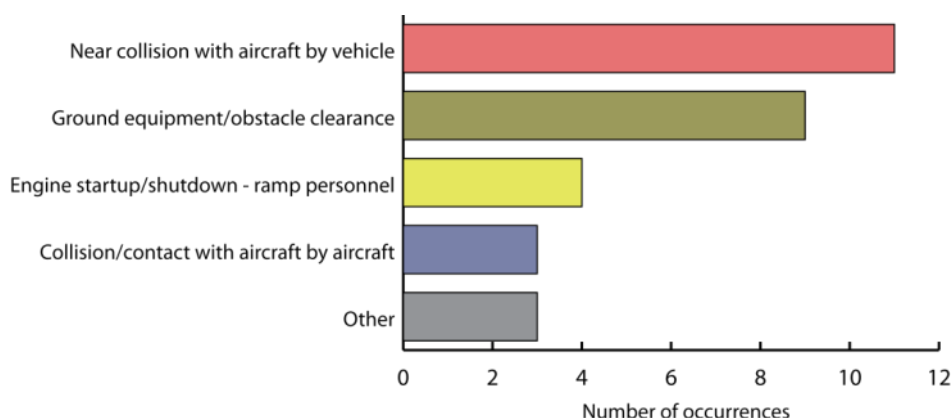
Figure 7: Approach to gate occurrences, 1998 to 2008

Thirty occurrences were reported while approaching the gate, accounting for about 11 per cent of all occurrences involving ground operations. Figure 7 shows that the most commonly reported occurrence was near collision with aircraft by vehicles (about 37 per cent). These occurrences required immediate braking action by the flight crew or vehicle driver in order to avoid a collision. Occasionally, cabin crew were injured during these events, as they were out of their seats preparing for arrival; the act of sudden braking threw them off balance.

Occurrences in the *other* category involved disembarking passengers, flight crew taxi techniques, and ground crew approaching the aircraft engines before the aircraft had stopped. In the first occurrence, the flight crew were cleared to enter a terminal gate, but upon entry, found disembarking passengers from an adjacent aircraft gate in their path. The second occurrence involved a pilot using a sharp-manoeuvring taxi technique close to terminal ground support equipment.

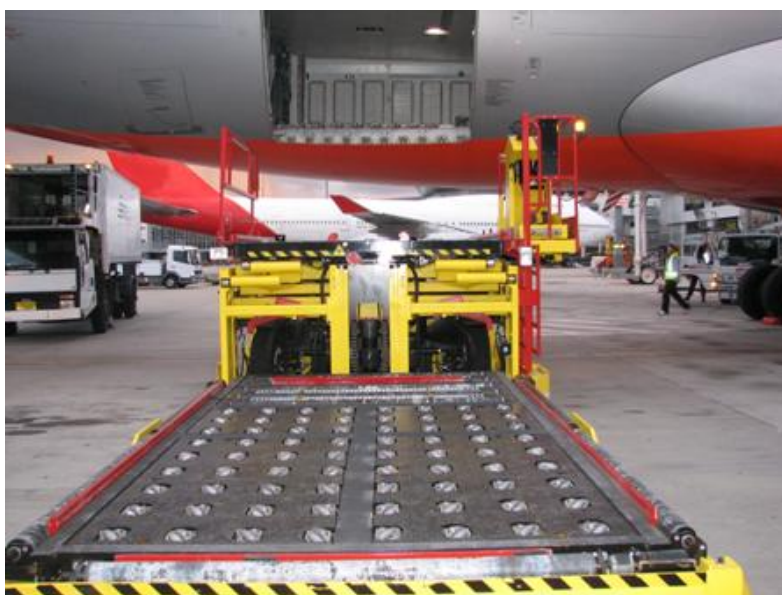
Figure 10: Pallet loader positioned next to an aircraft at an Australian airport

It is interesting to note that airlines using predominately hand-push vehicles for loading and unloading of luggage and passengers appear to have fewer ground operations occurrences involving damage. Use of motorised vehicles around aircraft cannot be totally eliminated, as pallet container and catering trucks must continue to lift heavy items into the cargo holds of an aircraft.

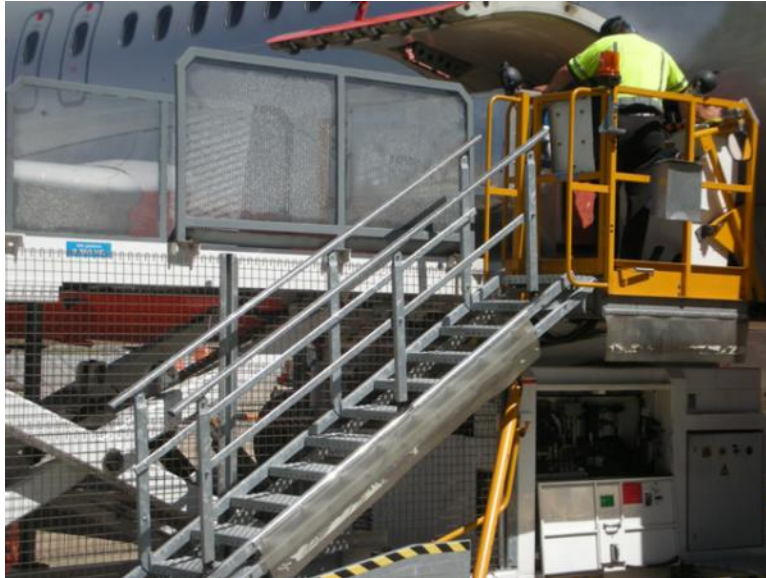
Figure 11: Concurrent refuelling and loading operations

There were 16 refuelling occurrences reported to the ATSB between 1998 and 2008. Most refuelling occurrences reported had consequential events relating to fuel venting and spills. Note that none of these occurrences related to aircraft weight and balance issues.

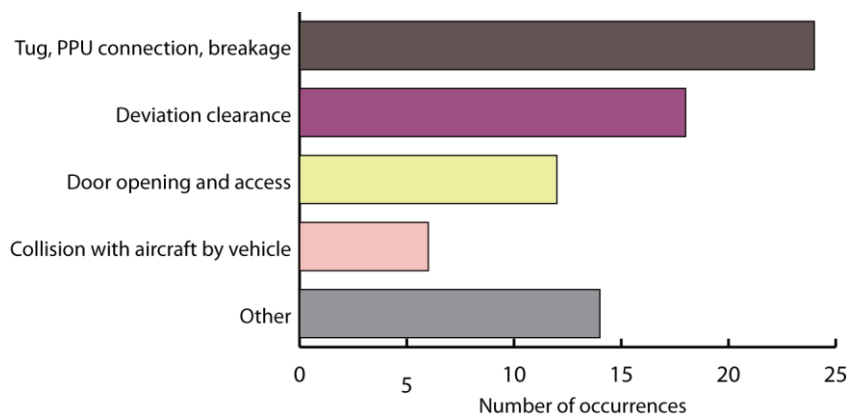
Figure 12: Pushback occurrences, 1998 to 2008

There were 74 pushback occurrences reported to the ATSB, making this the third most common type of ground operations occurrence (representing about 26 per cent). Ground operations events were defined as occurring in the pushback phase if they happened at any time between the connection of a tug or power push unit (PPU), and the point at which an aircraft taxis under its own power on a taxiway.

Four occurrence types accounted for about 80 per cent of all pushback occurrences; these were tug or PPU connection and breakage, failure to comply with pushback clearance procedures, inadvertent aircraft door opening, and collision with aircraft by vehicle.

By far, the most frequently reported pushback occurrence involved tug or PPU connections and disconnections (33 per cent), including breakages while the aircraft was moving. These connections and disconnections occur for a variety of reasons which revolve around communication between the dispatcher, flight crew, and tug or PPU driver.

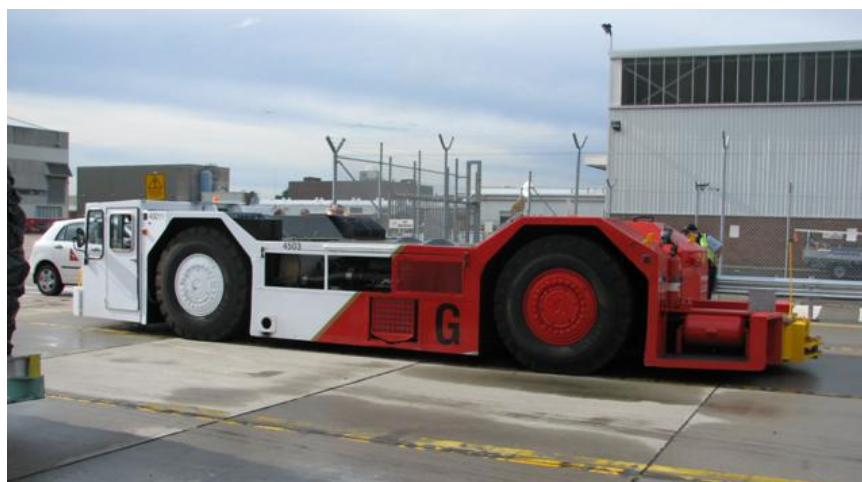
Figure 13: Pushback tug positioned airside

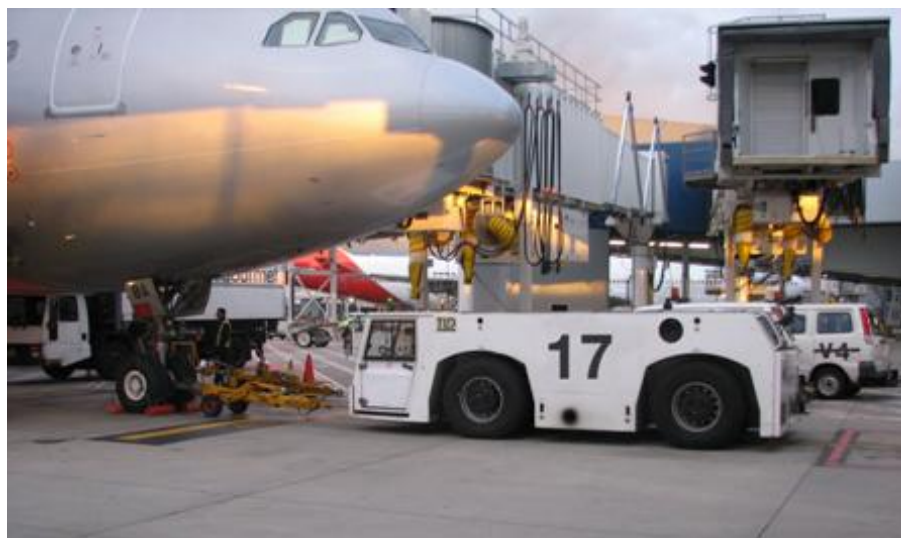
Figure 14: Pushback tug, with towbar, awaiting connection to the nose wheel

- tug was incompatible with the aircraft
- towbar was not the correct length
- PPU roller assemblies had fractured or failed.

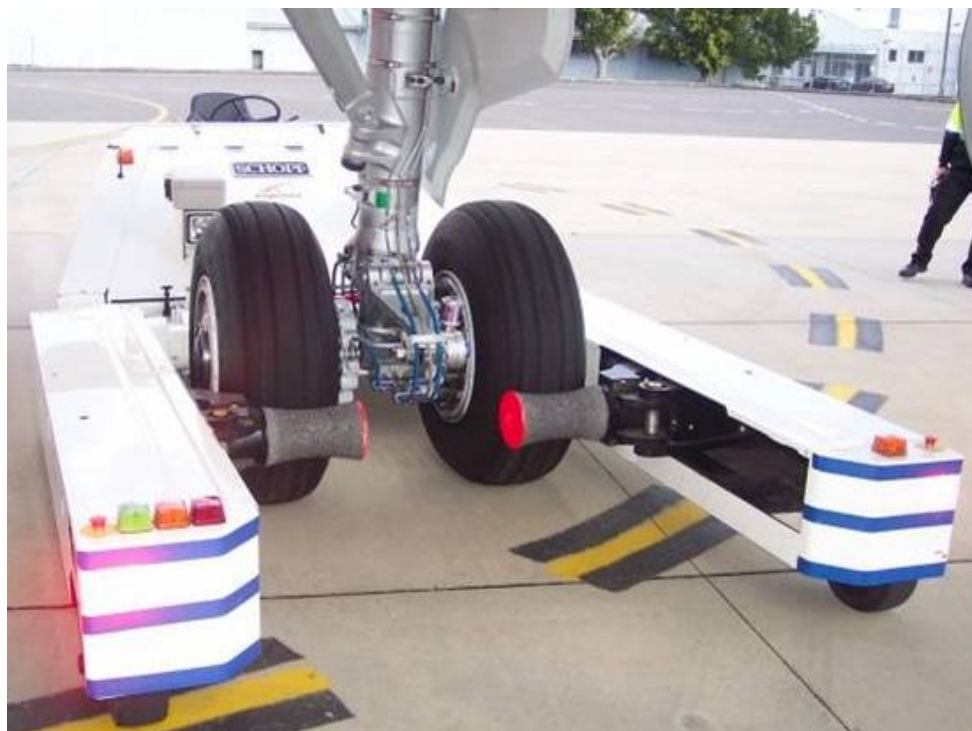
Figure 15: Powerpush unit attached to the main landing gear

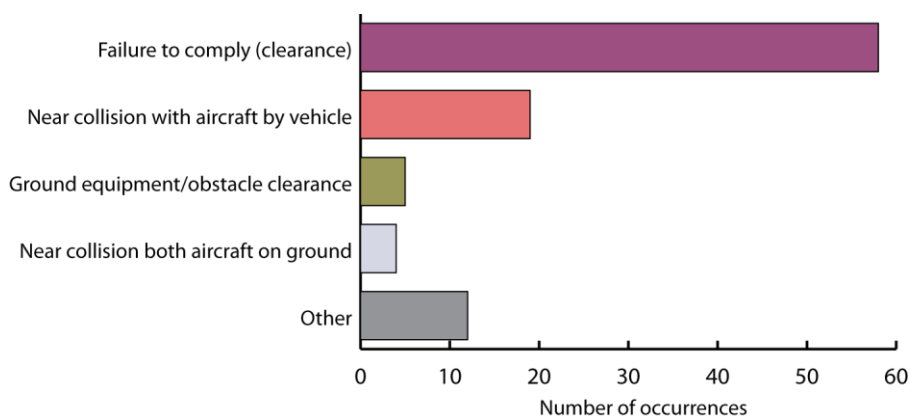
Figure 16: Taxiway occurrences, 1998 to 2008

Ninety-eight taxiway occurrences were reported to the ATSB over the reporting period. About 77 per cent of taxiway occurrences involved a deviation by vehicles from a surface movement controller clearance (not a runway incursion), or a near collision with aircraft.⁶ The remaining occurrences related to reduced clearance with ground equipment and obstacles, actual and near aircraft-aircraft collisions, jet blast, and vehicle clearance on taxiways, including near collisions with aircraft by vehicles.

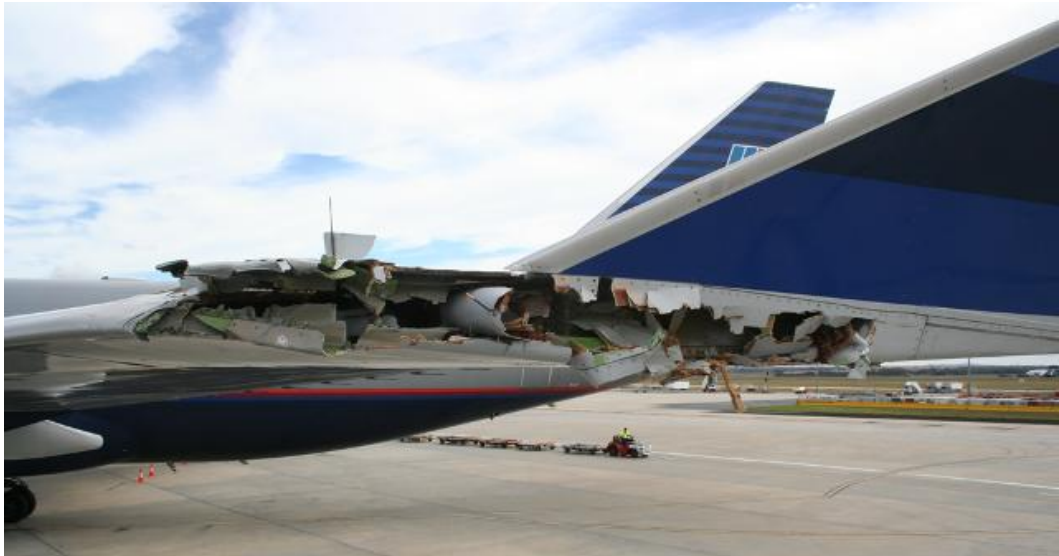
Figure 18: Taxiway aircraft-aircraft collision showing winglet damage

One taxiway occurrence during the reporting period involved an aircraft-aircraft collision. An experienced pilot in a Boeing 747 aircraft deviated from a taxiway clearance, attempting to squeeze past a Boeing 767 aircraft which was protruding into the taxiway. The pilot in command of the 747 misjudged the distance between the wingtip of the 747 and the right horizontal stabiliser of the 767, resulting in a collision (Figure 18).

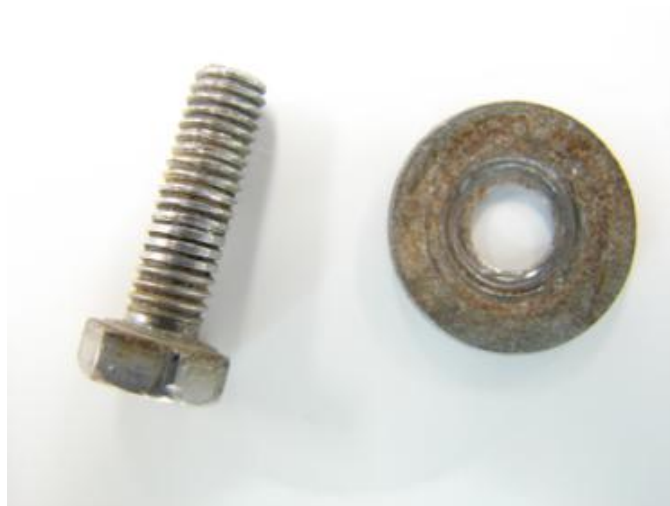
Figure 19: Nut and bolt found on an Australian flight strip

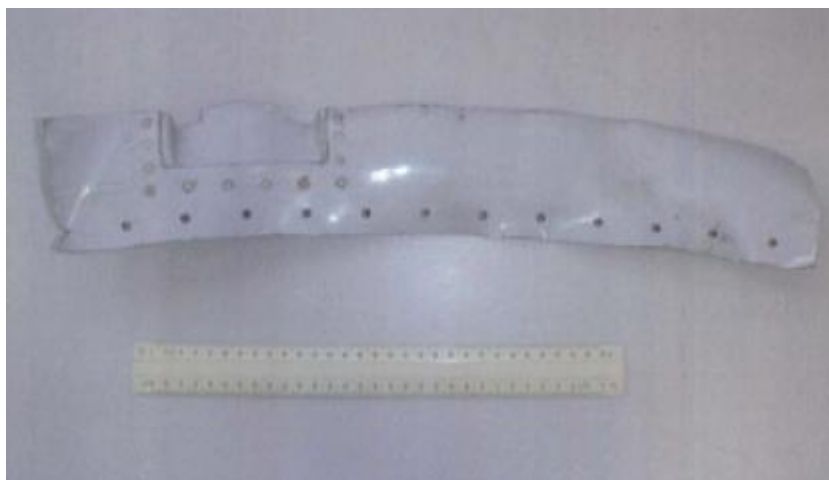
Figure 21: An aircraft component (FOD) found at an Australian airport

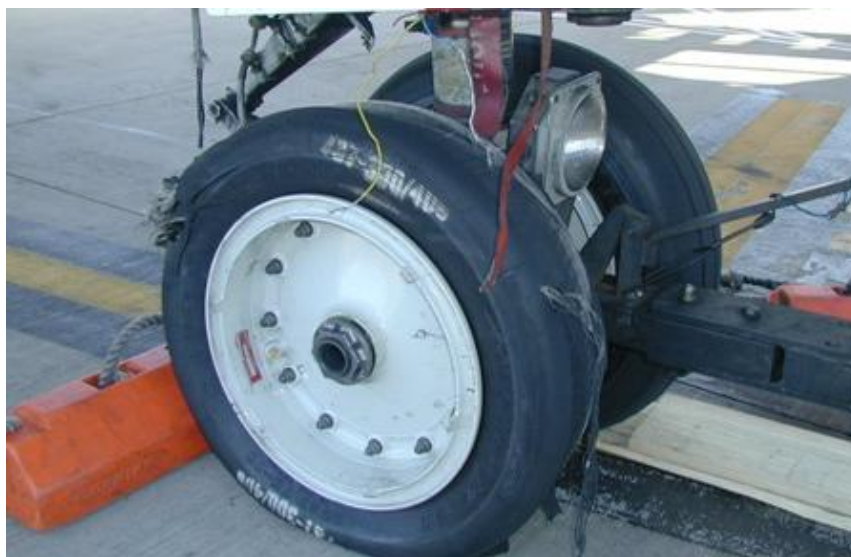
Figure 23: A Boeing 737 nosewheel tyre shredded as a result of FOD impact in Australia
