ATSB TRANSPORT SAFETY REPORT
Aviation Research and Analysis Report – AR-2007-057
Final

Trends in immediately reportable matters involving charter operations 2001 to 2006

Australian Transport Safety Bureau

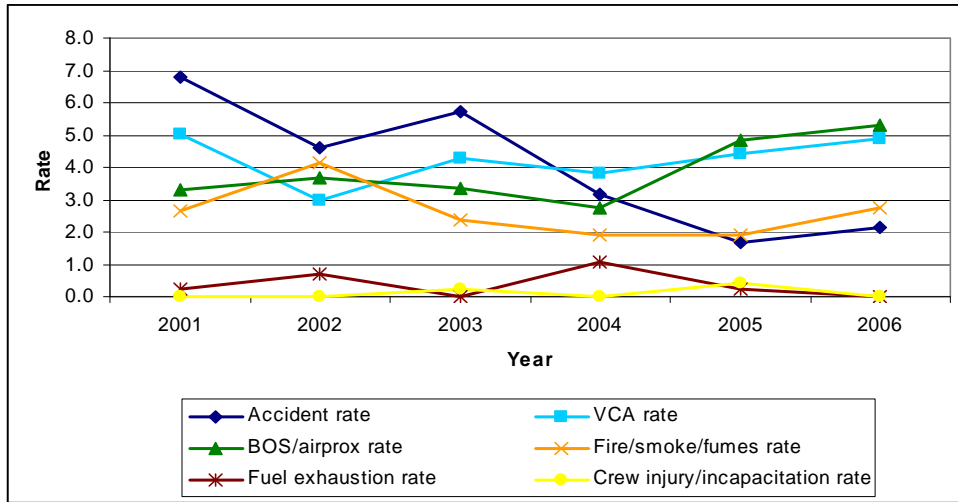
Summary of rates per 100,000 hours flown for each IRM group, 2001 to 2006

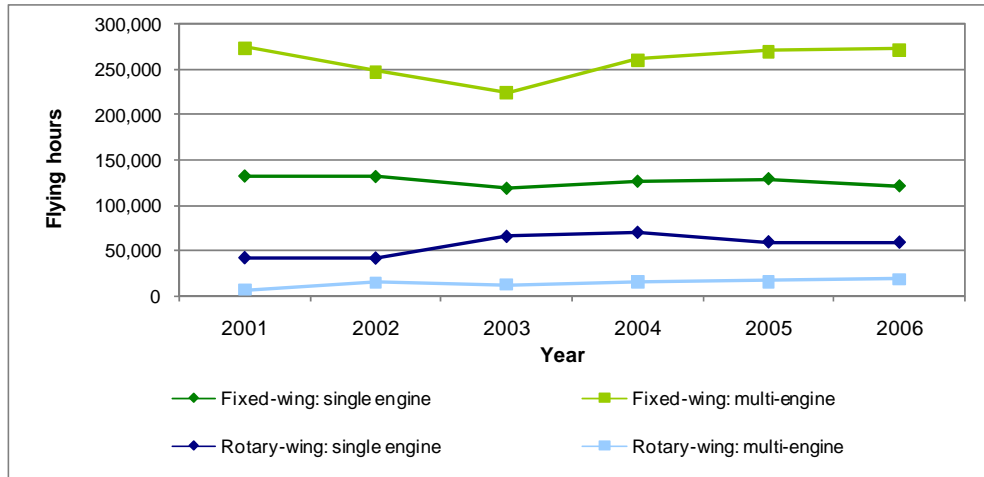
Figure 2: Hours flown by aircraft type and number of engines, 2001 to 2006

The majority of charter flying hours were performed by fixed-wing, multi-engine aircraft, followed by fixed-wing, single-engine aircraft, single-engine helicopter, and multi-engine helicopters, respectively. The distribution of charter hours by aircraft type is presented in Figure 2.

Figure 2 indicates that there was a change in the type of aircraft performing charter operations with growth in the hours flown by larger multi-engine aircraft and a decline in smaller fixed-wing aircraft.

Hours flown by single-engine fixed-wing aircraft dropped by eight per cent between 2001 and 2006.

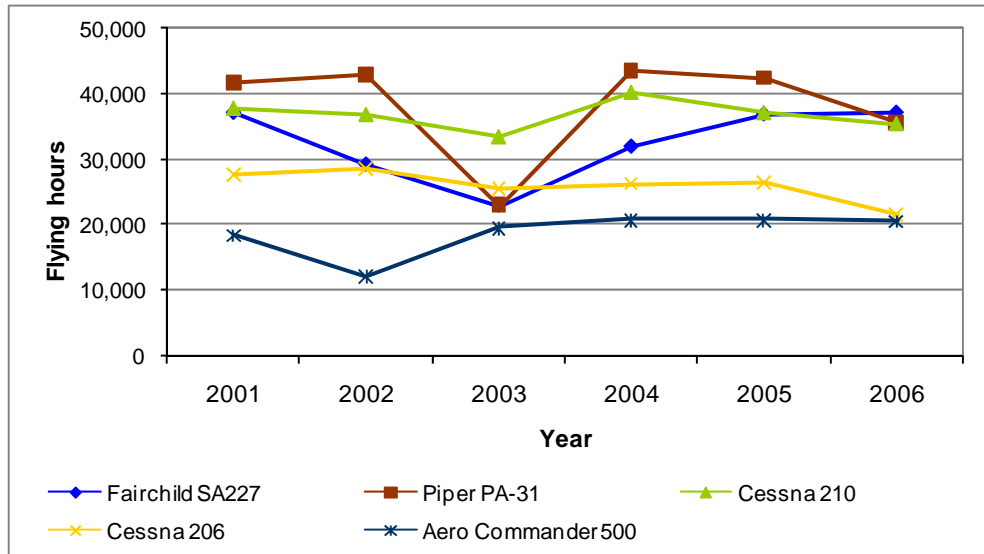
Figure 3: Hours flown by aircraft model (fixed-wing), 2001 to 2006

The top five fixed-wing aircraft models flying charter in Australia in 2006 were the Fairchild SA227 (Metro III and Metro 23), Cessna 210 (Centurion), Piper PA-31 (Navajo, Mojave and Chieftain), Cessna 206, and Aero Commander 500 (see Figure 3). Until 2006, the Piper PA-31 (twin-engine piston aircraft with seating of up to nine passengers) was the dominant fixed-wing aircraft used for charter operations across the period. However, by 2006, the Fairchild SA227 (a twin-engine turboprop aircraft with a seating capacity of up to 19 passengers) and Cessna 210 (a single-engine piston aircraft with seating of up to five passengers) were as commonly used for charter operations as the Piper PA-31 aircraft.

The Cessna 206 (a single piston-engine aircraft with up to five passengers) and Aero Commander 500 (a twin-engine piston aircraft with up to six passengers) flew less charter hours than the above three aircraft by 2006. The charter hours flown by the Cessna 206 consistently declined over the years studied.

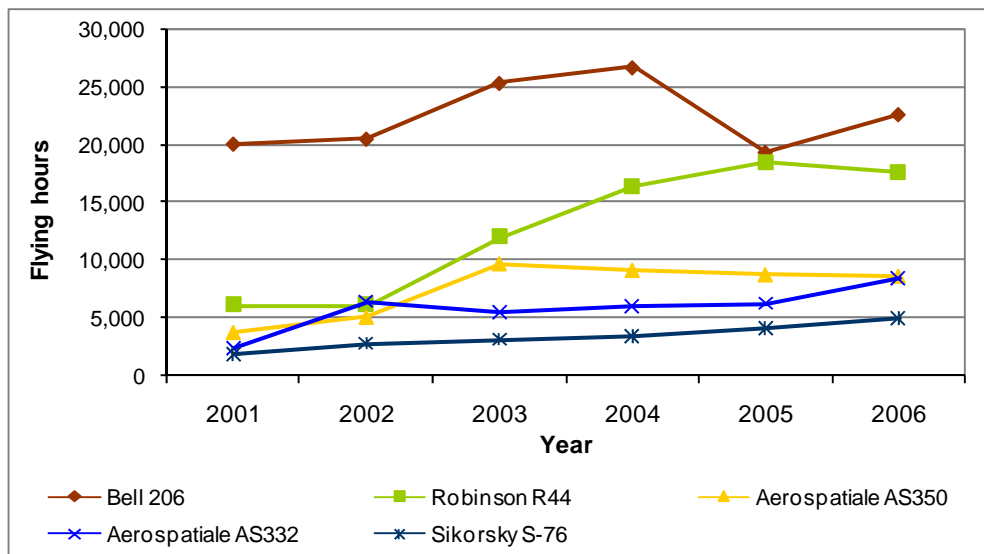
Figure 4: Hours flown by aircraft model (rotary-wing), 2001 to 2006

For rotary-wing aircraft, the top five aircraft models flying charter in 2006 were the Bell 206 (JetRanger), Robinson R44, Aerospatiale/Eurocopter AS350 (Ecureuil) and AS332 (Super Puma), and Sikorsky S-76 (see Figure 4). The Bell 206 (a single-engine turboshaft with maximum of five passengers) flew the most hours in charter operations each year between 2001 and 2006 while the popularity of the Robinson R44 (a piston-engine aircraft with a maximum of three passengers) grew steadily over the six years, flying nearly three times more hours in 2006 than in 2001.

Although flying considerable lower charter hours, there was some increase in the hours flown across the six years by the two larger and twin-engine turboshaft helicopters, the AS 332 (capacity of 17 passengers) and S-76 (capacity of 13 passengers).

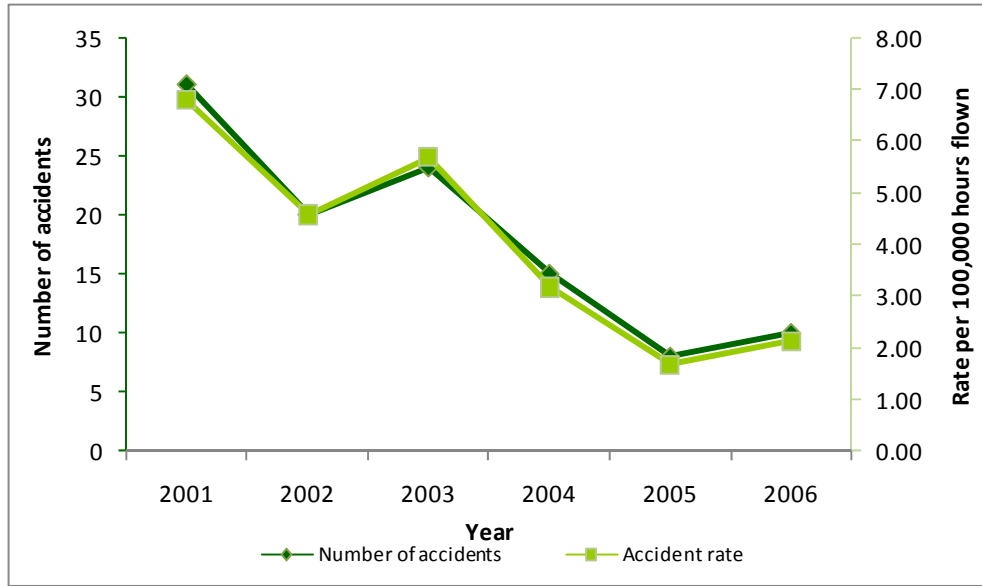
Figure 7: Accidents and accident rate per 100,000 hours flown (VH-registered aircraft), 2001 to 2006

There were 109 accidents involving aircraft flying charter operations between January 2001 and December 2006. Only one of those accidents involved a non-VH-registered aircraft. Figure 7 below shows there was a noticeable downward trend in the number of accidents reported in charter operations. The rate of accidents per 100,000 flying hours also reflected this trend, dropping by 30 per cent between 2001 and 2006. This was a statistically significant decrease in the rate of accidents.⁹

Of the 108 accidents, 12 were fatal (11 per cent), three resulted in serious injury (3 per cent), and 14 resulted in minor injuries (13 per cent). The remaining 79 accidents (73 per cent) resulted in nil injuries, however, aircraft damage was recorded. The number of fatal accidents each year has dropped from four in 2001 to one in 2005 and 2006. In 2004, there were no fatal accidents involving charter operations.

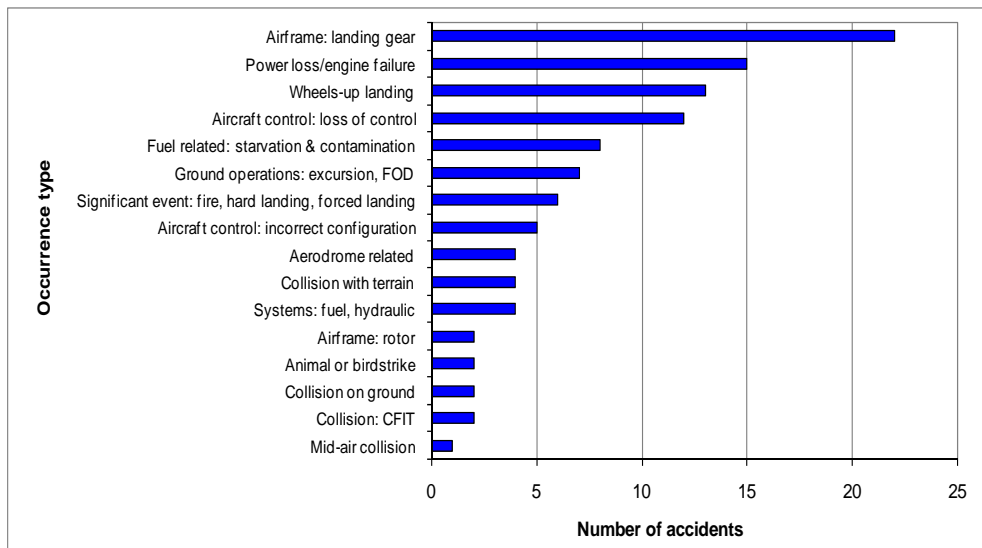
Figure 9: Charter accidents by occurrence type, 2001 to 2006

Table 1 and Figure 9 summarise the type of accidents that occurred during charter operations over the time period. Each accident was categorised into one occurrence type. While it is possible, but not necessarily common, for one accident to be classified into multiple occurrence categories, only the primary type of occurrence¹¹ was selected in this study.

To assist in the presentation of the data, Figure 9 collapses a number of the occurrence categories listed in Table 1. The five most common accident categories were: mechanical problems with the aircraft's landing gear (20 per cent), wheels-up landing (12 per cent), partial and complete power loss/engine failure (14 per cent), loss of aircraft control (11 per cent), and fuel-related accidents (7 per cent).

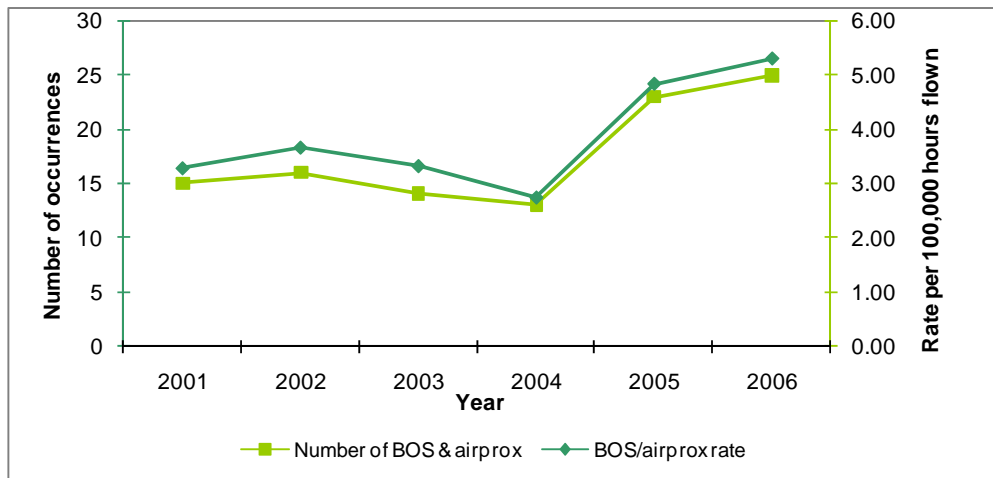
Figure 13: Number and rate (per 100,000 hours flown) of combined BOS and airprox occurrences involving VH-registered aircraft, 2001 to 2006

The combined rate of BOS and airprox occurrences for VH-registered charter aircraft increased from 3.3 per 100,000 flying hours in 2001 to 5.3 in 2006 (Figure 13). However, this change in the rate between 2001 and 2006 was not statistically significant.¹⁴

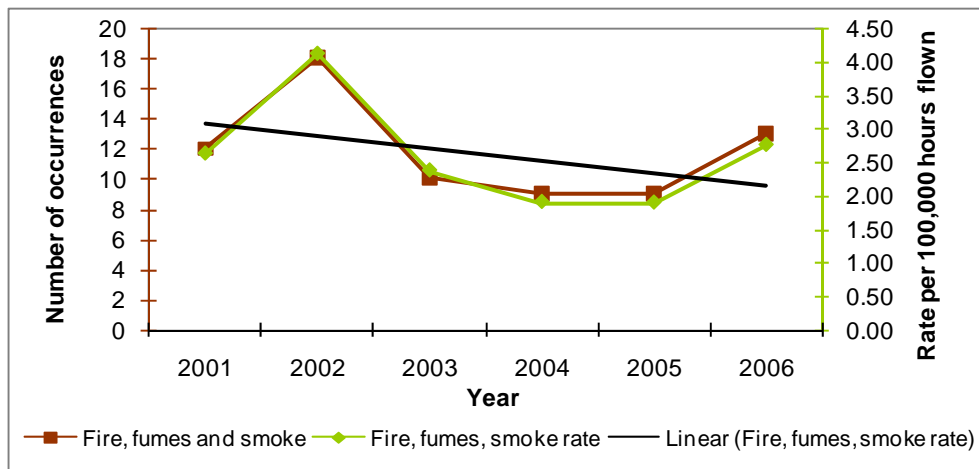
Figure 16: Number and rate (per 100,000 hours flown) of reported fire, smoke or fumes occurrences, 2001 to 2006

There were 71 occurrences involving fire, smoke, or fumes in charter operations between 2001 and 2006. The number of occurrences peaked at 18 in 2002 (see Figure 16). The rate of occurrences per 100,000 flying hours appeared to trend downward, primarily due to the low number of occurrences recorded in 2004 and 2005. However, the trend in the rate of fire, smoke or fumes occurrences was not statistically significant.¹⁷ There were no occurrences involving an explosion during the time period.

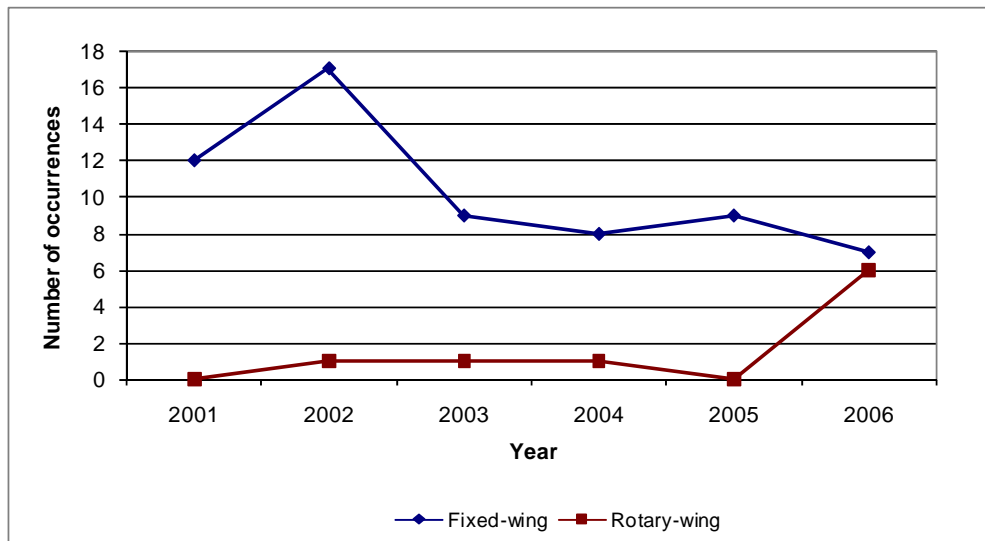
Figure 17: Fire, smoke or fumes occurrences by aircraft type, 2001 to 2006

The observed rise in occurrences between 2001 and 2002 reflected an increase in occurrences in fixed-wing aircraft while the rise between 2005 and 2006 reflected the jump in occurrences in rotary-wing aircraft (see Figure 17).
