ATSB TRANSPORT SAFETY INVESTIGATION REPORT
Aviation Research and Analysis Report – AR-2007-021
Final

Fibre composite aircraft – capability and safety

**Fibre composite aircraft – capability and
safety**

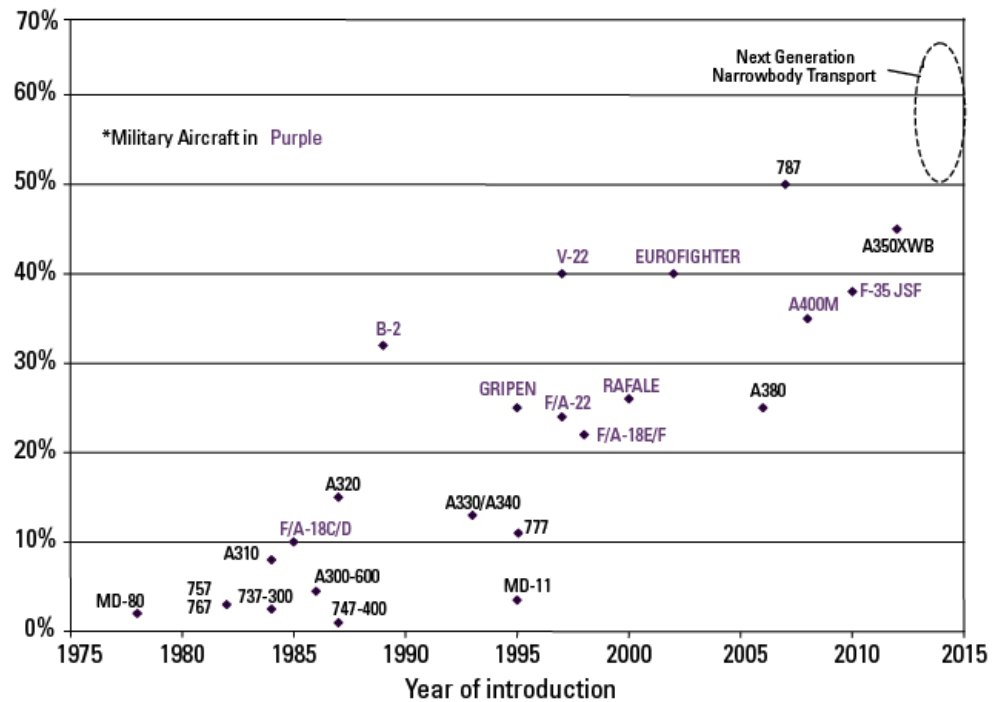
Figure 2: The growth of composite structure on major aircraft programs (1975-2010) as a percentage of weight

Fibre composites have been used in an ever-increasing percentage of jet airliner structures for several decades (Figure 2). Boeing began using composites over 30 years ago in 737 spoilers; composites have now replaced light alloys to create significantly lighter and lower-maintenance control surfaces and empennages in the

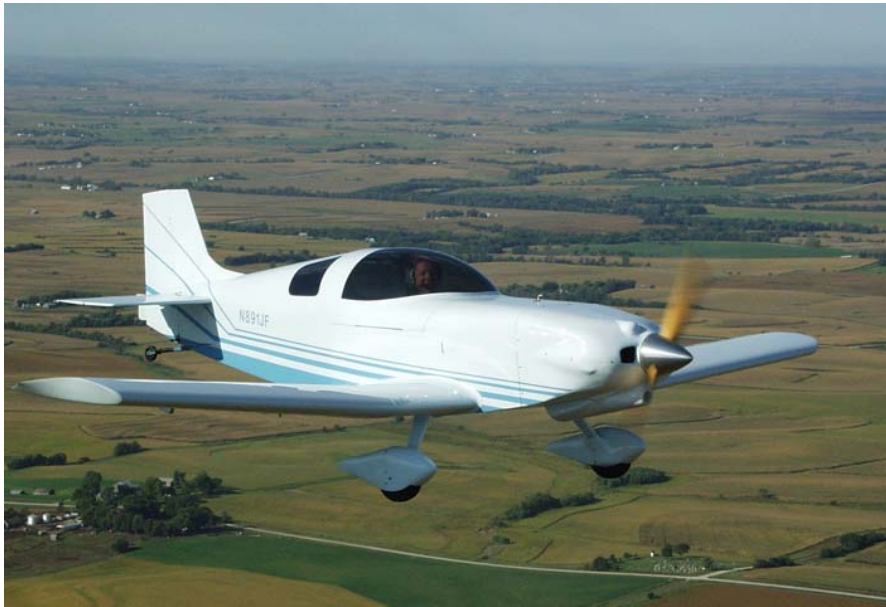
Figure 4: Rand KR-2 (derivative of the KR-1)

Fibre composites have been used extensively in amateur-built aircraft kits since the 1970s, when the Rand KR-1 kit was introduced. Since this time, many kit aircraft continue to heavily utilise composites, as many parts could be pre-moulded at the factory by the manufacturer, reducing build time and part count, and simplifying the required tooling and assembly procedures for the amateur builder. As fibre composites are a woven textile which is hardened by a thermoset resin (such as epoxy), they can be easily moulded into complex shapes. Loads are carried by the network of fibres in the composite, allowing these complex shapes to be used without the need for additional structural support. These factors make composite a more flexible building material than metal, allowing stronger, more aerodynamic aircraft, while reducing part count, weight and fuel consumption.

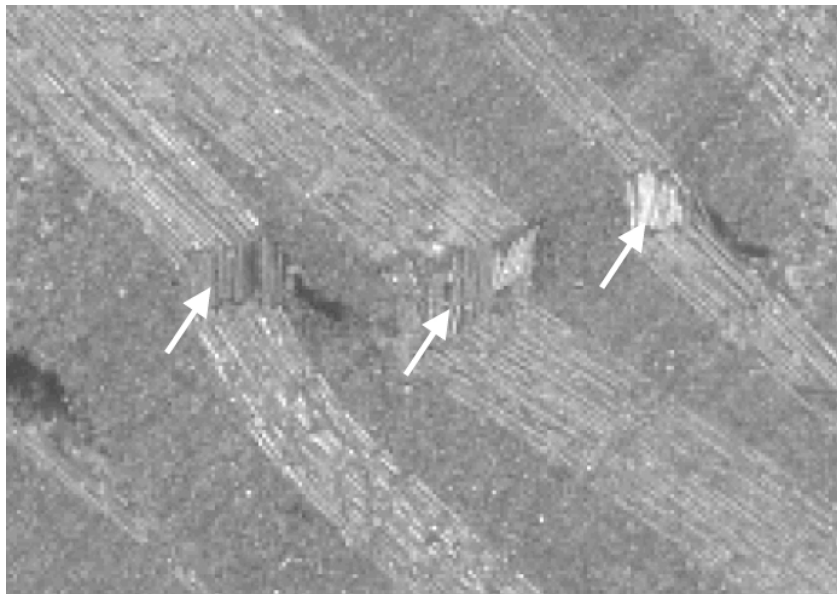
Figure 8: Formation of kink bands when composite laminates are under compression (marked with arrows)

On a microscopic level, a major indication of compression failure in fibre composites is the formation of kink bands in the fibres (Figure 8). Because fibres are poor in compression, kink bands occur due to plastic buckling as the compressive load approaches a critical level. Matrix splitting is often associated with these kink bands, which can be seen as gaps in the matrix at the failure surface. It occurs at points of high-stress concentration in the matrix, such as the fibre-matrix interface and between plies (i.e. in areas of delamination).

Kink bands	A phenomenon visible in fibre composite structures that have failed in compression. Kink bands are formed by fibres buckling before failure occurs and can be seen as cracks in the matrix. Figure 8 shows an example of kink bands.
Laminate	A sheet of composite material used in aircraft structures. It is made by bonding numerous plies of fibre together with a bonding material (e.g. epoxy).
Load cycle	Provides a measure of an aircraft or component's operational life. One cycle is one takeoff plus one landing of an aircraft.
Matrix splitting	Separation of the matrix that holds together the fibres in a composite structure, often caused by damage or by excessive compression loads.
Rib	An aircraft structural member that runs transversely across the wing and is attached to the main spar. Ribs maintain the aerofoil shape of the wing and provide structural support for the skin.
Scarf repair	A repair patch used where structures are too damaged or too thick to apply a simple bonded doubler. The damaged area is cut away and replaced with the scarf, which is replacement section tapered to reduce shear stress where it is joined to the original undamaged structure.

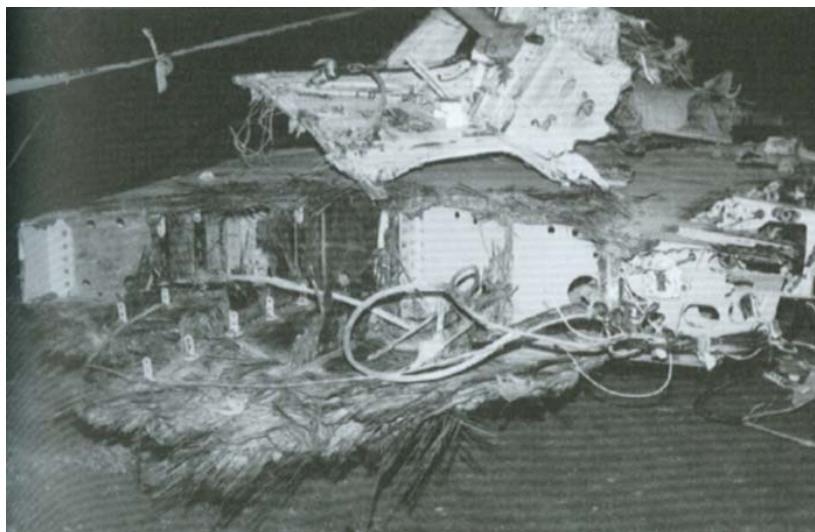
Figure 10: Wing that failed in bending, showing the difference between the tension (lower) and compression (upper) sides

Fibre composite structures that have failed in bending show obvious signs of tension and compression around the neutral bending axis. One side of the structure will contain pulled-out fibres (the side in tension), while the other will be relatively flat (the side in compression) (Rakow & Pettinger 2006). The wing in Figure 10, which failed in bending, shows drastically the difference between the tension and compression sides.

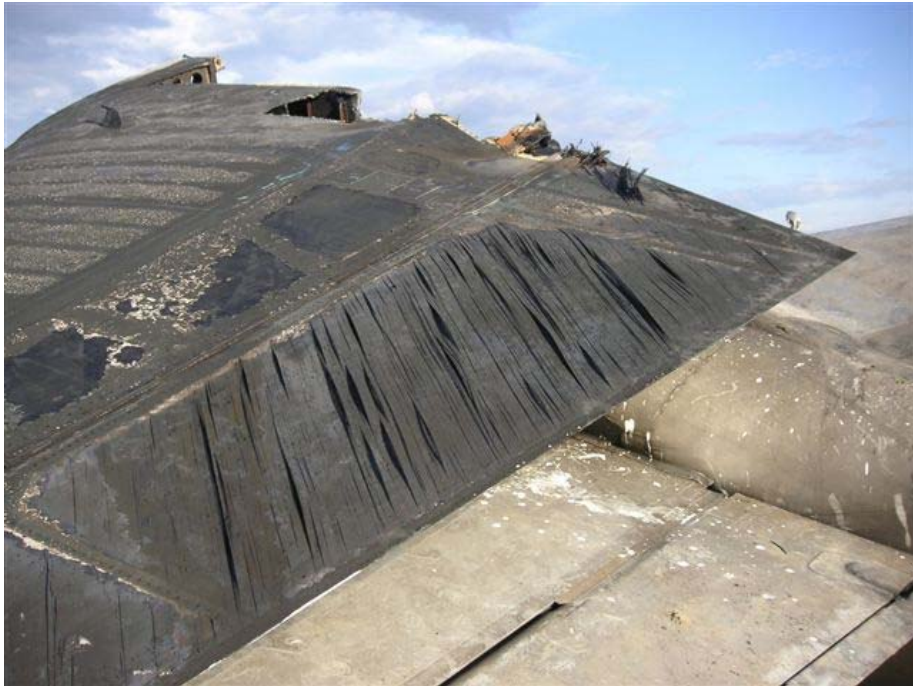
Figure 13: Burnt composite fibres in the rudder section of a Boeing 737-400 following a post-impact fire

In the event of a composite aircraft crash and/or fire, first responders should be aware of the dangers of both fibre fragments released from damaged composite structures, and the smoke/noxious gases from the bonding epoxy matrix which may have burned away (Figure 13).

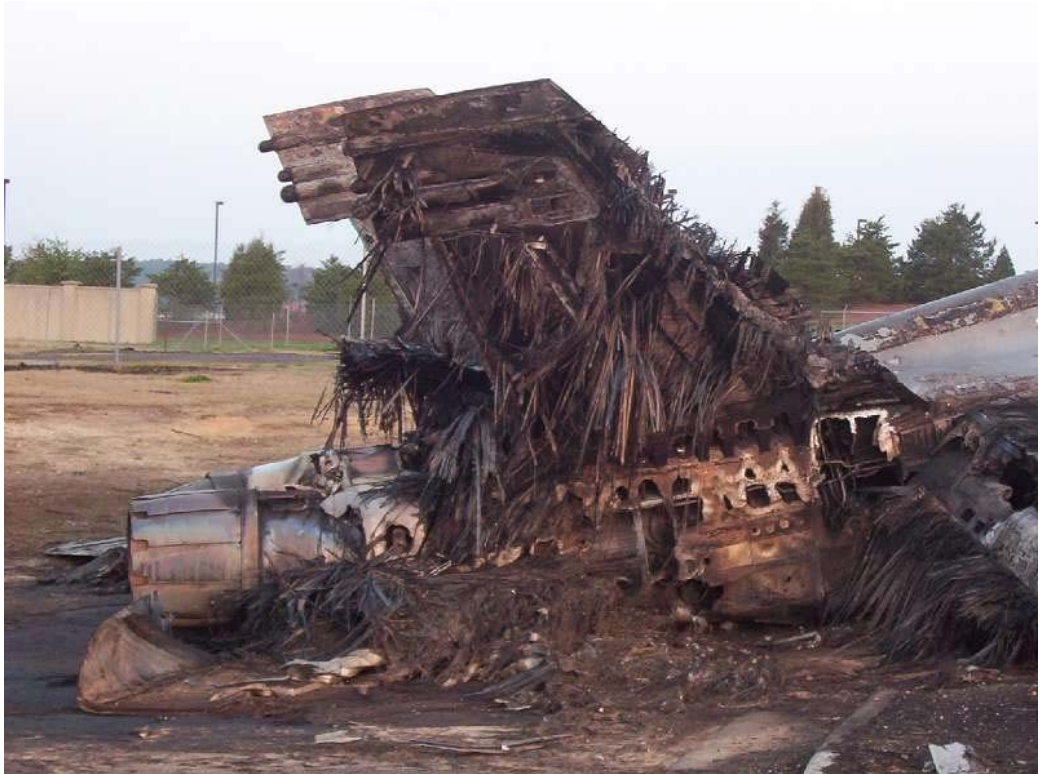
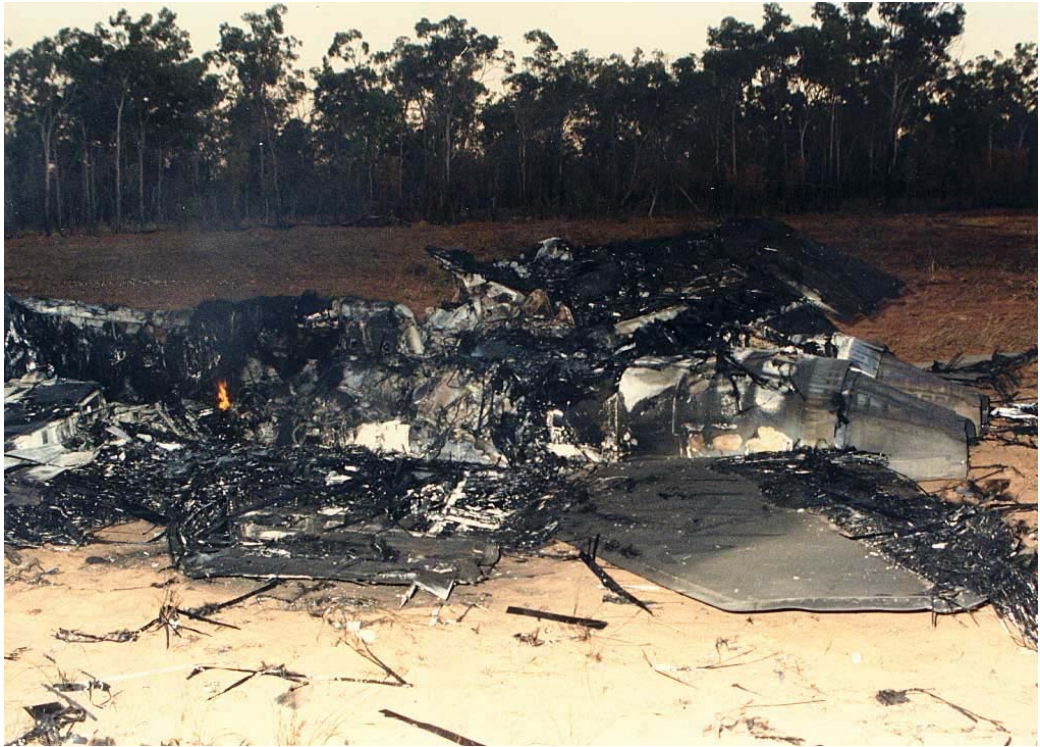
Figure 15: Significant carbon fibre debris following an F/A-18 Hornet fire – a typical scene at future accident sites?
