ATSB TRANSPORT SAFETY INVESTIGATION REPORT
Aviation Research and Analysis Report – B20070107
Final

Trends in immediately reportable matters involving regular public transport operations

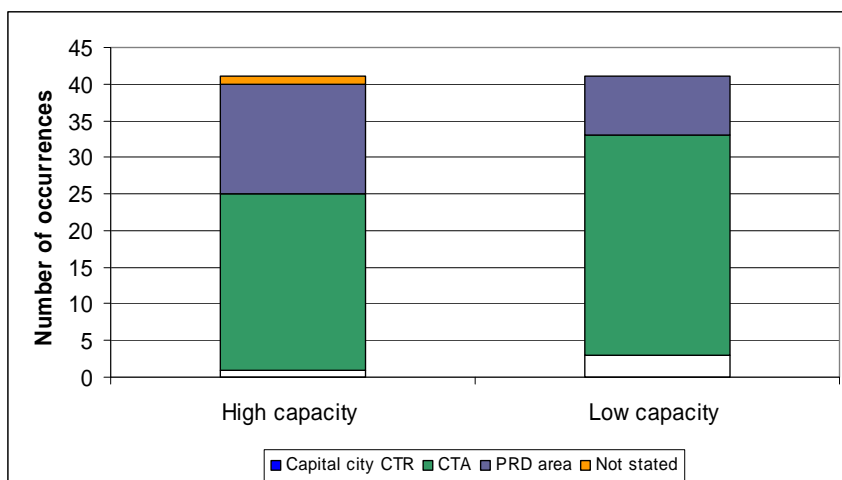
The data for VCA events was also analysed by the type of airspace involved for each occurrence. Figure 9 shows which type of airspace was most commonly involved in VCA occurrences for low and high capacity RPT operations. Entry without a clearance into controlled airspace, other than the control zone around an airport, was the most frequent event. The next most common reason for a VCA was entry into restricted airspace without a clearance, although this is less frequently the case for low capacity RPT compared with high capacity RPT operations.

Figure 9: Type of airspace violated by air transport operation type, July 2001 to June 2006

Note: CTR refers to a control zone and is defined as the controlled airspace around an aerodrome

CTA is an abbreviation for controlled airspace and refers to controlled airspace that is not a control zone (CTR) (Aviation Theory Centre, 2004; National Airspace System Implementation Group, 2003).
