Australian Transport Safety Bureau

## Turning safety issues into action

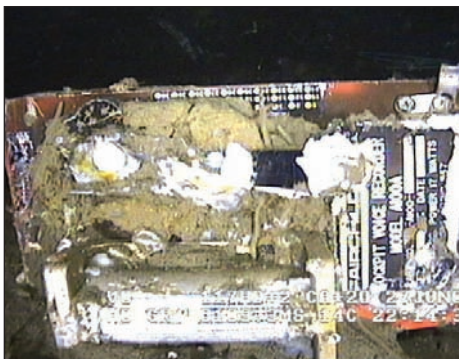
## Cockpit voice recorder on the ocean floor

There was no evidence of a midair breakup of the aircraft. Both of the aircraft's on-board flight recorders were recovered from the ocean floor, but they only contained data from a previous flight—not the accident flight.

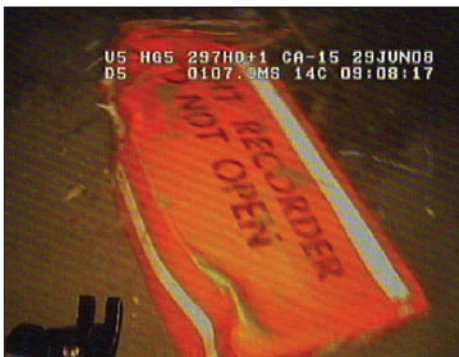
## Flight data recorder, popularly referred to as the 'black box'
