# Radio failure involving a Mitsubishi MU-2B, N64MD

Townsville Airport, Queensland, 5 April 2013

**ATSB Transport Safety Report**  
Aviation Occurrence Investigation  
AO-2013-066  
Final

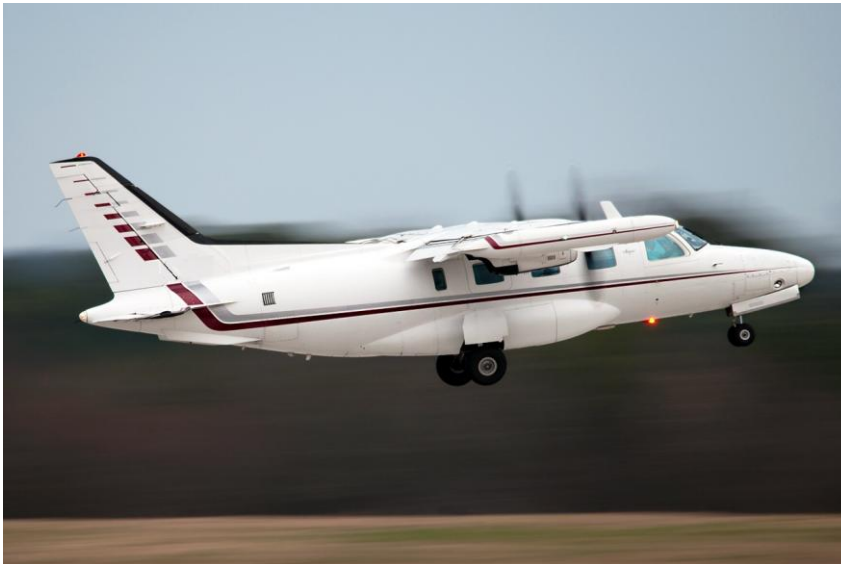
**Figure 1: A Mitsubishi MU-2B aircraft**

On 5 April 2013, at about 0830 local time,<sup>1</sup> a Mitsubishi MU-2B aircraft (Figure 1), with United States registration, N64MD, departed Honiara, Solomon Islands with two pilots onboard. The purpose of the flight was to ferry the aircraft from Honiara to Essendon, Victoria, with an intermediate stop at Townsville, Queensland.
