Australian Government  
Australian Transport Safety Bureau

AVIATION SAFETY RESEARCH REPORT

# **Airspace-Related Occurrences Involving Regular Public Transport and Charter Aircraft within Mandatory Broadcast Zones**

December, 2003

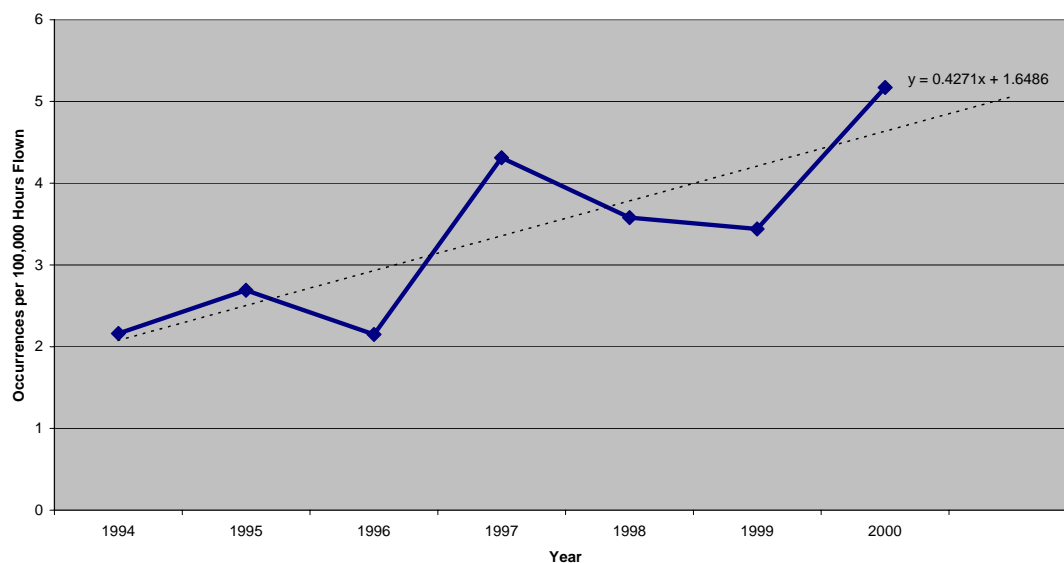
**Figure 1. MBZ Airspace-Related Occurrence Rates by GA and Regional Airline Hours Flown within Australia (with trend line)**

Figure 1 illustrates an upward trend in the rate of airspace related occurrences within MBZs since 1994. However, before drawing any conclusion regarding this trend it must be assumed that activity patterns in the total hours flown within Australia are indicative of the aircraft activity levels within MBZs.

The current study uses total aircraft activity levels within Australia to identify any trends in activity which may be influencing the occurrence of airspace-related issues within MBZs. One common measure of aircraft activity is hours flown. Figure 1 illustrates the rate of occurrences in MBZs per 100,000 hours flown by GA and regional airline aircraft within Australia for the period 1994-2000.

The requirement to make this assumption weakens any conclusions that can be drawn. However, statistical analysis<sup>20</sup> revealed that the average increase in occurrence rates of 0.427 per year was significant.<sup>21</sup> The overall increase in rates may be indicative of:

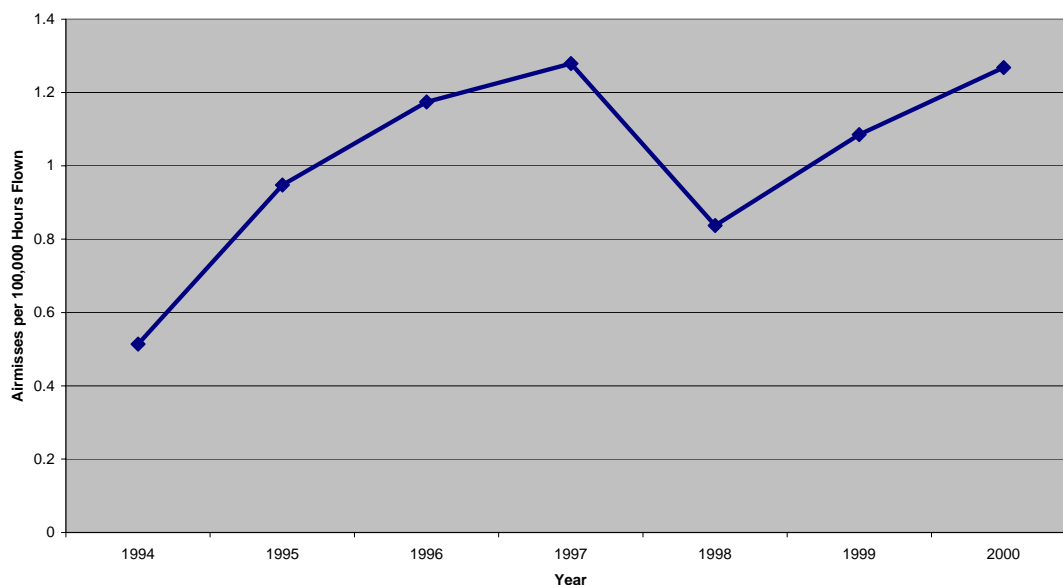
Figure 2. MBZ Airmis Rate per 100,000 Hours Flown (1994-2000)

As can be seen, the rate of reported airmisses per 100,000 hours seems to be increasing in MBZs. However, the trend was not found to be statistically significant.<sup>25</sup> A closer analysis of airmis rates for charter and RPT operations in MBZs revealed that airmis rates within these sectors had not changed significantly since 1994.<sup>26</sup>

Figure 3 illustrates the occurrence rate of airmisses within MBZs per 100,000 hours flown for the years 1994-2000.

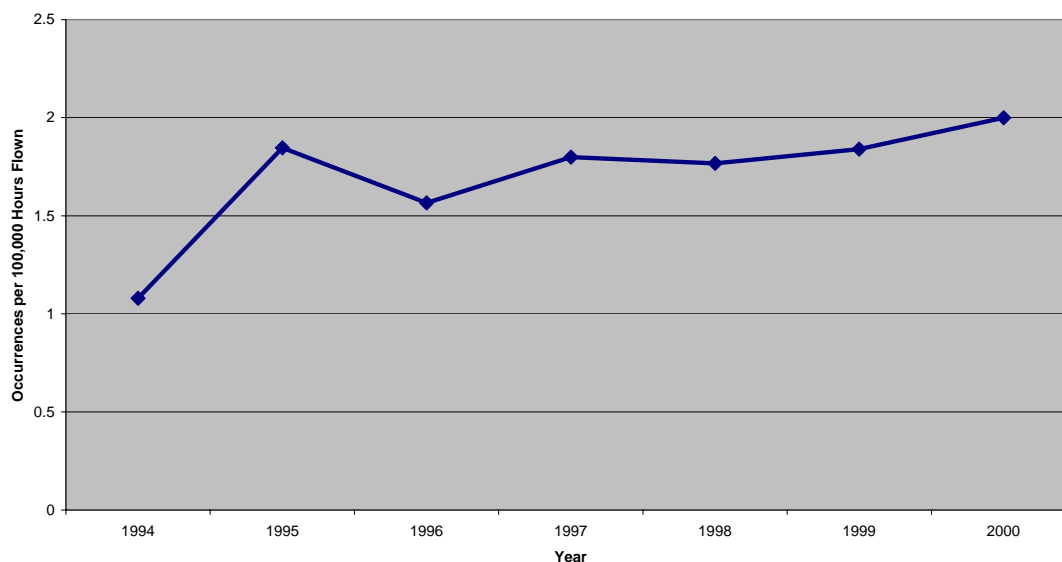
Figure 3. CTAF Occurrence Rates per 100,000 Hours Flown by GA and Regional Airline Aircraft within Australia

According to the graph, there appears to be a steady increase in airspace-related occurrences within CTAF areas. Closer analysis revealed that this increase did not reach statistical significance.<sup>30</sup>

Figure 3 illustrates the rate of reported airspace-related occurrences in CTAF areas per 100,000 hours flown, for the years 1994-2000.
