Safety

INVESTIGATIONS

Supplement

Aviation Safety Occurrence Statistics

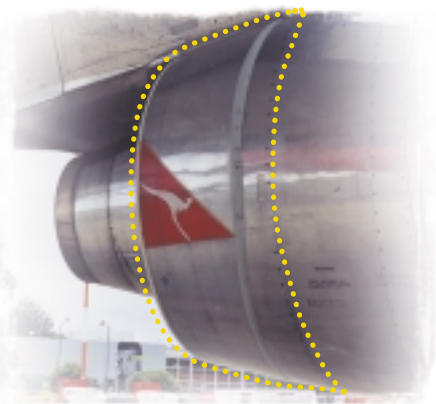
Boeing 747-238 cold stream nozzle cracks

Most of the engine's cold stream nozzle was later found to have separated from the aircraft, and some of the wing leading edge panels had been damaged by the departing nozzle, as was the no. 1 flap fairing (canoe).

A fleet-wide check of 13 aircraft found a further six nozzles cracked in the nozzle skin structure under the acoustic lining in the top corners of the nozzles.

Inspection requirements did not detect the cracks before they separated the nozzle from the aircraft. The area cannot be inspected on an installed nozzle without removing the panels and using a visual aid.

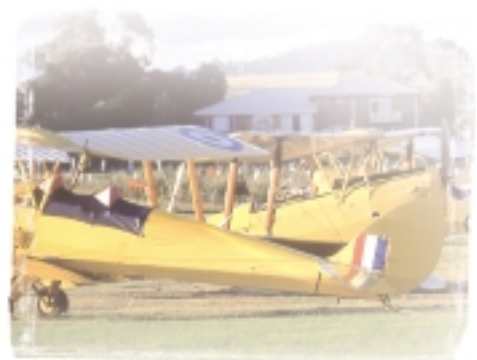
The aircraft's fuel system showed that sufficient clean fuel should have been available to power the engine. But the carburettor float valve, which was made from natural cork covered with a fuel-proof varnish seal, had two large blisters in the varnish. The larger of these was binding against the float chamber housing walls. This could have caused either an excessively rich or lean mixture, either of which would have caused the engine to run rough and stop. Oil wetness and sooting of the spark plugs suggested the mixture was excessively rich.

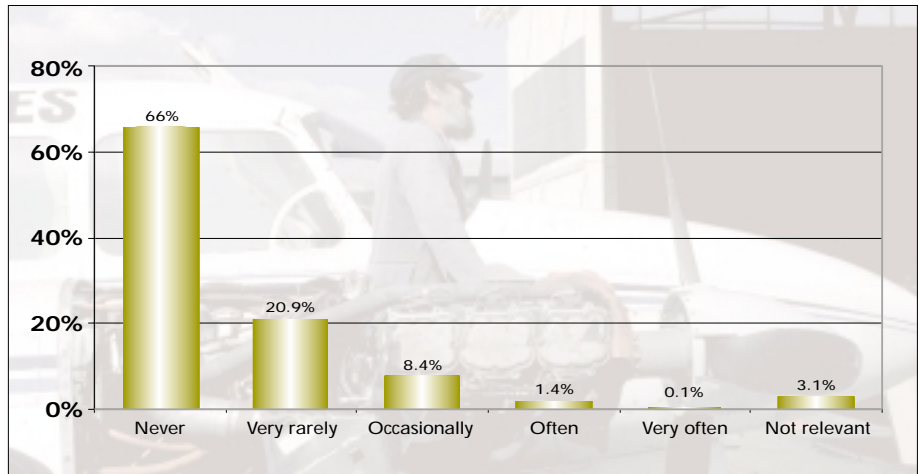
Figure 1.

'How often have you decided not to do a required functional check or engine run because of a lack of time?'

LAMEs are frequently faced with the temptation to take procedure shortcuts. When asked about their day-to-day job, many LAMEs reported that they took shortcuts from time to time. For example, fig. 1 indicates that just under a third of LAMEs reported that, in the previous year, they had decided to omit a functional check or engine run due to a lack of time.
