Australian Transport Safety Bureau

The Australian A

ATSB Funding Boost

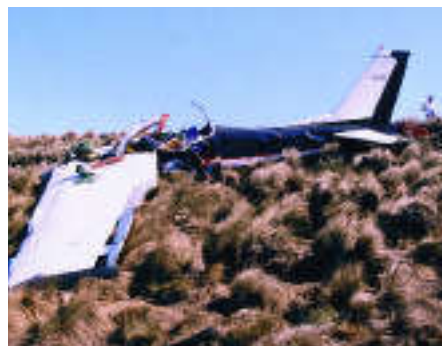
Occurrence 200300929

The Cessna 172G aircraft was undertaking consecutive charter flights to the Trefoil Island Aircraft Landing Area (ALA) from the Smithton, Tasmania aerodrome.

According to witnesses, at approximately 1745 hours EsuT the aircraft with the pilot and three passengers took off from the island ALA on the third return flight of the afternoon, on a magnetic heading of approximately 290 degrees. Witnesses reported that the aircraft turned to the left on a southerly heading while climbing, followed by a turn to the east. They reported that following the turn to the east, and after it had overflowed the buildings on the island at approximately 200 feet above ground level, the nose of the aircraft pitch abruptly upward to an angle of 30-40 degrees. According to the witnesses, following the nose up pitching, the aircraft rolled abruptly to the left and it lost altitude and fell from line of sight. The witnesses heard the impact of the aircraft and ran to render assistance. All four occupants received fatal injuries. The aircraft was destroyed by impact forces.

The subsequent engine disassembly and examination revealed no evidence of a preimpact internal component failure or anomaly. Weather conditions at the time of takeoff were plotted on a carburettor icing probability chart and indicated 'Icing at all Power Settings'. ■
