Australian Transport Safety Bureau

Executive Director's Message

Safety **briefs**

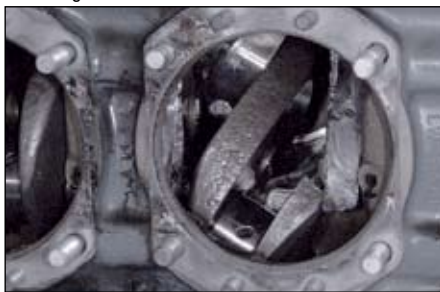
Photograph showing the fractured section of the crankshaft in the position found during initial engine examination

During a flight from Essendon to Armidale, the left engine of a Piper PA31P-350 (VH-IGW) failed during cruise at 17,000 feet. An engine examination revealed that the crankshaft had fractured in two locations: through the web between the No. 4 main bearing journal and the No. 4 connecting rod journal; and through the web between the No. 3 main bearing journal and No. 3 connecting rod journal. It is evident that rubbing contact between the main bearing insert and the No. 4 main bearing journal fillet radius initiated surface damage, which created the multiple fractures of the crankshaft and the subsequent engine failure. The factors that contributed to this event may be related to the retention of the main bearing insert in its housing and the crankshaft loading conditions that act to displace the bearing insert from its location in the bearing housing.

The movement of main bearing inserts during engine operation is a function of the magnitude of the forces that resist movement (created by establishing an interference fit) and the magnitude of forces acting to move the insert (crankshaft bending moments).

One factor that lowers the resistance of an insert to movement, the inclusion of material between the parting faces of the main bearing housings during engine assembly, was identified. However, other factors that may contribute to bearing insert movement, such as the magnitude of crankshaft bending moments, could not be established from an examination of the physical evidence.

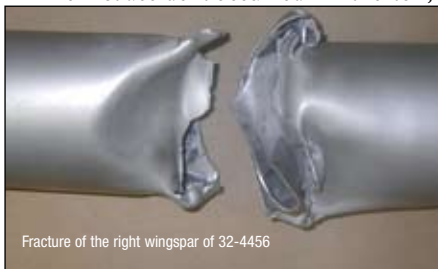
In all three accidents, the failure of the main wingspars (Airborne Edge design) had occurred near the wingtip. Qualitative analysis of the structural design and loading of the part during this safety investigation and the examination of the coronial findings from the Hexham accident, revealed that the main wingspar had failed under negative G loading. Such loading was likely if the aircraft entered or encountered flight conditions outside of the manufacturer's specified flight envelope. Examination of material characteristics of the failed wingspars did not show evidence of material deficiencies that could have contributed to these accidents.
