Australian Transport Safety Bureau

Robinson R22 helicopter aerial mustering usage investigation

REPCON Status – Australia's aviation voluntary confidential reporting scheme

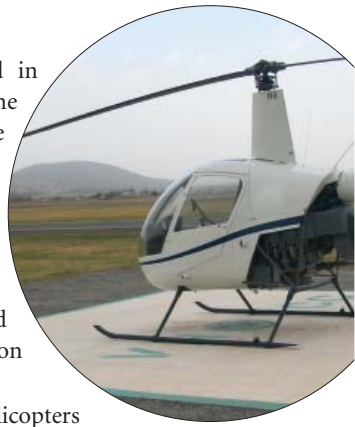
The number of helicopters registered in Australia has grown steadily over the last decade. By the end of 2006, there were 1,322 helicopters on the Australian civil aircraft register including 818 piston helicopters. The most common make of piston-engine helicopter in Australia is the Robinson R22, manufactured by Robinson Helicopter Company (RHC) in the United States. Around half of all the single-engine piston helicopters operating here are R22 helicopters.

In 2004 the ATSB commissioned AeroStructures, an Australian engineering company, to undertake a study of forces acting on an R22 engaged in aerial mustering operations. Their study provided some useful data on R22 flight profiles in aerial mustering operations, which were compared with the flight profiles used by Robinson Helicopter Company when the helicopter was initially certified. This study also assessed the stresses placed on the helicopter and tail rotor drive shaft during aerial mustering operations.

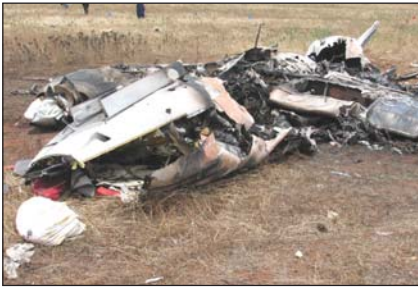
Occurrence 200506266

The wreckage trail extended for more than 4 km. The wings, outboard of the engine nacelles, the right engine, and sections of the empennage, had separated from the aircraft in flight. The remaining structure impacted the ground inverted and was destroyed by a post-impact fire. No evidence was found that aerodynamic flutter, in-flight fire or explosion, or lightning strike damage contributed to the circumstances that led to the break-up. However, the extent and nature of the damage precluded a complete examination of the aircraft and its systems.

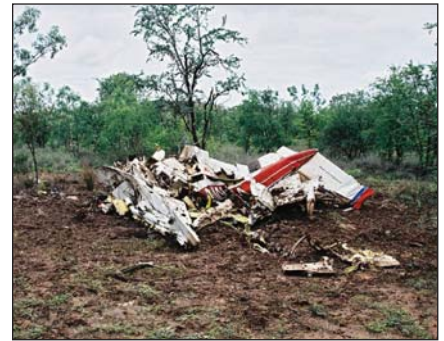
Occurrence 200600256

The wreckage was located about 4 km east of the aerodrome. An examination of the wreckage indicated that the aircraft impacted the ground inverted in a steep nose-down attitude. The accident was not survivable. The wreckage was consistent with a loss of control situation, but the likely reason for the loss of control could not be determined.
