Australian Government
Australian Transport Safety Bureau

Aviation Occurrence Statistics

2005 to 2014

ATSB Transport Safety Report
Aviation Research Statistics
AR-2015-082
Final – 23 December 2015

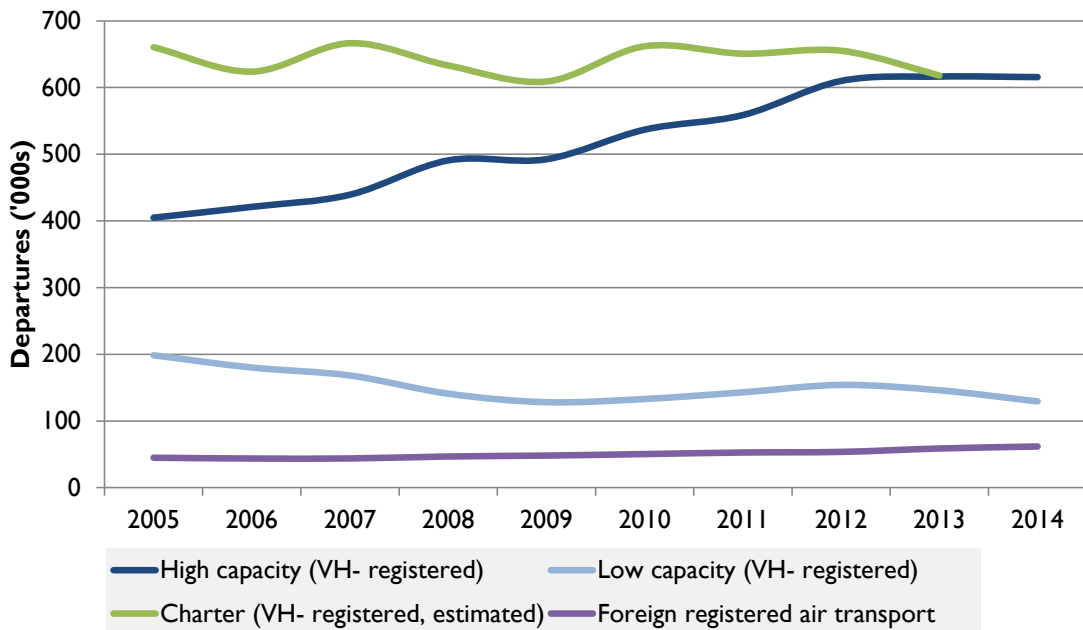
Figure 2: Departures in commercial air transport, 2005 to 2014

Within air transport, high capacity regular public transport (RPT) departures have steadily increased since 2005. Low capacity RPT departures have decreased to around two-thirds their 2005 levels, while charter departures have remained relatively steady over the last decade (Figure 2). By 2013, there was a similar number of departures in charter and high capacity RPT.

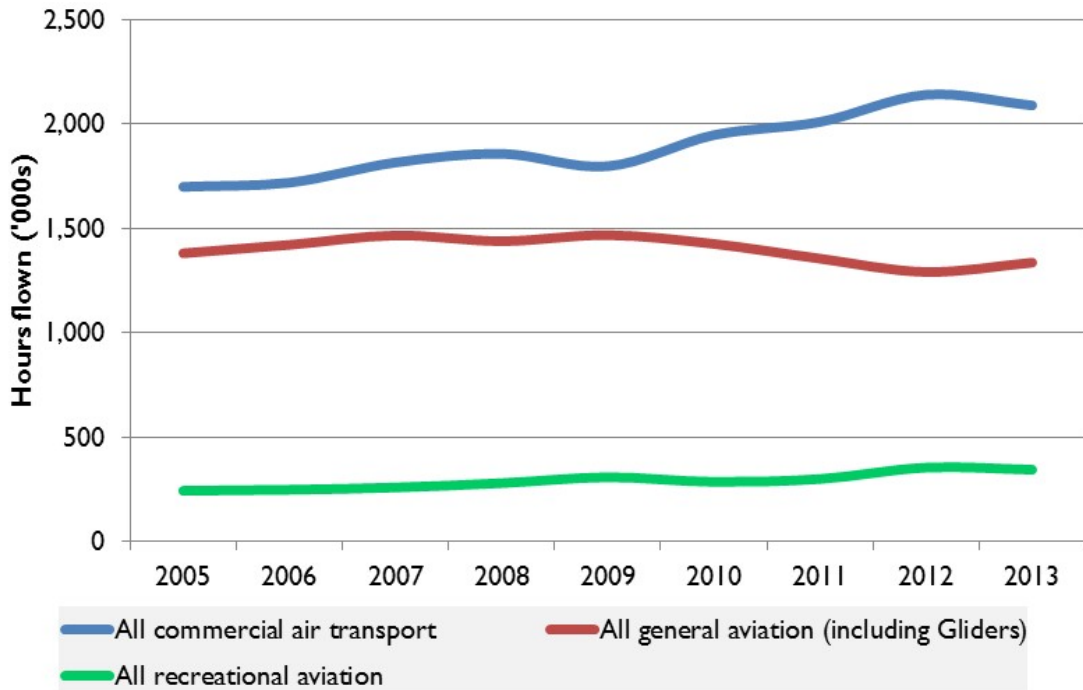
Figure 3: Hours flown by operation type, Australian-registered, 2005 to 2013

Air transport and recreational flying hours have significantly increased over the last 10 years. In contrast, general aviation has remained relatively steady (Figure 3). In 2013, commercial air transport had 1.5 times more hours flown than GA. In turn, GA had nearly 4 times more hours flown than recreational aviation.

40 per cent of the total hours flown by Australian-registered aircraft (as shown in Figure 3 on page 7).

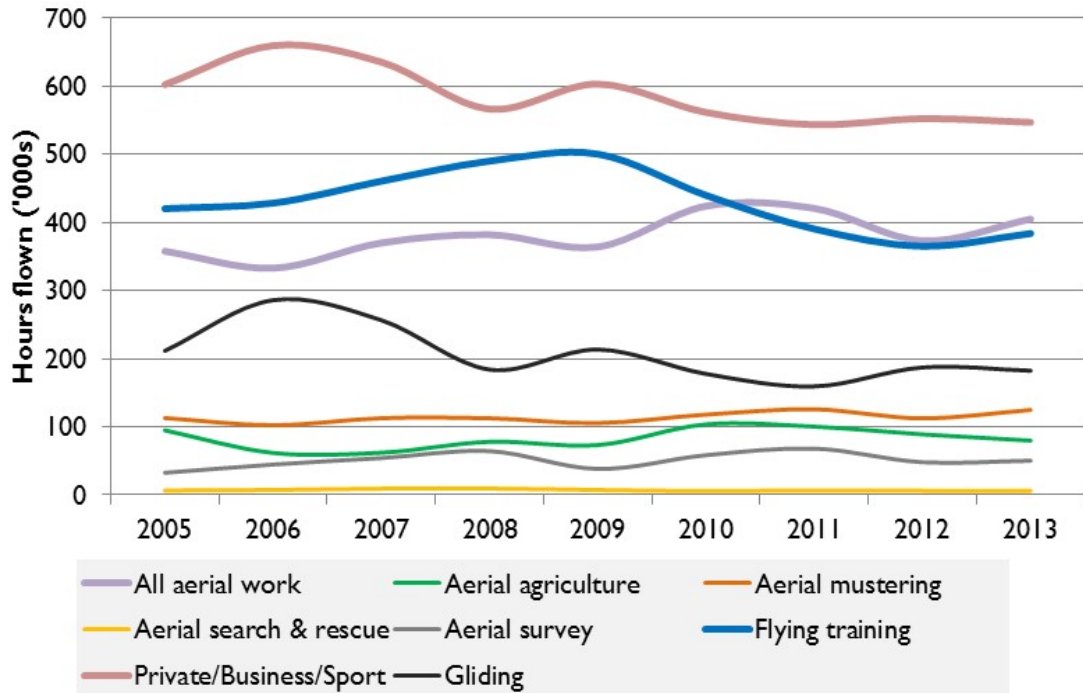
Figure 5: Hours flown in general aviation, 2005 to 2013

Figure 5 shows a comparison of flying activity across GA. Flying training has fallen by more than 20 per cent since its peak in 2009. Gliders' activity has also decreased during the study period – down around 36 per cent since 2006. Other types of GA had steady flying activity from 2005 to 2013.

Aerial work makes up around one-third of all GA flying hours.

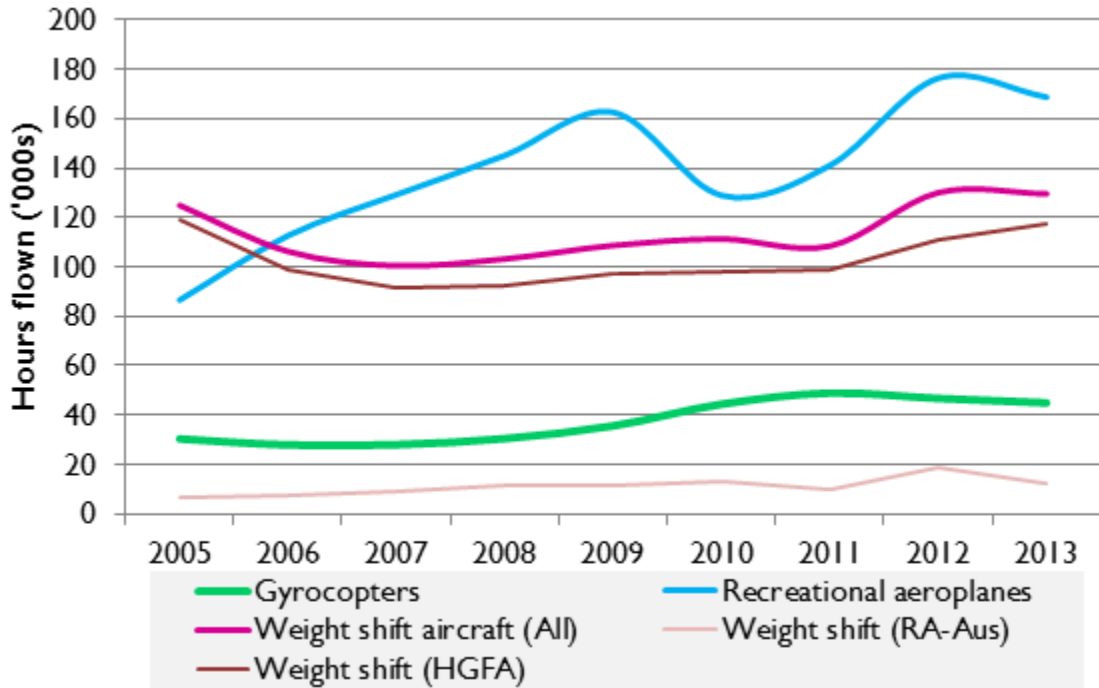
Figure 6: Hours flown in recreational aviation, 2005 to 2013

Activity data (hours flown) is now available for Australian (non-VH) recreational aviation. Figure 6 shows a comparison of flying activity across different types of RAAO, as reported by each RAAO to the BITRE. Flying hours of RA-Aus registered recreational aeroplanes have almost doubled over the last 10 years. This increase in activity is notably higher than other common flying operations, such as high capacity RPT (43 per cent increase over this period), aerial work (14 per cent increase), flying training (nine per cent decrease), charter (1 per cent increase), and private and business (decrease of around seven per cent over this period). Gyrocopters also had a significant increase over this period.

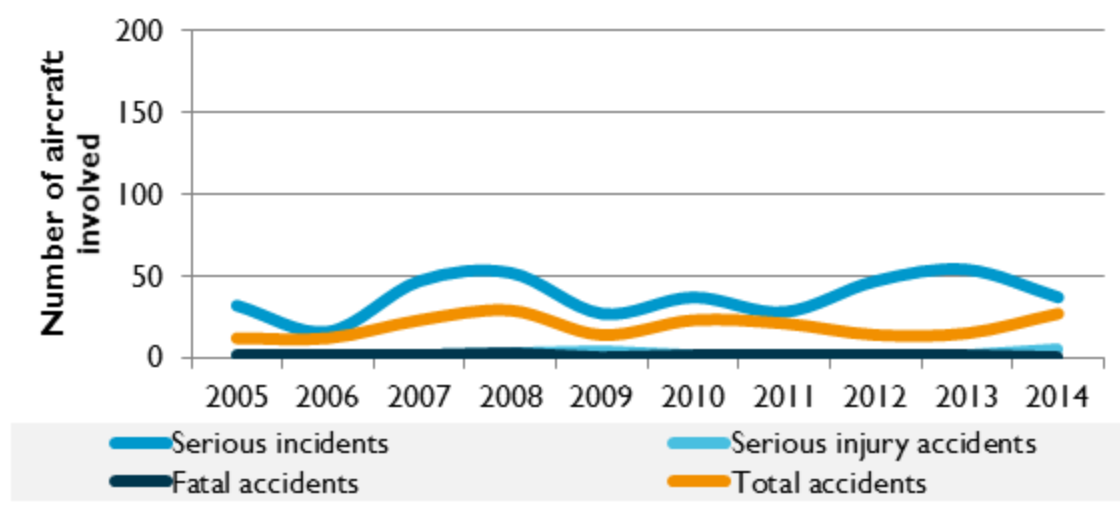
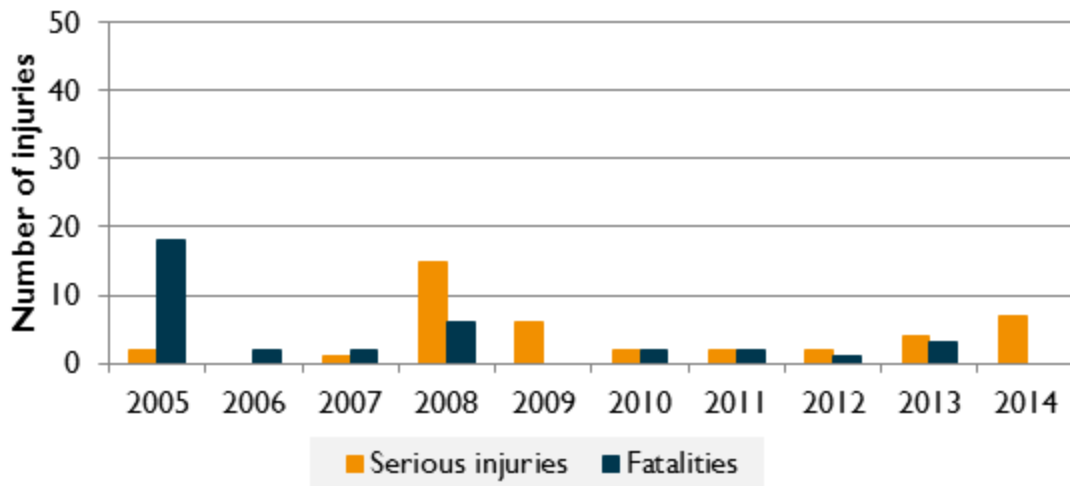
Figure 8: Commercial air transport occurrence and injuries, 2005 to 2014

2005	2006	2007	2008	2009	2010	2011	2012	2013	2014
Number of aircraft involved										
Incidents	3,332	3,081	3,152	3,337	3,162	3,477	4,002	4,222	4,402	4,308
Serious incidents	32	16	47	52	27	37	28	47	54	37
Serious injury accidents	2	0	1	3	4	2	2	2	2	5
Fatal accidents	2	1	2	3	0	1	2	1	2	0
Total accidents	12	12	23	29	14	23	21	14	15	27
Number of people involved										
Serious injuries	2	0	1	15	6	2	2	2	4	7
Fatalities	18	2	2	6	0	2	2	1	3	0
Rate of aircraft involved										
Accidents per million departures	9.2	9.5	17.5	22.1	11	16.6	14.9	9.5	10.4	N/A
Fatal accidents per million departures	1.5	0.8	1.5	2.3	0	0.7	1.4	0.7	1.4	N/A

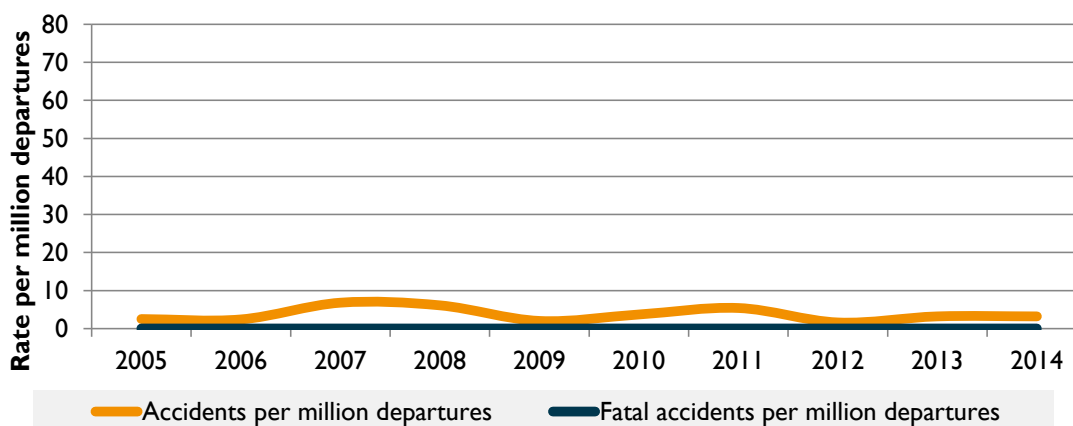
Figure 10: Accident rate for high capacity RPT aircraft (VH- registered) (per million departures), 2005 to 2014

The number of incidents reported to the ATSB involving VH- registered high capacity RPT has risen by around 56 per cent in the last 10 years. This is consistent with the increase in the rate of departures (52 per cent) over this time. That is, the incident to departures ratio has remained relatively constant. Provided these trends remain constant, the number of reported incidents would double every 14 years, with departures doubling every 15 years.

2005	2006	2007	2008	2009	2010	2011	2012	2013	2014
Number of aircraft involved										
Incidents	2,053	1,900	1,916	2,130	2,016	2,428	2,853	3,106	3,291	3,214
Serious incidents	11	4	16	20	10	13	13	12	23	13
Serious injury accidents	1	0	1	1	1	2	1	0	1	1
Fatal accidents	0	0	0	0	0	0	0	0	0	0
Total accidents	1	1	3	3	1	2	3	1	2	2
Number of people involved										
Serious injuries	1	0	1	12	1	2	1	0	1	1
Fatalities	0	0	0	0	0	0	0	0	0	0
Rate of aircraft involved										
Accidents per million departures	2.5	2.4	6.8	6.1	2	3.7	5.4	1.6	3.2	3.2
Fatal accidents per million departures	0	0	0	0	0	0	0	0	0	0
Accidents per million hours	1.1	1	2.9	2.7	0.9	1.6	2.3	0.7	1.5	1.5
Fatal accidents per million hours	0	0	0	0	0	0	0	0	0	0

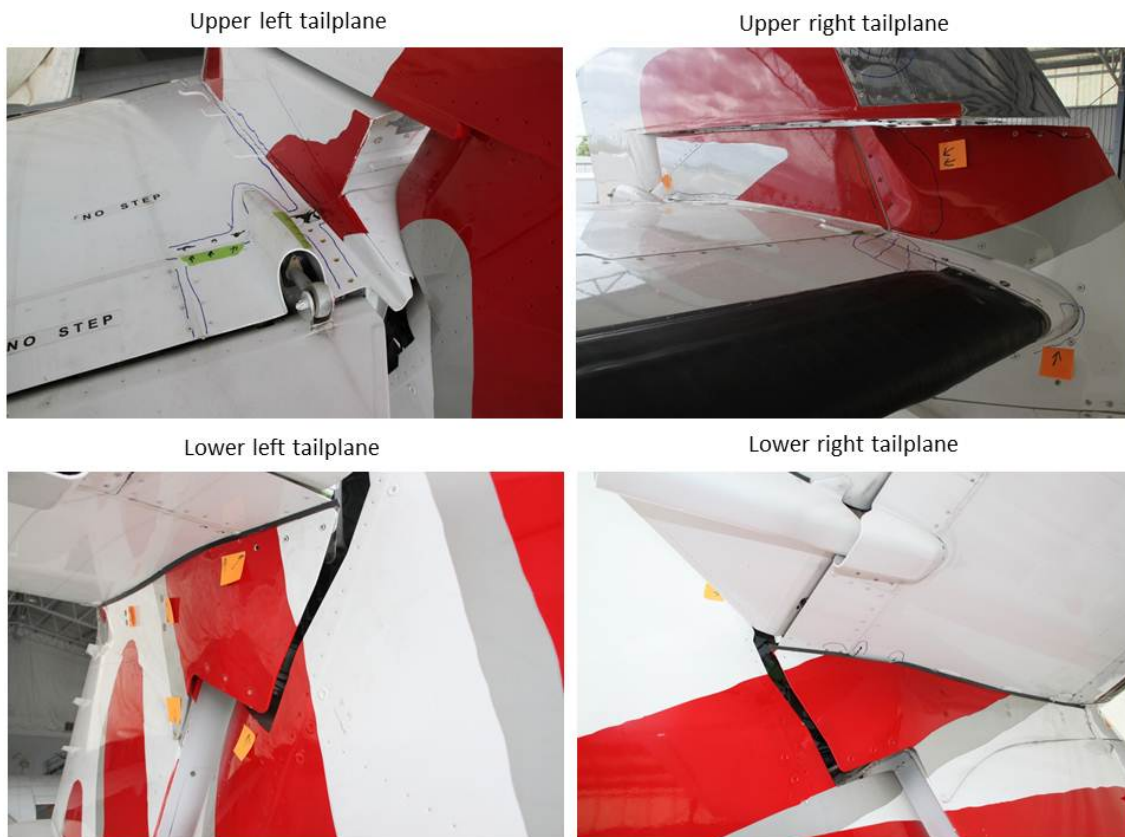
- The two accidents involved the same aircraft five days apart. On 20 February 2014, a cabin crew member received a serious injury on a Virgin Regional Airlines ATR 72 en route from Canberra to Sydney. The injury resulted from a flight control event caused by a decoupling of the left and right elevator control systems. Maintenance engineers on a post-occurrence inspection detected no defects. The aircraft returned to service the following day. During descent into Albury NSW on 25 February, after operating for 13 sectors since 20 February, the aircraft passed in close proximity to birds alerting the captain to the possibility of birdstrike. On the ground, the aircraft’s pitch trim system fluctuated abnormally despite any indications of a birdstrike. A deformity of the fairing at the top leading edge of the vertical stabiliser was the only abnormality found by the captain on a post-occurrence walk-around inspection. At the captain’s request, an inspection of the tailplane by an engineer confirmed the fairing damage might have resulted from a birdstrike. Significant structural damage to the top of the tailplane

was also identified which may have been a result of the occurrence on 20 February. The ATSB investigation is ongoing ([ATSB investigation AO-2014-032](#)).

Flight control event involving an ATR72, 47 km WSW Sydney Airport, NSW on 20 February 2014 (ATSB investigation AO-2014032) - tailplane external damage (indicated by marks and stickers). Source ATSB.

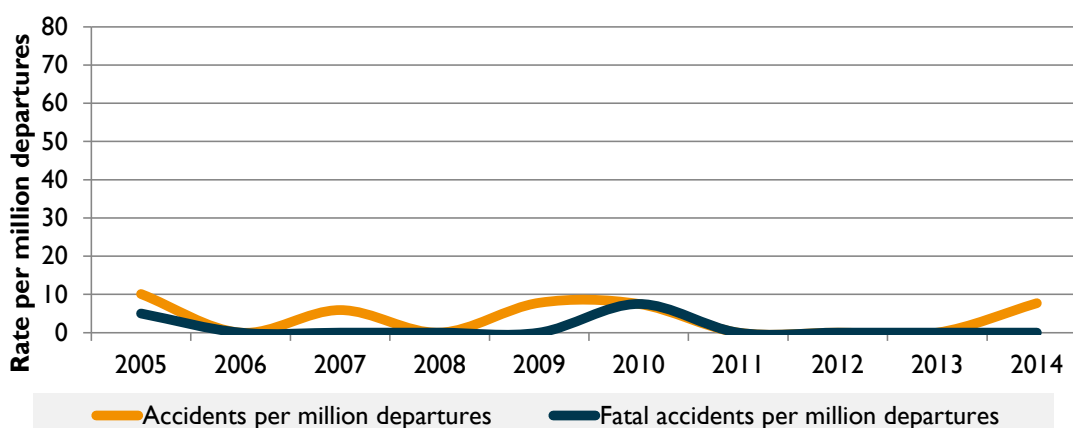
Figure 11: Accident rate for low capacity RPT aircraft (VH- registered) (per million departures), 2005 to 2014

2005	2006	2007	2008	2009	2010	2011	2012	2013	2014
Number of aircraft involved										
Incidents	567	468	481	393	405	432	453	392	368	374
Serious incidents	7	5	8	11	4	6	2	5	3	1
Serious injury accidents	0	0	0	0	0	0	0	0	0	0
Fatal accidents	1	0	0	0	0	1	0	0	0	0
Total accidents	2	0	1	0	1	1	0	0	0	1
Number of people involved										
Serious injuries	0	0	0	0	0	0	0	0	0	0
Fatalities	15	0	0	0	0	2	0	0	0	0
Rate of aircraft involved										
Accidents per million departures	10.1	0	5.9	0	7.8	7.5	0	0	0	7.7
Fatal accidents per million departures	5	0	0	0	0	7.5	0	0	0	0
Accidents per million hours	9.9	0	6	0	9	8.6	0	0	0	7.9
Fatal accidents per million hours	5	0	0	0	0	8.6	0	0	0	0

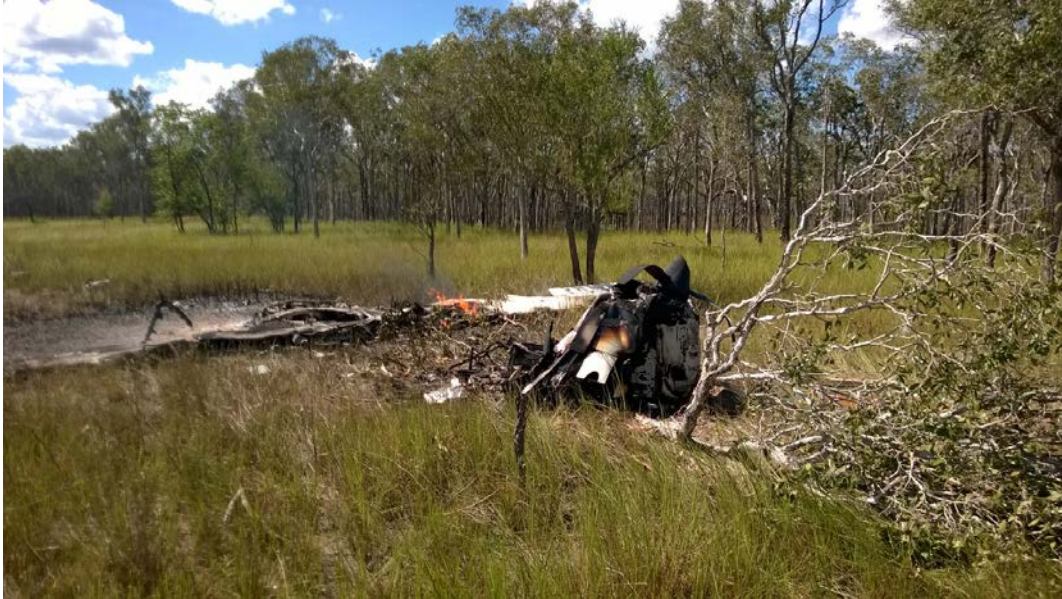
- The passenger and pilot of a Katherine Aviation Cessna 210 received serious injuries from a collision with terrain near Numbulwar NT. At around 22 NM out from Numbulwar, en route to Tindal, the passenger felt a bump and detected smoke emanating from the floor area beside the pilot. The pilot broadcast a 'MAYDAY' on the CTAF advising of an engine failure and also that there were no roads in sight on which to conduct a forced landing, only trees. The pilot then asked the passenger to retrieve the fire extinguisher, which was passed to the pilot. The passenger reported that the smoke stopped very quickly. The aircraft descended and the pilot retrieved the portable emergency locator transmitter (ELT) from the front compartment, extended the antenna and activated it. The pilot advised the passenger to brace for landing. The passenger reported that the aircraft landed heavily, skidded, and collided with two trees prior to coming to rest at an angle, but upright. The passenger quickly undid the seatbelt and exited the aircraft through the open right door, assisting the pilot out of the aircraft. The passenger and the pilot moved about 10 m from the aircraft, prior to multiple explosions occurring. Both sustained serious injuries and the aircraft was destroyed. An initial engineering

inspection found that a broken connecting rod was the most likely cause of the engine failure ([ATSB investigation AO-2014-059](#)).

Collision with terrain involving a Cessna 210 50 km W of Numbulwar Aerodrome, NT on 28 March 2014 (ATSB investigation AO-2014-059) – accident site and aircraft wreckage. Source: Rescue crew.

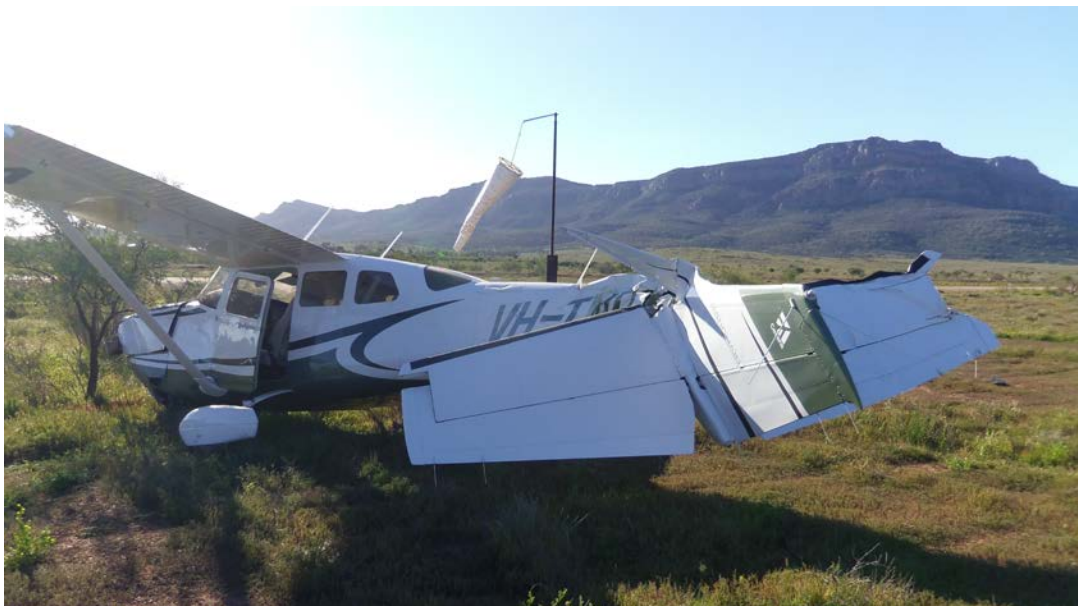
- One passenger sustained serious injuries from a collision with terrain of a Cessna 206. On return to Rawnsley Park Authorised Landing Area (ALA), SA, after the first of three scheduled scenic flights for the day, the pilot conducted a straight-in-approach onto the runway. The pilot did not compensate for the 8 to 10 knot crosswind during the flare and touchdown. After landing the pilot retracted all stages of flap, and applied light pressure to the brakes. The aircraft then began to veer to the left. The pilot applied right rudder, but was unable to correct the situation, so initiated a go-around. During the go-around the horizontal stabiliser struck a shrub, causing significant damage to the aircraft. The pilot lowered the aircraft nose. After clearing a small tree, the pilot raised the aircraft's nose in an attempt to clear the windsock. Moments later, the aircraft spun rapidly to the left and collided with the ground. The pilot shut down the aircraft and assisted the passengers to exit. One passenger sustained serious injuries and another sustained minor injuries. The pilot was not injured. The aircraft was substantially damaged ([ATSB investigation AO-2014-135](#)).

Collision with terrain involving a Cessna C206 at Rawnsley Park, SA on 2 August 2014 (ATSB investigation AO-2014-135) – rear fuselage and tail damage. Source: South Australian Police.

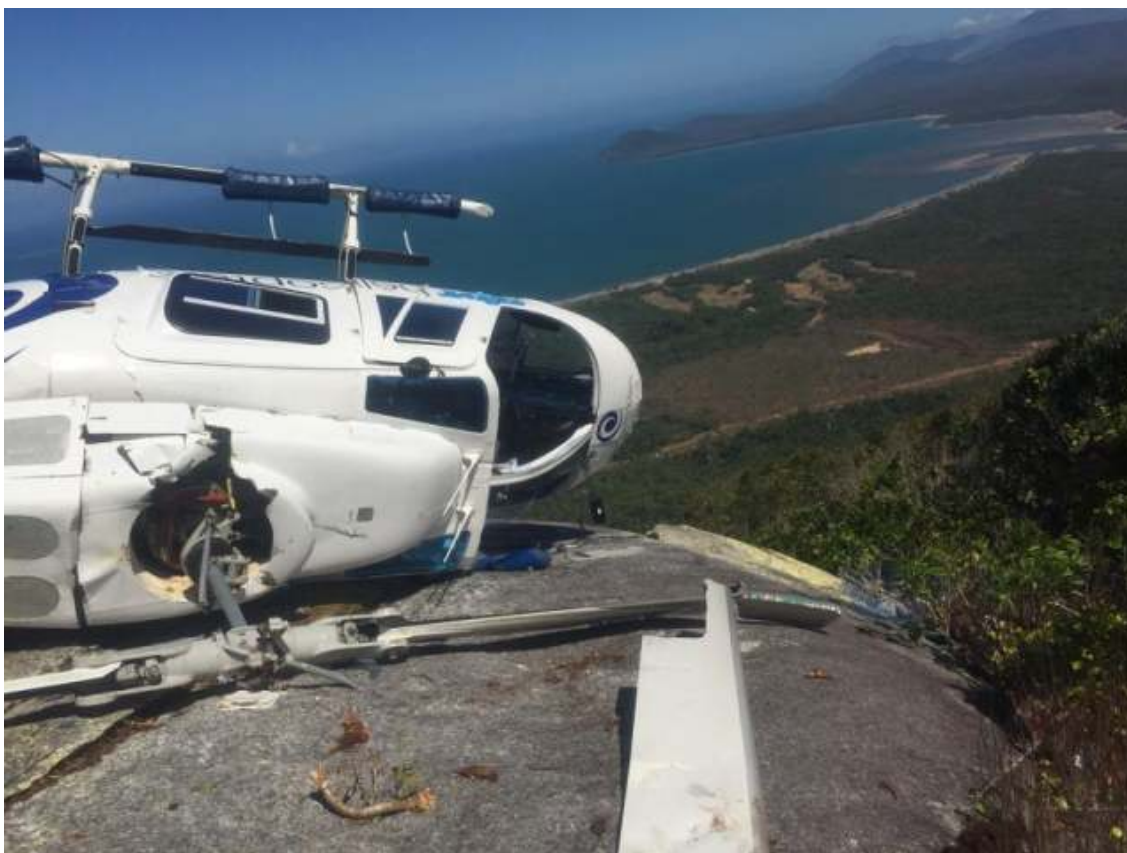
- A ground coordinator sustained serious injuries and a passenger received minor injuries when a Bell 206 helicopter collided with terrain at Mount Cook, Qld. The helicopter departed Cairns with one passenger to conduct a charter flight to Mount Cook. To assess the landing area at Mount Cook the pilot made three-to-four practice approaches and a practice landing prior to continuing to Cooktown to pick up the remaining passengers. The landing area was a rocky ledge jutting out from the south-eastern side near the top of Mount Cook. The pilot conducted two flights to drop off a total of five passengers. The pilot reported that the wind during these two flights was about 10 knots from the south-east. Upon returning to pick up the first load of passengers, the wind had increased to about 14-15 knots. During the approach to land, the pilot reported that the helicopter felt stable and appeared unaffected by the increased wind. As the helicopter prepared to touch down, both the ground coordinator and a passenger walked closer to it. Just prior to touching down on the right skid, the pilot felt the helicopter momentarily lift, most likely from a gust of wind, and drift to the right. The helicopter rolled rapidly onto its right side and slid a short distance forward, prior to coming to rest. The helicopter fell onto the ground coordinator and nearby passenger. The ground coordinator sustained serious injuries. The pilot and passenger received minor injuries and the helicopter was substantially damaged.

The roll onto the right side by the helicopter is consistent with the phenomenon known as dynamic rollover. When a helicopter rests on one skid, the aircraft may begin rolling, and under certain circumstances it cannot be controlled ([ATSB investigation AO-2014-161](#)).

Loss of control during landing, involving a Bell 206B3 9km south-east of Cooktown Airport (Mount Cook), Queensland, 7 October 2014 (ATSB investigation AO-2014-161) – dynamic rollover accident on Mount Cook. Source: Queensland Police.

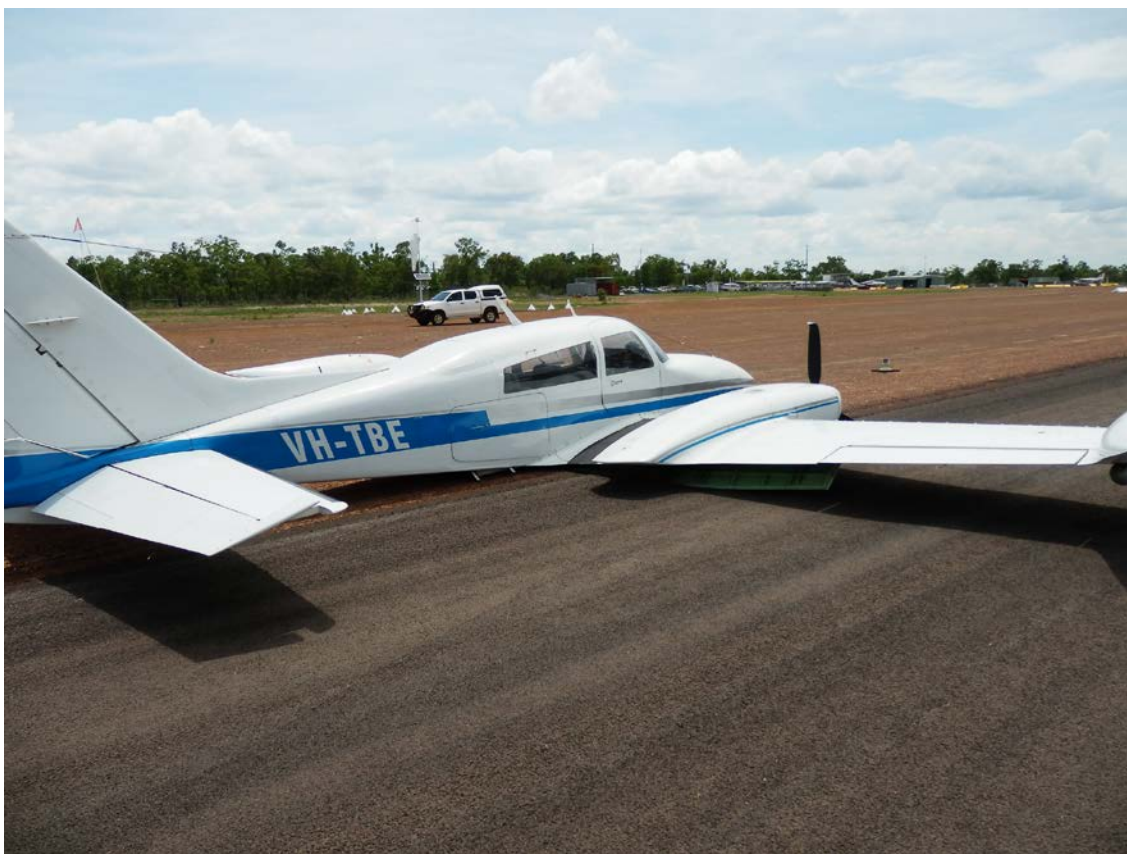
Wheels-up landing involving a Cessna 310 at Jabiru Airport on 12 December 2014 (ATSB investigation AO-2014-188). Source: Grant Hampton.

- The pilot of a Cessna 310 conducted an unintentional wheels-up landing at Jabiru Aerodrome, NT. There were five passengers on board, including three children, on the flight from Oenpelli, NT. During the short flight, one of the passengers coughed incessantly through the headset, which distracted the pilot. Once the aircraft was stable, the pilot reached over and unplugged the headset. The pilot manoeuvred the aircraft to join a late downwind for runway 27 at Jabiru. The pilot reported that during the pre-landing checks, they verbalised 'undercarriage down' but made a decision to defer the associated procedure. The pilot elected to keep the aircraft speed slightly higher than normal and, as per the company procedures, kept a stable power setting and profile and only made adjustments when needed at around 300 ft. The pilot was also mindful of a Cessna 210 aircraft close behind. The pilot then focused on the passengers, and made sure that they had their seatbelts correctly fastened prior to landing. The pilot reported that they normally completed the remaining memory-recall PUFF (set Propeller pitch, Undercarriage down, and Flaps Full down) check on final approach, but on this occasion did not. As the aircraft was flared for landing the pilot became aware that the undercarriage was not down and the propellers contacted the ground ([ATSB investigation AO-2014-188](#)).

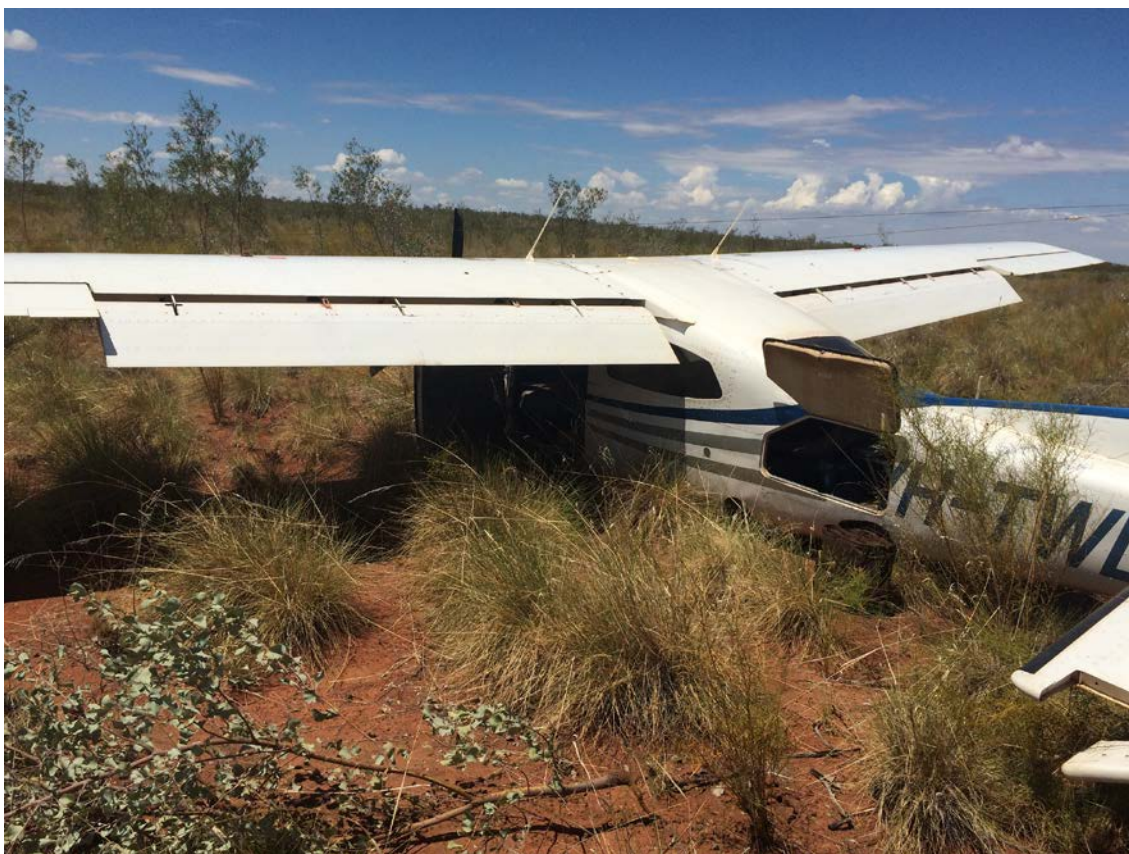
Engine failure and forced landing involving Cessna 210, 111 km SE Halls Creek, WA on 28 November 2014 (ATSB investigation AO-2014-186) – showing aircraft after emergency equipment had been retrieved. Source: Pilot.

- An engine failure resulted in the pilot of a Cessna 210 aircraft conducting a forced landing. The charter flight departed from Broome WA with four passengers and landed at Fitzroy Crossing to refuel before continuing to Balgo Hill where three of the passengers disembarked. The aircraft then departed for Ringer Soak ALA, WA, where the remaining passenger was due to disembark. About 25 NM from Ringer Soak while cruising at 5,500 ft AMSL, the pilot noticed a low oil pressure indication. The pilot reported that all other engine instrument indications were within normal parameters, so they elected to continue and assess the situation at Ringer Soak. Shortly after, the pilot detected a burning smell in the cockpit followed by a loud bang from the engine. The pilot immediately commenced the memory items from the emergency checklist and configured the aircraft for an optimum glide. The pilot broadcast a MAYDAY on the area frequency and selected a suitable forced landing area from among the predominantly thick scrub. After touchdown with the gear retracted, the aircraft slid to a stop and the pilot and passenger exited the aircraft. The pilot retrieved first aid items, emergency rations and the GPS, and set up a temporary shelter under the wing until assistance arrived. This was the aircraft's first operational flight after maintenance for excessive oil consumption ([ATSB investigation AO-2014-186](#)).

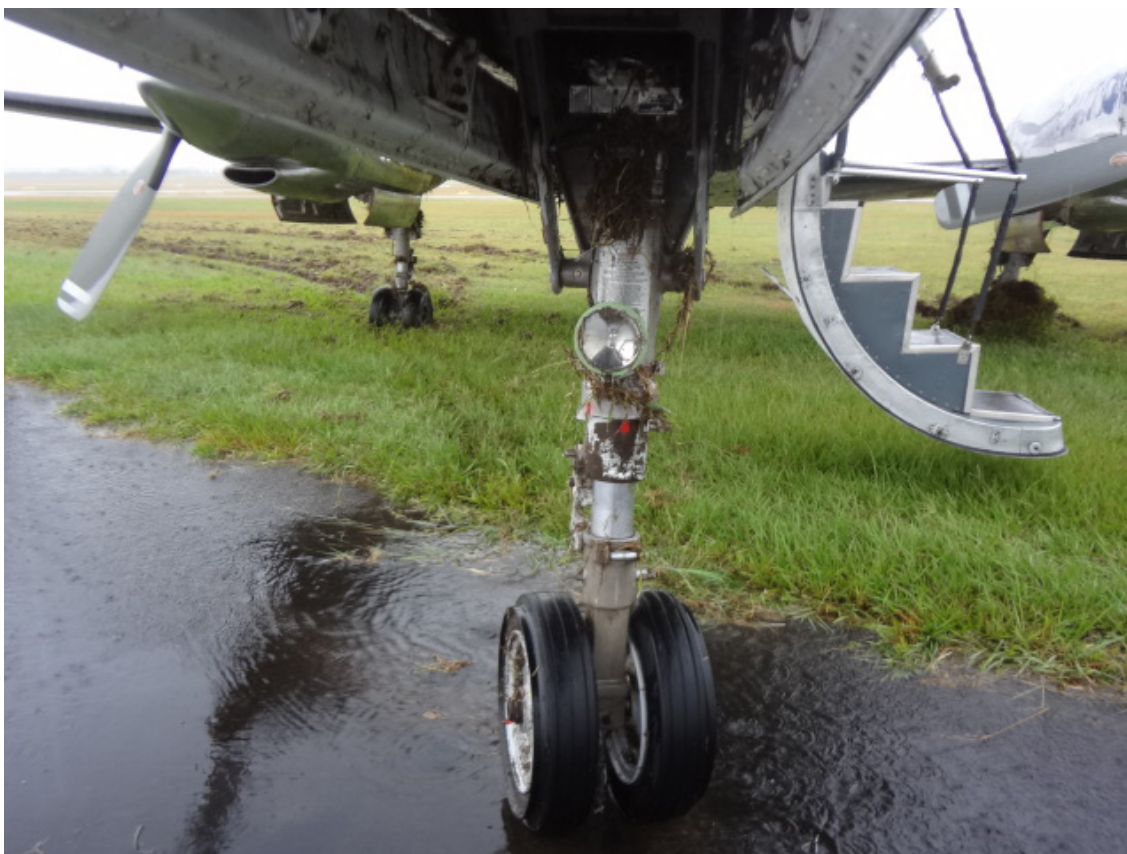
Runway excursion involving a Fairchild SA226 at Archerfield Airport, Qld on 23 January 2014 (ATSB investigation AO-2014-016) – skid marks in the grass following a runway veer off in wet conditions.

- Landing in wet conditions, a Fairchild SA226 aircraft veered off the side of the runway at Archerfield Airport, Qld. En route from Thangool, the pilot received the current Automatic Terminal Information Service (ATIS) for Archerfield, which indicated cloud at 800 ft and that the runway was 'wet'. At about 1615, the pilot commenced an instrument approach to Archerfield. On approach to the aerodrome, the pilot sighted the runway and circled at 900 ft AGL before approaching to land on runway 10 Left. When lined up on final, the aircraft was to the right of the extended runway centreline and the pilot elected to conduct a go-around. The second circuit was still tight, due to low cloud to the west of the runway, and the pilot reported that the aircraft was about 30 to 50 m right of the extended runway centreline when on final. It was raining heavily as the aircraft touched down close to the runway centreline and about 300 m beyond the runway threshold. The pilot reported that as the wheels touched down, the aircraft commenced sliding towards the right, possibly due to aquaplaning. The aircraft veered off the right side of the runway and onto the grass. The aircraft then returned to the runway, slid along and veered off to the left side. The left main landing gear entered the grass and the aircraft came to rest at an angle to the runway. A runway inspection revealed standing water on the right side of the runway near the threshold ([ATSB investigation AO-2014-016](#)).

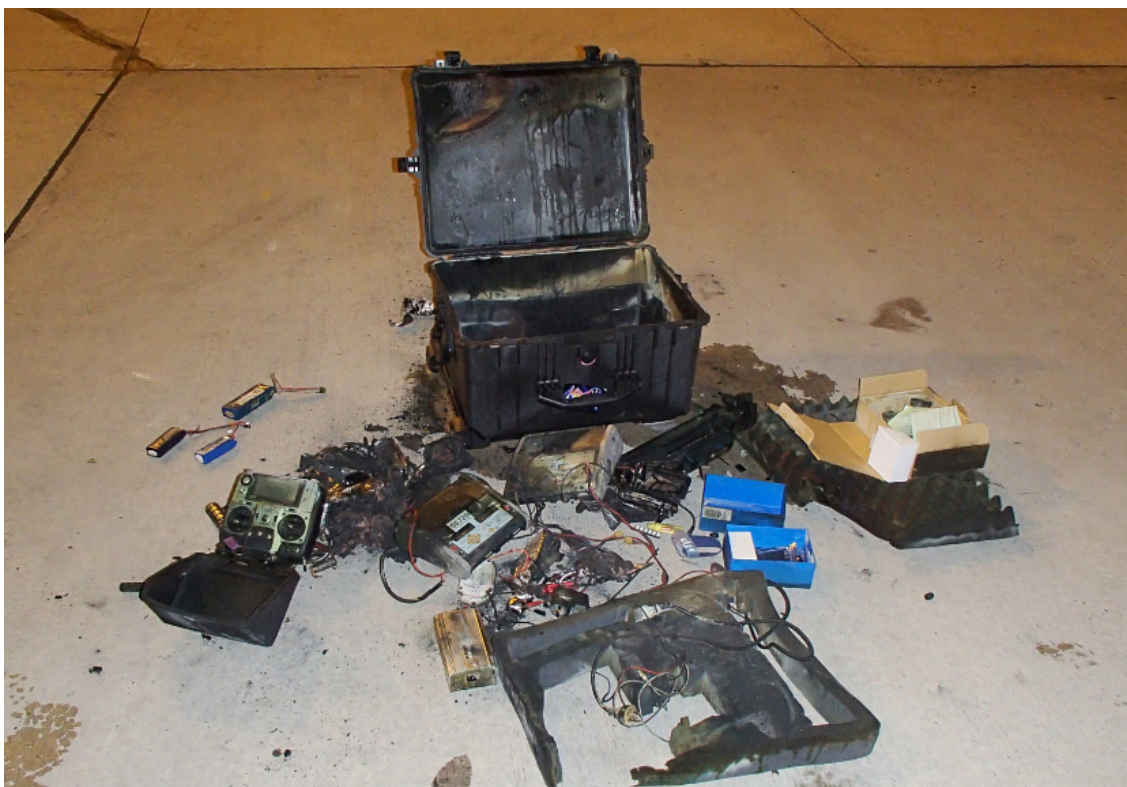
Cargo hold smoke event involving a Boeing 737, Melbourne Airport, Vic, on 26 April 2014 (ATSB investigation AO-2014-082) – fire-damaged bag and contents. Source: CASA.

- While still at the gate prior to departure at Melbourne Airport, the first officer of a Fiji Airways Boeing 737 declared a 'MAYDAY' due to smoke billowing from the aft cargo hold. Undeclared lithium-ion batteries in a passenger's checked baggage were the cause of the fire and subsequent smoke. At the time of the fire, the passengers' bags were being loaded. The cabin crew members were on board preparing the aircraft prior to passengers boarding. The first officer was in the cockpit conducting pre-flight checks. The captain was on the tarmac conducting an external inspection of the aircraft. A ground engineer observed smoke emanating from the aft cargo hold, alerted the captain and notified the aerodrome rescue and firefighting (ARFF) service. The captain saw white heavy smoke billowing from the hold and immediately called the first officer to advise him. The first officer observed that the aft cargo fire warning light was illuminated. The captain directed the first officer to activate the aft cargo hold fire suppression system, shut down the auxiliary power unit and order an evacuation of the aircraft. The first officer advised air traffic control and declared a 'MAYDAY'. The ARFF arrived and a smouldering hard-plastic case was removed to a safe location and cooled with a fine water spray. The passenger who had checked in the case was located and asked whether any batteries were in it, to which the passenger responded there were none. The ARFF and Australian Federal Police inspected all four of the bags checked in by the passenger and found 19 batteries intact and an additional 6-8 batteries that had been destroyed by fire. An initial investigation revealed that several lithium-ion polymer batteries and an RPA controller were contained in the case. An electrical short circuit involving the batteries resulted in the initiation of a fire, destroying the contents and damaging the case. An RPA controller containing other, similar, lithium-ion polymer batteries was found in another of the passenger's checked-in bags. The fire-damaged case had been screened through the oversized luggage point at Melbourne Airport ([ATSB investigation AO-2014-082](#)).

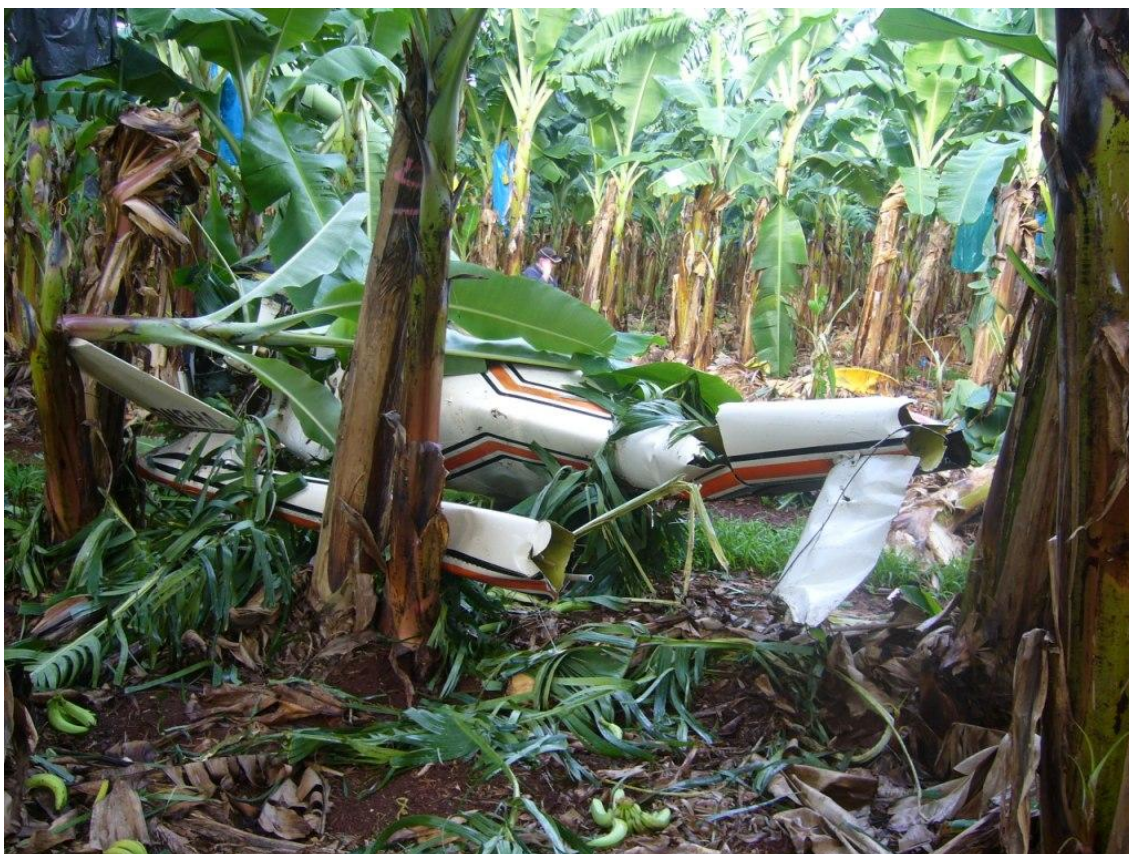
Controlled flight into terrain involving a Bell 206B, VH-BNG, near Mission Beach, Qld on 20 February 2014 (ATSB investigation AO-2014-027) - Damage to the aircraft. Source: Operator.

- The pilot of a Bell 206B helicopter sustained serious injuries from a collision with terrain near Mission Beach, Qld. The helicopter took off from a banana plantation to conduct aerial spraying. The pilot conducted pre-application checks including assessing the wind strength and direction, the position of the sun, identifying the area to be sprayed and any hazards. The block was to be sprayed as soon as possible after first light and the pilot planned to conduct the spraying in an east-west direction. After about 5 minutes of spraying, some overspray accumulated on the windscreen, resembling a white paint. The pilot then noted that the on-board smoke generator indicated the wind had changed direction, so flew the helicopter to the southern end of the block and resumed spraying into wind. After completing spraying, the pilot commenced a return to the staging area. To comply with local noise abatement procedures, the pilot climbed the helicopter to about 250-300 ft AGL and established a flight path to avoid overflying noise-sensitive areas. On descent to the staging area, at about 150-200 ft AGL, the helicopter's rotor blades collided with a tree, dislodged a branch, and the helicopter subsequently collided with terrain. The helicopter was substantially damaged ([ATSB investigation AO-2014-027](#)).

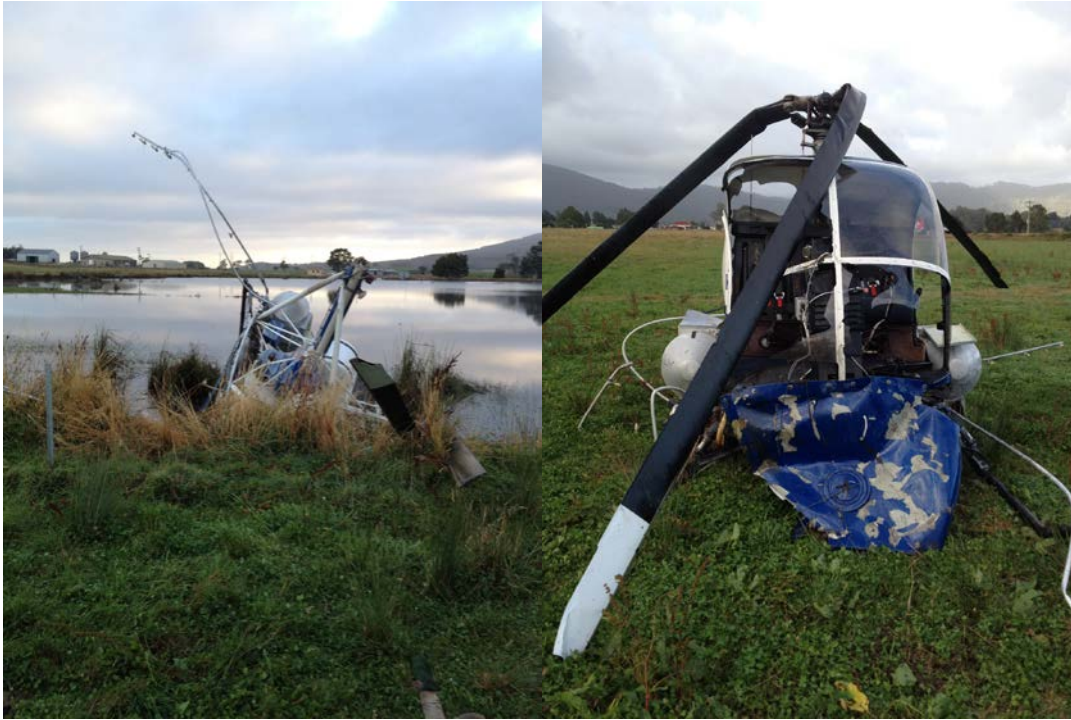
Collision with terrain involving a Hughes 269C, 55 km NE Launceston Airport, Tasmania on 23 February 2014 (ATSB investigation AO-2014-030) – damage of the aircraft. Source: Operator.

- The pilot of a Hughes 269C helicopter conducted a forced landing after fuel exhaustion at a property about 55 km north-east of Launceston, Tas. Subsequently, the aircraft received substantial damage. About a week before the accident, the pilot had parked the helicopter beside a dam, aware that it was low on fuel. On the day of the accident, the pilot prepared for a short 200 m flight to reposition the helicopter to the other side of the dam for refuelling. Fuel drains were conducted and no contaminants found. The helicopter took off and climbed to about 20 ft above ground level. About three quarters of the way across the dam, the engine stopped due to fuel exhaustion. The pilot conducted a forced landing onto the edge of the dam, with part of the helicopter sinking into the water and mud. The main rotor blades collided with the embankment resulting in substantial damage to the aircraft. The pilot was not injured ([ATSB investigation AO-2014-030](#)).

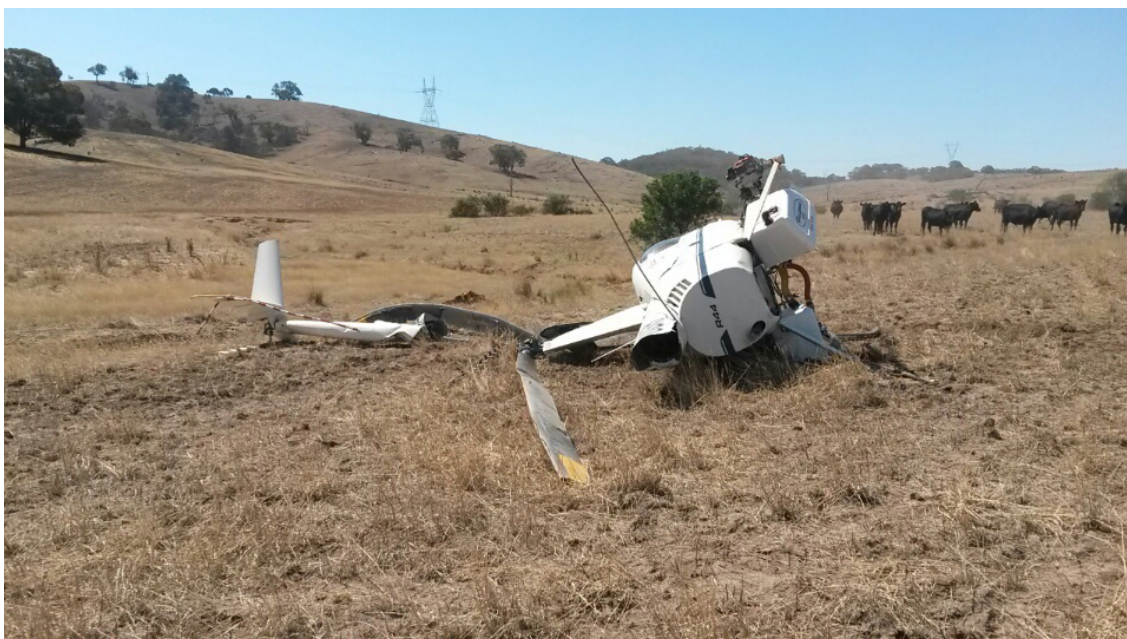
Collision with terrain involving a Robinson R44, near Yass, NSW on 22 February 2014 (ATSB investigation AO-2014-031) – damage to the aircraft. Source: Operator.

- A Robinson R44 helicopter collided with terrain while conducting aerial agricultural operations near Yass NSW. Prior to the accident, after successfully completing five loads of spraying, the helicopter was refuelled and reloaded with chemical for the next flight. The wind at the time was light and variable but favouring a southerly direction and the pilot manoeuvred the helicopter to take off towards the south. During the take-off, when at about 3 ft AGL, the pilot reported that the helicopter was not climbing as expected and thought that the wind had veered to a more westerly direction. The pilot commenced a right pedal turn towards the west, and down the slope, in an attempt to gain translational lift. The pilot reported that the wind had actually turned more easterly, and the helicopter therefore had a tailwind. The low rotor RPM warning sounded and the pilot jettisoned the chemical load. The helicopter was then about 5 ft AGL, the pilot was attempting to gain lift and concentrating on keeping the helicopter straight in order to keep the landing skids level. The pilot sighted a dry creek bed ahead and attempted to gain altitude prior to crossing it. The helicopter was about 40-50 m beyond where the load had been jettisoned, and the pilot was focused on gaining lift, when the left skid contacted the ground, and the helicopter rolled over. The pilot was not injured in the accident ([ATSB investigation AO-2014-031](#)).

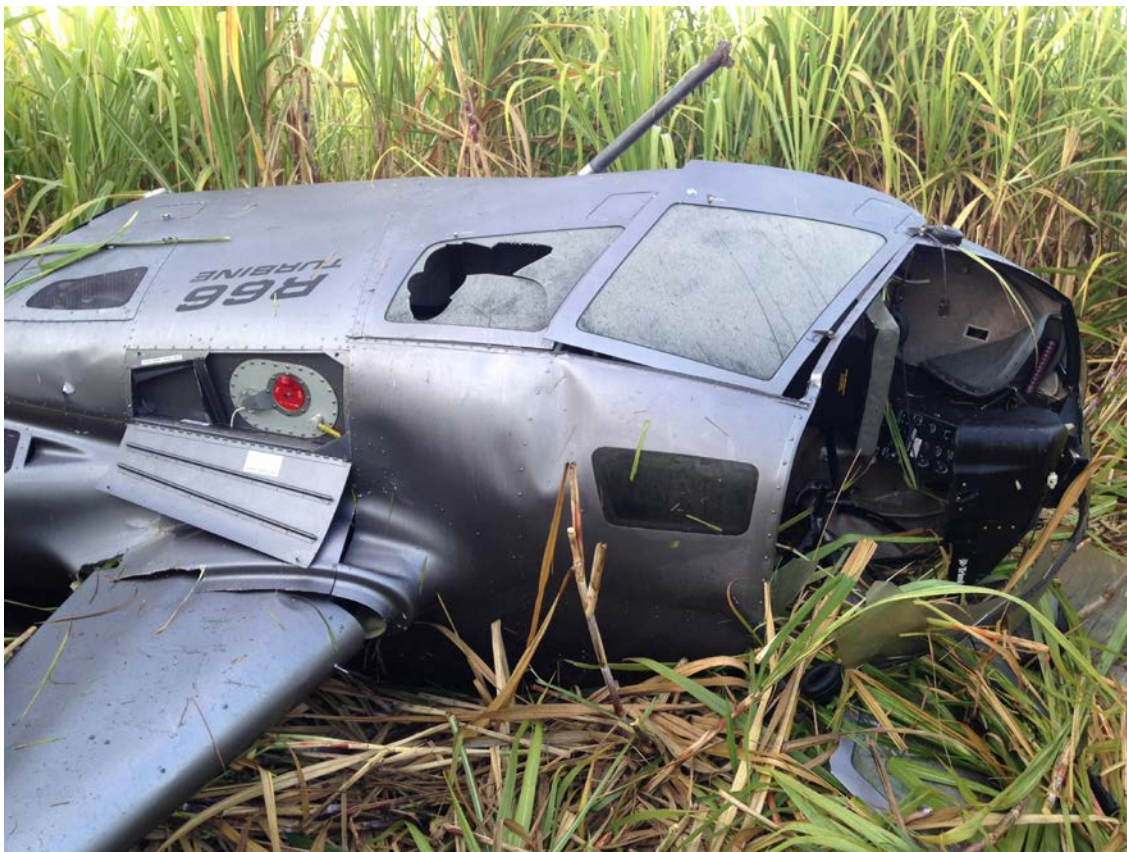
Wirestrike involving Robinson R66, near Giru, Qld. on 20 August 2014 (ATSB investigation AO-2014-142) – aircraft damage. Source: Operator.

- The pilot of a Robinson R66 helicopter received minor injuries when the aircraft struck powerlines and subsequently collided with the ground near Giru, Qld. The pilot conducted a site inspection from a vehicle prior to commencing aerial spraying. The pilot identified powerlines running along the eastern, southern and northern boundaries of the paddock to be sprayed. The pilot then conducted a flight over the paddock and assessed the hazards in the area, and confirmed they were able to see all of the powerlines he had identified from the ground. The pilot commenced aerial spraying in an east-west direction. At the end of each run, the pilot climbed the helicopter up and over the powerlines, turned then descended once clear of the powerlines and sprayed the paddock in the opposite direction. The helicopter was operating along the southern boundary of the paddock, parallel to the powerlines running along the southern and northern borders. The pilot was aware of those powerlines, however, when about 5 m from the eastern boundary, they sighted the powerlines running perpendicular to the direction of flight. The pilot assessed that it was too late to climb over the powerlines and elected to fly underneath them. The crop was about 6 ft tall and the pilot wanted to ensure the helicopter remained above the crop. The main rotor blade hub struck the powerlines and the helicopter collided with the ground and was substantially damaged ([ATSB investigation AO-2014-142](#)).
