Australian Government
Australian Transport Safety Bureau

Aviation Occurrence Statistics

2005 to 2014

ATSB Transport Safety Report
Aviation Research Statistics
AR-2015-082
Final – 23 December 2015

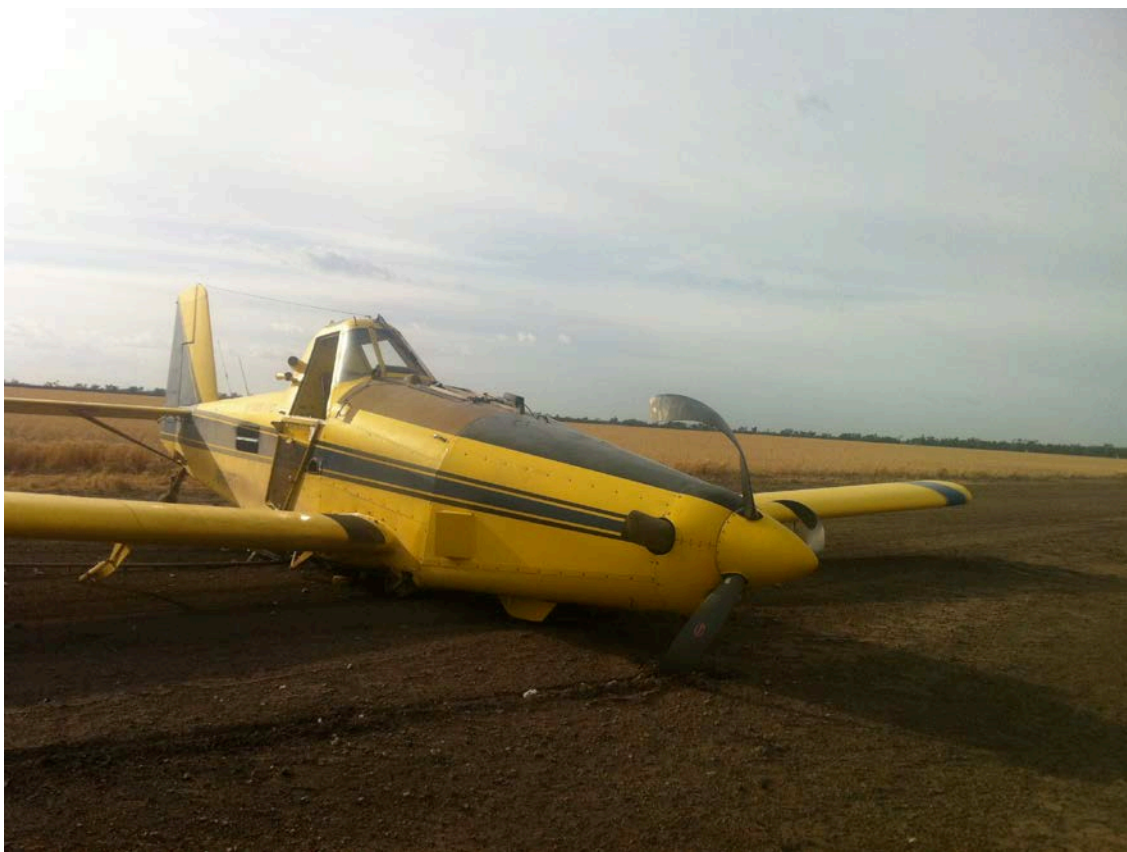
Collision with terrain involving an Air Tractor AT-502B, 45 km west of Moree Airport, NSW on 18 December 2014 (ATSB investigation AO-2014-191) - Damage to aircraft. Source: Pilot.

- An Air Tractor AT-502B conducting aerial agricultural spraying collided with terrain resulting in substantial damage to the aircraft near Moree, NSW. The job consisted of spraying four fields and the two western-most fields were sprayed in a north-south direction. To avoid an adjoining property, the two remaining fields were sprayed in an east-west direction. The pilot established a racetrack pattern at the southern end of the field and overflew a storage dam wall heading east. At that time, the pilot could observe the dam wall as the sun was rising but obscured by cloud. The pilot then turned the aircraft towards the west and commenced the first spray run, again overflying the dam wall. After completing that spray run, the pilot turned the aircraft to the east again for the second spray run. The sun was then above the cloud and directly in the pilot's eyes obscuring their visibility ahead of the aircraft. As the pilot was about to commence a climb and turn at the end of the spray run, they extended the run to spray some weeds. The pilot then turned the spray off and commenced a climb. As the aircraft climbed to about 30 ft, the landing gear collided with the dam wall, about 60 cm below the top of the wall. The pilot then dumped the chemical load and returned to the airstrip on the property about 4 km away. Both landing gear struts had been detached, which had then broken off the right flap, damaged the left flap and ruptured both fuel tanks. During the landing, the propeller was damaged. The pilot was not injured ([ATSB investigation AO-2014-191](#)).

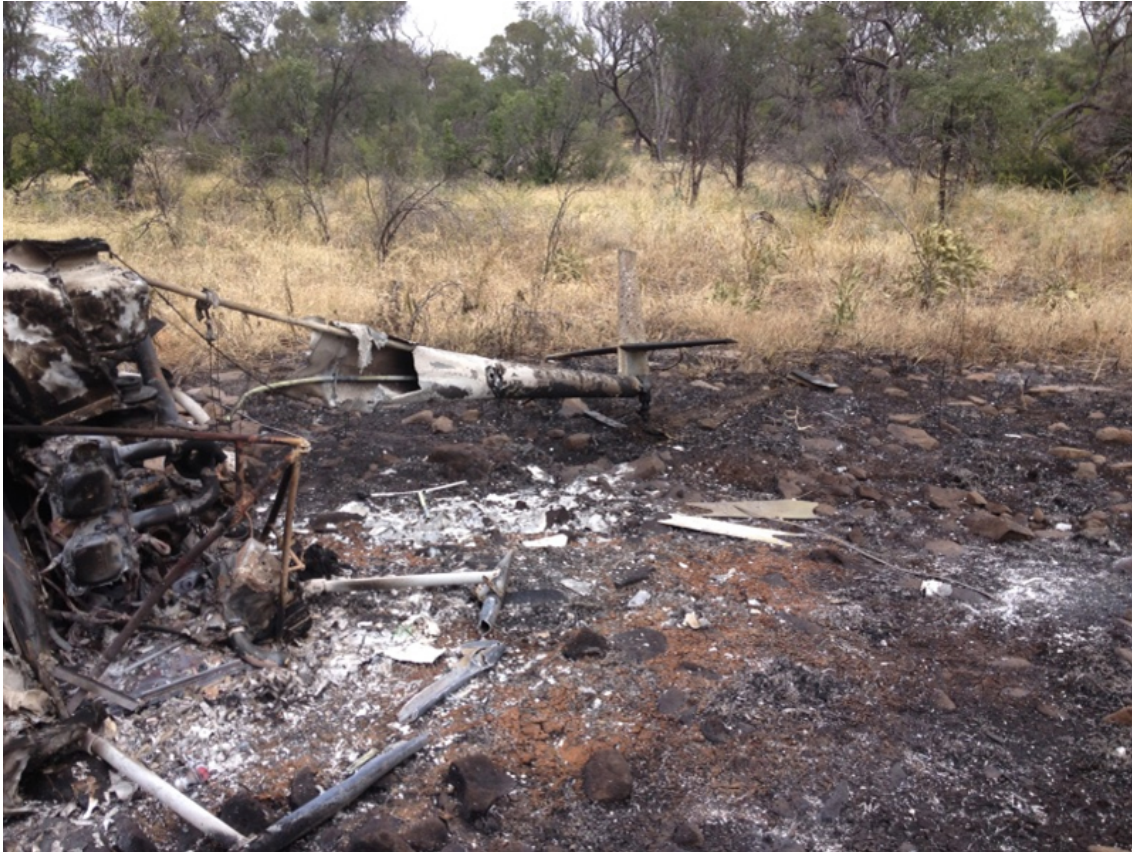
Collision with terrain involving Robinson R22, 40 km NE of Hughenden, Qld on 13 May 2014 (ATSB investigation AO-2014-087) – accident site showing long, dry grass and 'gidgee' trees in the background. Source: Operator.

- A Robinson R22 conducting aerial mustering was destroyed by fire following a collision with terrain about 40 km north-east of Hughenden, Qld. Prior to the accident, during mustering, the pilot noticed a number of cattle retreat to a protected area beneath trees. The pilot descended in what appeared to be a clear area adjacent to the trees in an attempt to keep the cattle moving, but as the aircraft descended, the main rotor blade struck a dead tree. Concerned about the extent of damage to the helicopter and possible loss of control, the pilot elected to make a controlled descent to the ground immediately beneath. A fire ignited in the grass beneath the engine behind the cockpit area after the helicopter settled on the ground. The pilot was able to retreat to a safe area and was uninjured, but the fire grew rapidly and destroyed the helicopter ([ATSB investigation AO-2014-087](#)).

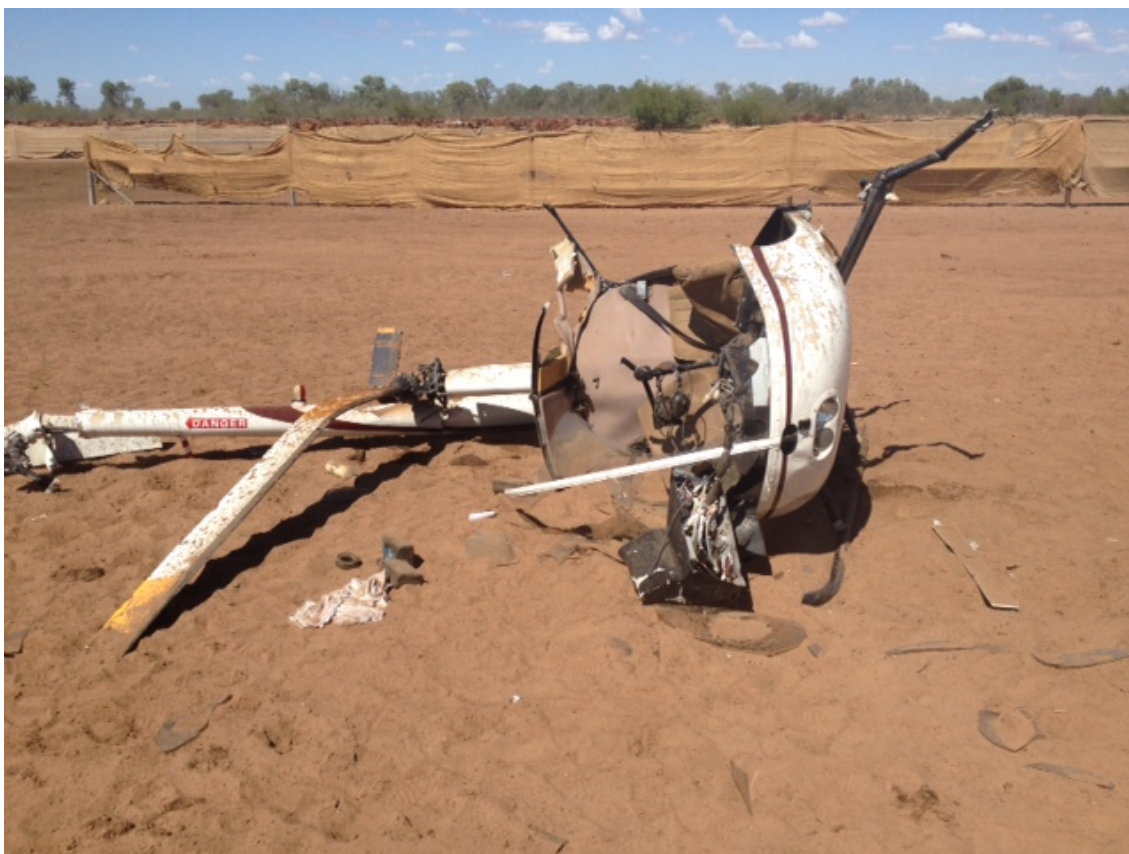
Groundstrike and loss of control involving Robinson R22 helicopter, near Fitzroy Crossing, WA on 18 May 2014 (ATSB investigation AO-2014-091) – accident site. Source: Operator.

- The pilot of a Robinson R22 sustained serious injuries from a ground strike while mustering near Fitzroy Crossing, WA. As the pilot was manoeuvring the helicopter at low level, the tail rotor struck the ground. The helicopter commenced a severe right yaw. The pilot kept the helicopter in a clear area, while it rapidly completed about four full rotations to the right. To arrest the yaw, the pilot immediately closed the throttle. This resulted in a rapid rate of descent. In an attempt to lessen the rate of descent, the pilot raised the collective. The helicopter struck the ground heavily, and then rolled onto the right side. The pilot sustained serious injuries and the helicopter was substantially damaged ([ATSB investigation AO-2014-091](#)).

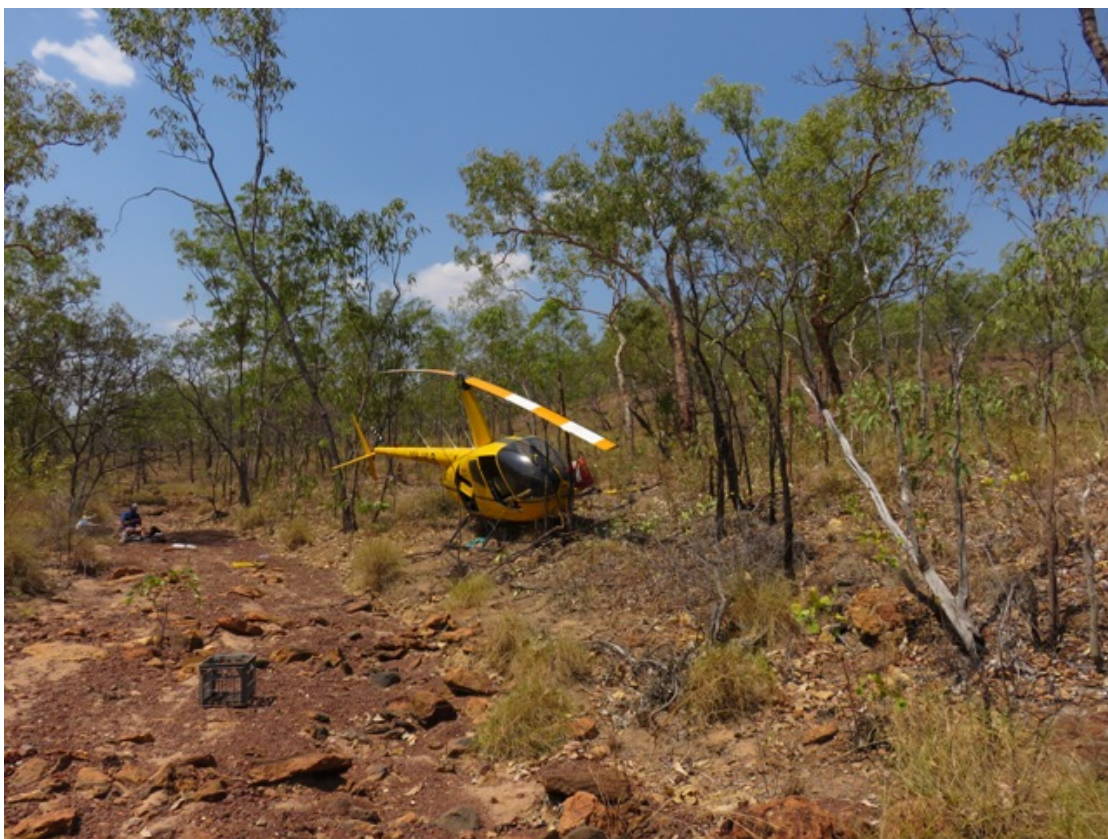
Collision with terrain involving a Robinson R44, 126 km ESE of Tindal Airport, NT on 23 September 2014 (ATSB investigation AO-2014-154) – accident site. Source: Operator.

- A Robinson R44 helicopter conducting a gravity survey was substantially damaged in a collision with terrain about 126 km east-south-east of Tindal Aerodrome, NT. On the aircraft were a pilot and a geophysical technician. The operation involved flying to specified locations 2 km apart and selecting a suitable landing site within 400 m of the location. After completing landings at about 30 sites, the helicopter arrived overhead at the specified location. The pilot identified a potential landing site, overflew it to make a closer assessment and then entered an out-of-ground-effect hover just above the treetops to determine if the site was suitable for landing. The pilot decided the site was unsuitable as trees prevented sufficient clearance for the main and tail rotors. As the pilot attempted to depart the area, the helicopter started to sink and the pilot observed the rotor RPM decaying. The pilot lowered the collective and rolled on throttle in an attempt to increase the rotor rpm. The outside air temperature gauge indicated about 40 °C and the pilot reported that increasing the throttle did not provide any detectable increase in power. The pilot then eased forward on the cyclic. The helicopter continued to descend and the main rotor blade collided with multiple tree branches. When at about 6 ft AGL, the helicopter rotated about 180° and landed hard with the left skid touching the ground first. The helicopter sustained substantial damage but the pilot and passenger were uninjured ([ATSB investigation AO-2014-154](#)).

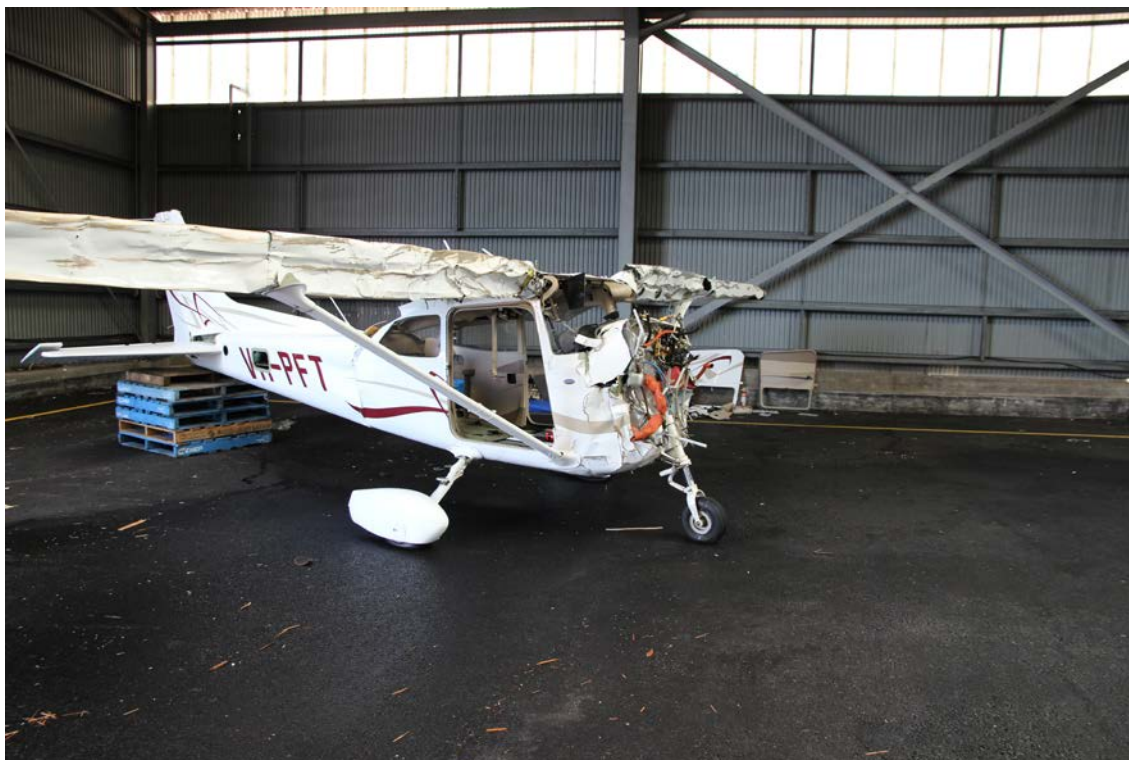
Collision with terrain involving Cessna 172, Storm Bay near Port Arthur, Tasmania on 29 December 2014 (ATSB investigation AO-2014-192) – aircraft wreckage. Source: ATSB.

- The pilot and photographer were fatally injured when their Cessna 172S collided with terrain at Storm Bay near Port Arthur, Tas. The purpose of the flight was to photograph yachts participating in the Sydney Hobart Yacht Race 2014 as they sailed around the Tasman Peninsula and into Storm Bay en route to Hobart. The pilot of the aircraft had completed a number of low-level passes on various yachts in the vicinity of Storm Bay before commencing a low-level pass from a southerly direction on the yacht Mistraal. After passing abeam of Mistraal, the aircraft continued on its northerly track for about 20 seconds and then commenced what witnesses described as a level, steep left turn. Witnesses stated that shortly after commencing the turn, the aircraft's nose dropped sharply and the aircraft descended rapidly, impacting the surface of the ocean. Mistraal and several other yachts diverted to assist. The aircraft was recovered from about 90 m of water by Tasmania Police and transported to Hobart. Initial inspection of the aircraft wreckage has not identified any mechanical failures that may have contributed to the accident. Damage to the aircraft structure confirmed that it impacted the water in a steep, nose-down attitude. The investigation is continuing ([ATSB investigation AO-2014-192](#)).

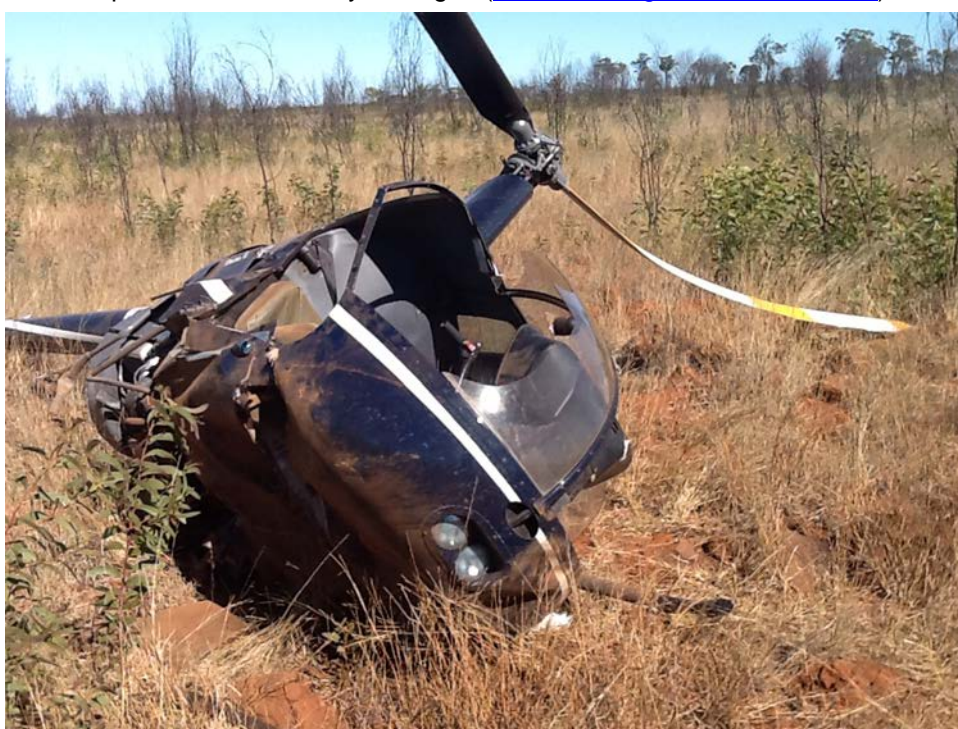
Collision with terrain involving Robinson helicopter, 115 km W Rockhampton Airport Qld on 12 July 2014 (ATSB investigation AO-2014-126) – damage to aircraft. Source: Owner

- The pilot under instruction (PUI) of a Robinson R22 sustained serious injuries and the supervising pilot (SP) received minor injuries following a collision with terrain 115 km west of

Rockhampton Airport, Qld. After completing about 7 hours of mustering, the helicopter was returning to a homestead near Dingo, Queensland. At about 1,000 ft AGL, the SP instructed the PUI to conduct a practice autorotation turning through 180°, which the PUI completed, increasing power when at about 5 ft AGL. During the subsequent climb, at about 450 ft AGL, the SP took control of the helicopter and initiated a second autorotation. The SP initially observed the airspeed at about 65 kt, the rotor rpm in the green arc and the autorotation 'looking good', and assumed at this stage that they had handed control of the helicopter to the PUI. At about 100 ft AGL, the PUI detected the rotor RPM decaying and a rapid rate of descent, but still assumed that the SP had control of the helicopter. When at about 20-40 ft AGL, the SP observed the vertical speed increasing and the rotor RPM decreasing, and rapidly lowered the collective and increased the throttle. Just prior to the helicopter contacting the ground, the SP flared, then levelled the helicopter and raised the collective. The helicopter landed hard, bounced once and rotated through about 180° before coming to rest. The helicopter was substantially damaged ([ATSB investigation AO-2014-126](#)).

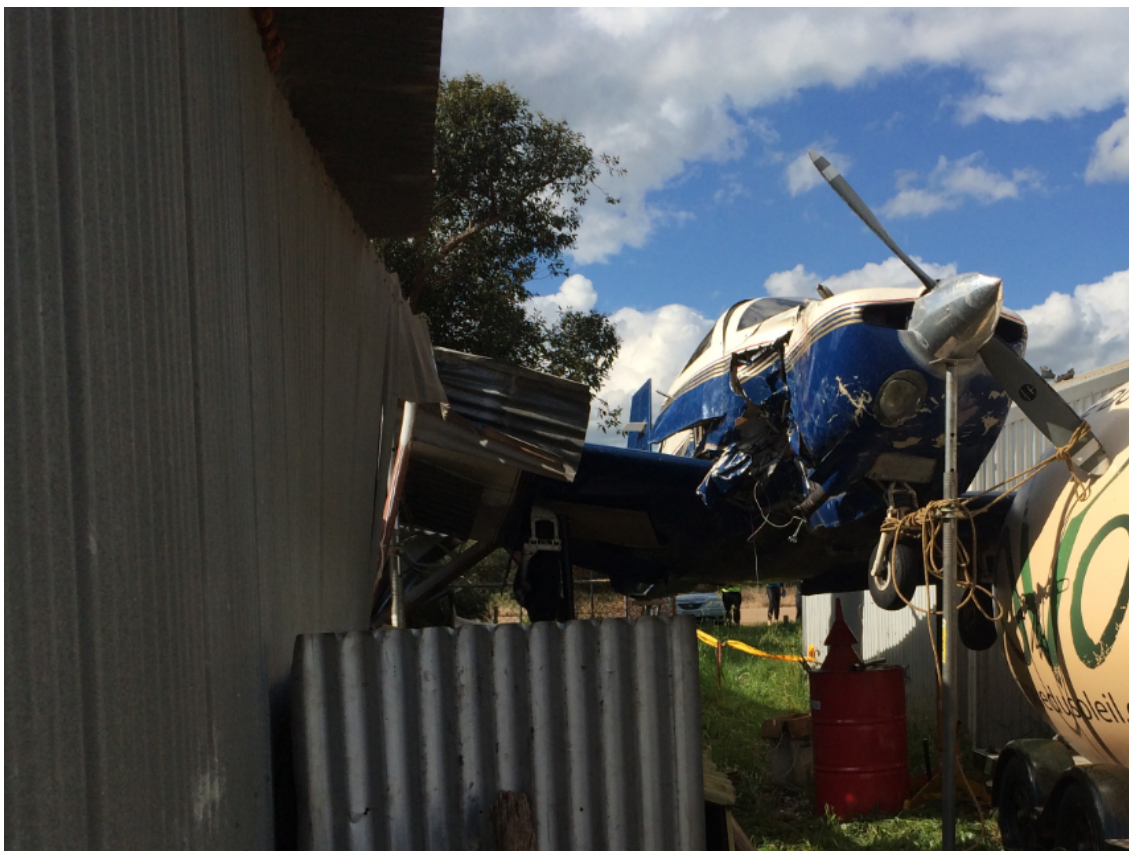
Collision with terrain involving a Mooney M20J, at Northam (ALA), Western Australia on 5 September 2014 (ATSB investigation AO-2014-148). - accident site and damage to the aircraft. Source: Operator.

- A Mooney M20J sustained substantial damage during a solo training flight in a collision with terrain at Northam ALA, WA. After a touch-and-go landing, the pilot conducted a second circuit with a missed approach from about 600 ft on final approach. The pilot then intended to conduct a third circuit with a touch-and-go landing. When on final approach, the pilot trimmed the aircraft in the approach configuration with full flaps and airspeed at about 70 kt. The pilot flared the aircraft for landing and touched down about one third of the way along the runway. As the aircraft slowed, the pilot selected the flaps to 15° and applied full throttle along with right rudder to counteract the aircraft's tendency to yaw left. As the airspeed increased to about 65 kt, the pilot rotated the aircraft for take-off and applied forward pressure against the control column as the aircraft nose tendency was to pitch up due to the combination of trim, flap and power settings. At about 50 ft AGL, the aircraft had drifted to the right of the runway centreline and the pilot reduced the right rudder input. Soon afterwards, the aircraft nose pitched up. The stall warning sounded and the pilot applied full right rudder and pushed forward on the control column in an attempt to level the aircraft's wings and recover from the stall. The left wing dropped as the aircraft stalled, and it collided with a hangar. The aircraft pivoted about the left

wing and came to rest wedged between two hangars, resulting in substantial damage ([ATSB investigation AO-2014-148](#)).

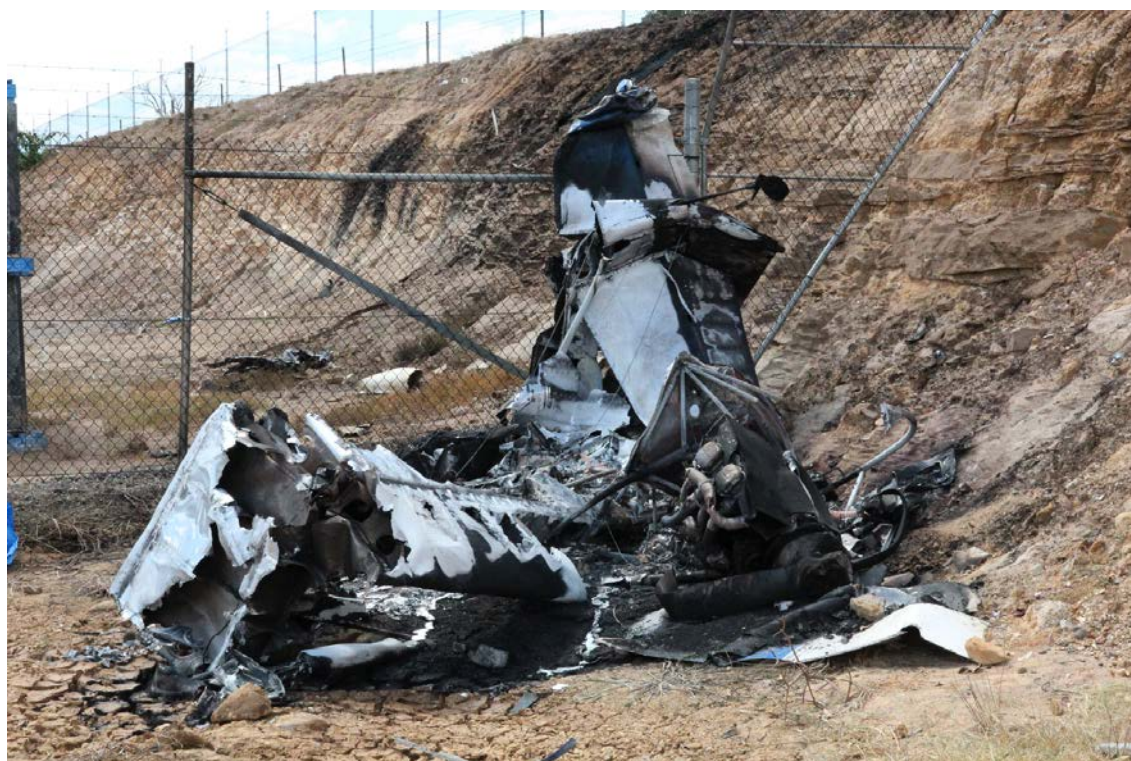
Collision with terrain involving Vans RV-6, near Gatton, Queensland on 2 March 2014 (ATSB investigation AO-2014-035) – accident site. Source: ATSB.

- The pilot of an amateur-built Van's aircraft RV-6 was fatally injured from a collision with terrain at Gatton Airpark, Qld. The ATSB determined that it was very likely the pilot was performing a low-level aerobatic manoeuvre at a height from which recovery to normal flight was not completed before the aircraft collided with terrain. The pilot held a Civil Aviation Safety Authority student pilot licence and a Recreation Aviation Australia pilot certificate, but did not hold qualifications that entitled the pilot to fly the aircraft as pilot in command. ([ATSB investigation AO-2014-035 was discontinued](#)).

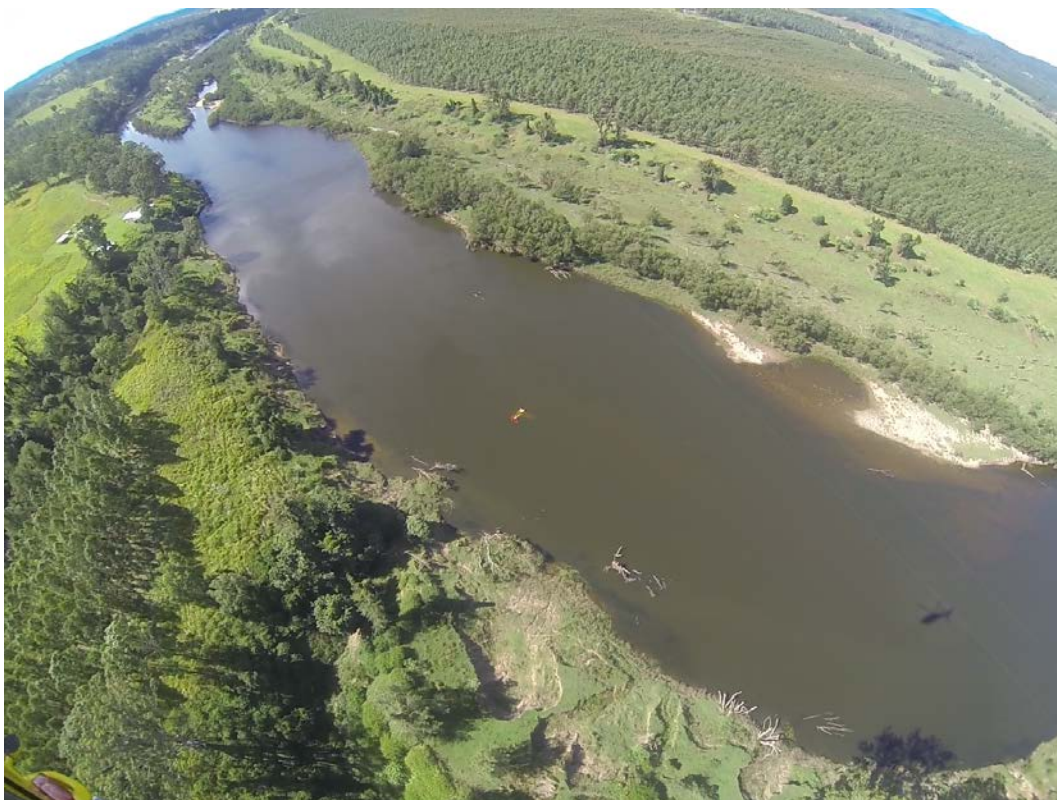
Wirestrike involving Maule M-5, 50 km WSW of Casino, NSW on 12 April 2014 (ATSB investigation AO-2014-068) – accident site. Source: Northern Region Westpac Life Saver Rescue Helicopter Service.

- A child passenger of a Maule M-5 was fatally injured after the aircraft struck a wire spanning the Clarence River and came to rest inverted with the cabin submerged, west-south-west of Casino, NSW. The wirestrike and resulting loss of aircraft control was an unintended consequence of the pilot's spur of the moment decision to fly at very low level along the river, in an unfamiliar environment and below the minimum stipulated height for flights over unpopulated areas. The pilot reported seeing the powerline cables just before the collision, but with insufficient time to avoid a wirestrike. The pilot repeatedly attempted to free the child, seated in the rear of the aircraft by the right-rear door, before recovering the child through the cockpit door. Sustained attempts to resuscitate the child were unsuccessful. An adult passenger seated in the front of the cabin survived the accident ([ATSB investigation AO-2014-068](#)).

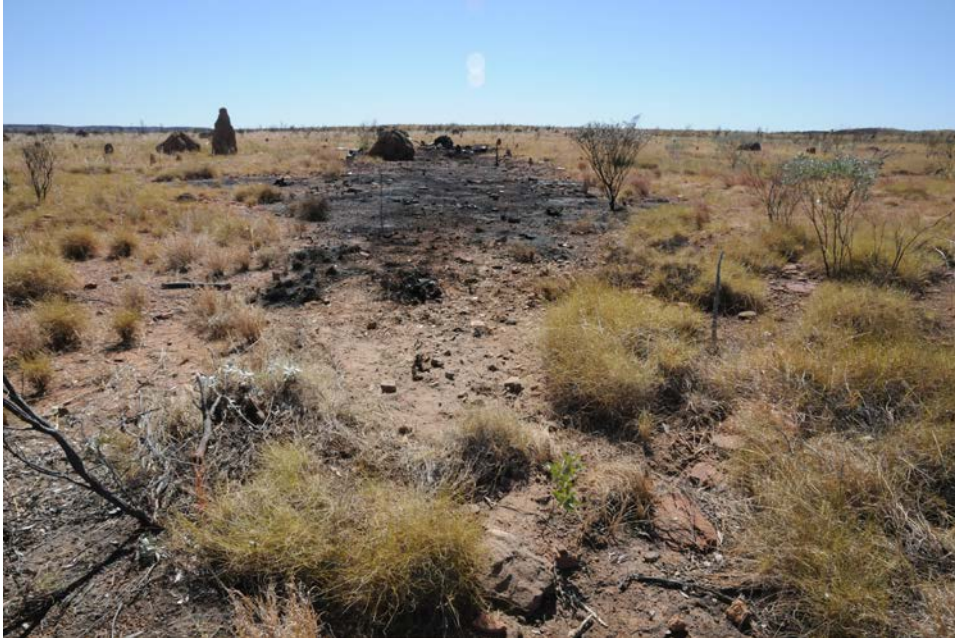
Collision with terrain involving Robinson R22 helicopter, 70 km north west of Halls Creek, WA on 25 August 2014 (ATSB investigation AO 2014 144) – wreckage trail with initial ground impact in the foreground. Source: Western Australia Police.

- The pilot of a Robinson R22 sustained fatal injuries from a collision with terrain at night, 46 km west of Springvale. The ATSB found that the pilot, who did not hold a night visual flight rules (VFR) rating or instrument rating, continued flying towards the destination after last light (end of civil twilight), then in dark night conditions without local ground lighting, inadvertently allowed the helicopter to descend into terrain. ([ATSB investigation AO-2014-144](#)).

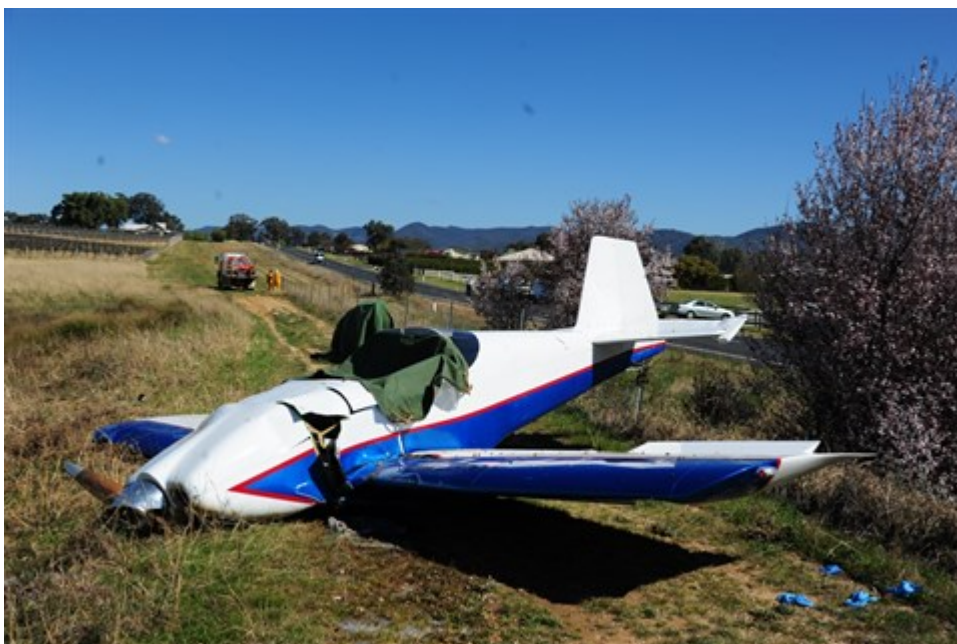
Collision with terrain involving Vans RV-6, near Mudgee Airport NSW 14 September 2014 (ATSB investigation AO-2014-149) – accident site. Source: NSW Police.

- The pilot and passenger of an amateur-built Vans aircraft RV-6 were fatally injured when the aircraft collided with terrain on approach at Mudgee Airport, NSW. Prior to turning onto the downwind leg of the circuit, the aircraft descended to about 600 ft above ground level. Witnesses stated that the pilot conducted a tight left turn onto final approach at a reported slow speed and low height. Witnesses also recalled hearing the aircraft's engine 'sputter' and 'stall'. The aircraft continued its high angle of bank left turn and collided with terrain about 300 m south-west of the threshold of the runway. The ATSB investigation is ongoing ([ATSB investigation AO-2014-149](#)).

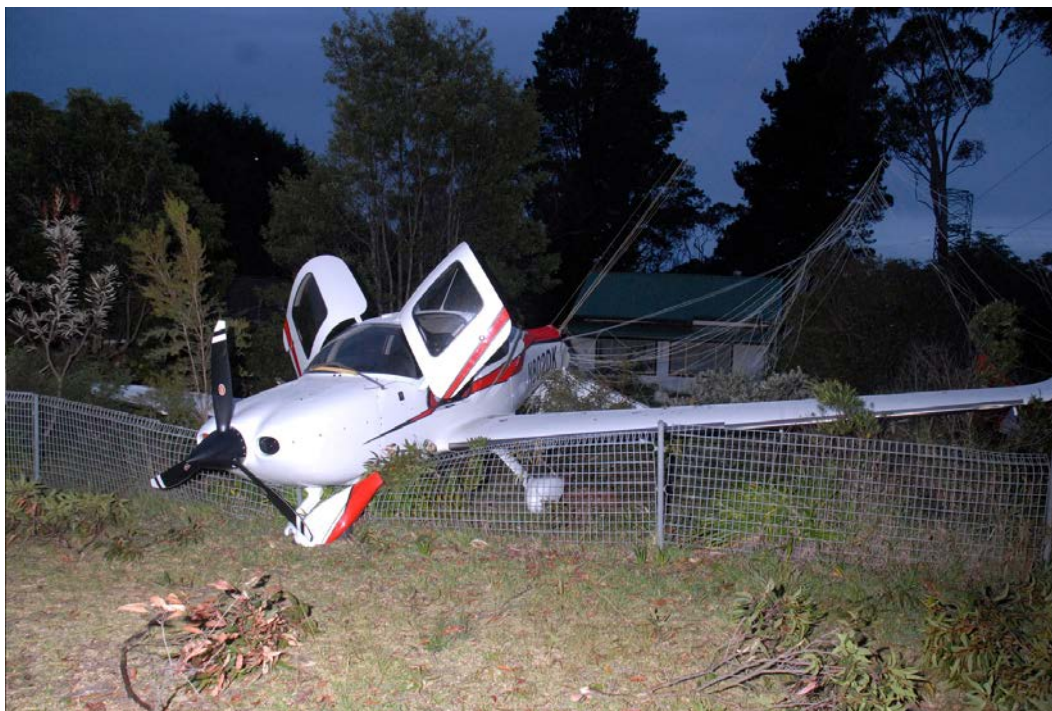
Loss of control involving a Cirrus SR22, near Katoomba, NSW on 10 May 2014 (ATSB investigation AO-2014-083) – accident site. Source: NSW Police.

- A DG Flugzeugbau LS10 glider was substantially damaged from a hard landing after stalling on short final approach at Stonfield Gliding ALA, SA (ATSB occurrence 201401664).
- A Cirrus SR22 aircraft was substantially damaged following a loss of control and subsequent forced landing near Katoomba, NSW. The flight was conducted as a sales demonstration, with the salesman acting as the pilot in command (PIC) and the prospective purchaser (who held a private pilot licence) conducting some of the pilot duties. During the flight, while conducting roll manoeuvres, the PIC lost control of the aircraft. At around 2,000 ft the PIC deployed the aircraft's parachute. On descent, the aircraft narrowly avoided powerlines and came to rest on a fence in the garden of a residential dwelling. No major injuries were sustained to the occupants of the aircraft ([ATSB investigation AO-2014-083](#)).

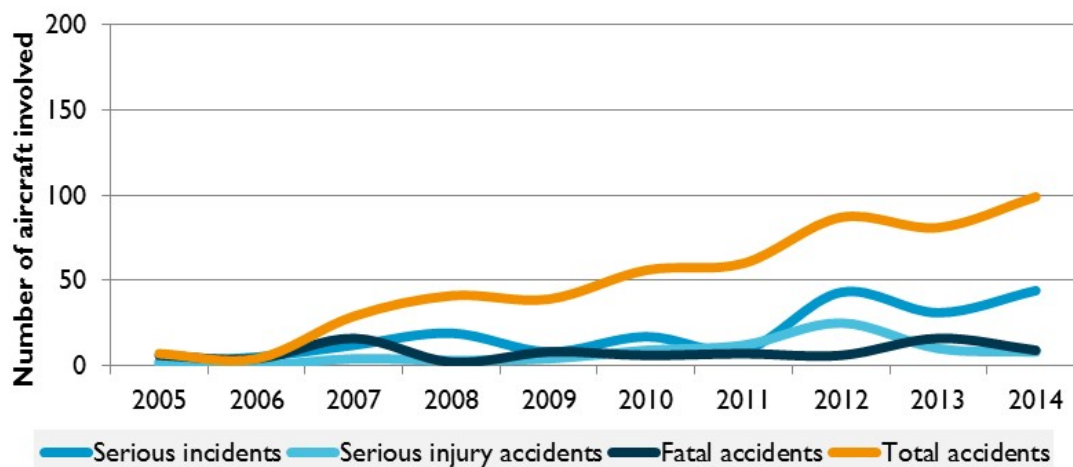
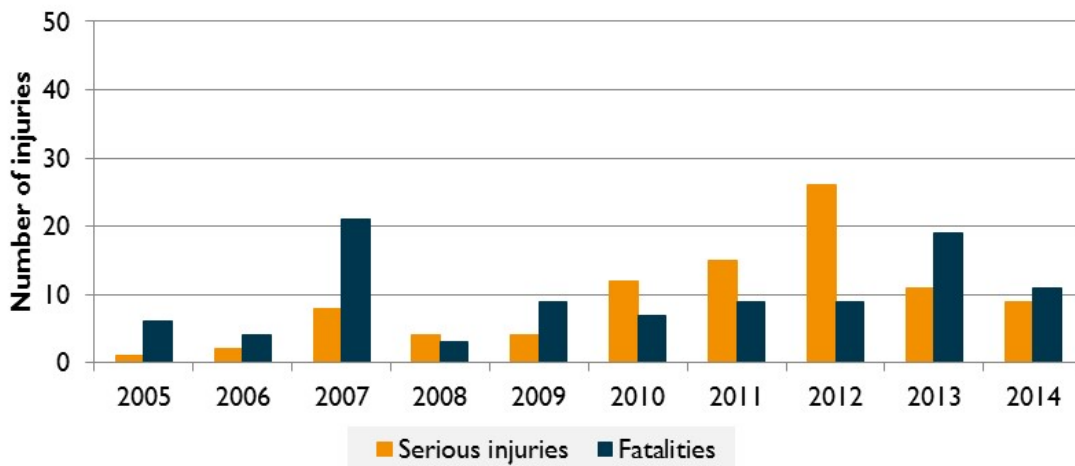
Figure 19: Recreational aviation occurrences and injuries, 2005 to 2014

Figure 19 shows that the accident rate in recreational aviation has increased dramatically since 2006. While this increase is likely to be due to better reporting of accidents to the ATSB, the recreational aviation accidents in 2013 (215.6 accidents per million hours flown) was higher than any other type of flying in Australia. Recreational aeroplanes (those aircraft registered with Recreational Aviation Australia (RA-Aus)) made up the largest proportion of recreational flying hours, and were also involved in around 74 per cent of all recreational aviation accidents in the 2005 to 2014 period, and 48 per cent of the fatal accidents. Although the recreational aeroplane accident rate over this period was higher than all other types of flying, gyrocopters had a higher fatal accident rate.

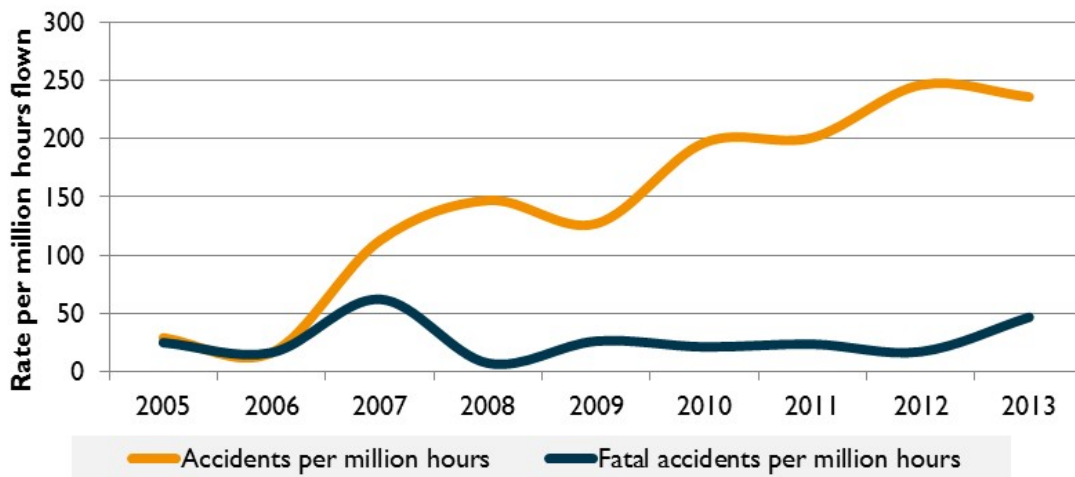
Figure 20: Recreational aviation accident and fatal accident rate (per million hours flown), 2005 to 2013

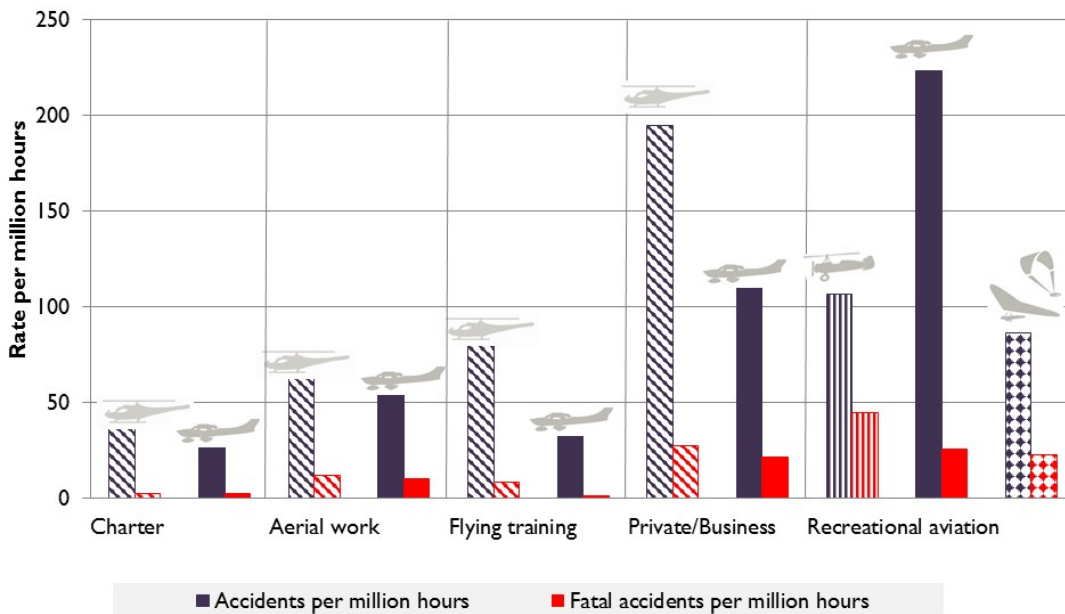
Figure 24: Rate of accidents and fatal accidents by operation and aircraft type

When comparing the accident rate of aircraft types¹⁸ by operation type, there is significant difference between air transport (charter), GA, and recreational aviation (Table 29 and Figure 24). These differences are discussed below.

Operation	Aircraft type	Accidents per million hours	Fatal accidents per million hours
Charter	Helicopters	37.5	2.5
	Aeroplanes	28.1	2.5
	Balloons	-	-
Aerial work	Helicopters	70.1	11.7
	Aeroplanes	61.1	10.4
Flying training	Helicopters	88.7	8.3
	Aeroplanes	35.8	1.4
Private/business	Helicopters	194.3	27.2
	Aeroplanes	123.9	21.2
	Balloons	1,040.7	-
Recreational aviation	Gyrocopters	106.7	44.5
	Aeroplanes	223.0	25.6
	Weight Shift	86.0	22.5
