Emerging trends in Australian aviation safety

January – June 2015

ATSB Transport Safety Report

AR-2016-002

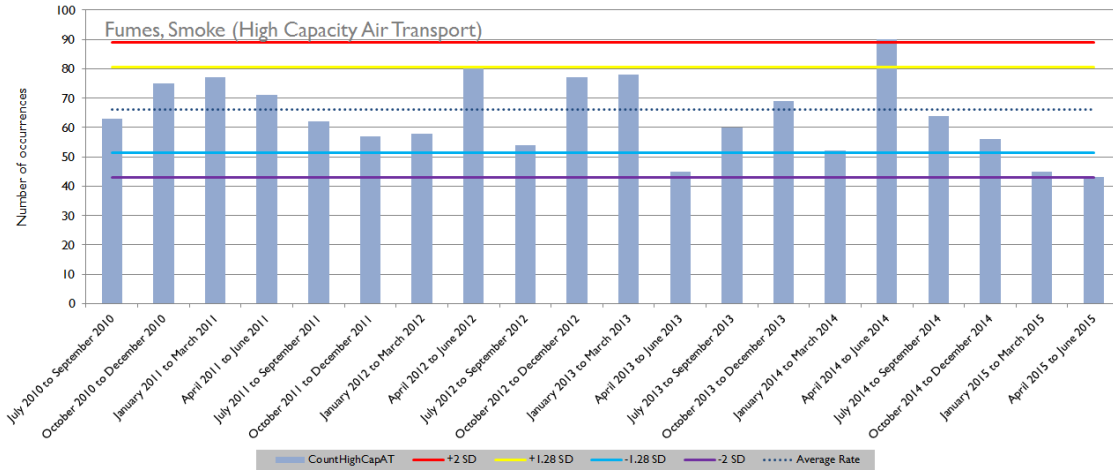
Operational / Fumes and smoke – High capacity air transport

The number of *fumes* and *smoke* occurrences reported to the ATSB between January-June 2015 in high capacity air transport was significantly lower than the 5-year average. One operator was the primary contributor to the decrease – reducing from an average of around 16.8 (Jul 2010-Dec 2014) to 3.0 (Jan-Jun 2015) occurrences per quarter.

All other airlines and operation types were relatively consistent with their 5-year averages. Further, the decrease was not determined to be dependent upon location or season.

None of the 88 *fumes* and *smoke* occurrences – including all operators – were classified as high risk according to the ERC matrix.

The same trends were identified individually for both *fumes* and *smoke* occurrences when analysed separately.

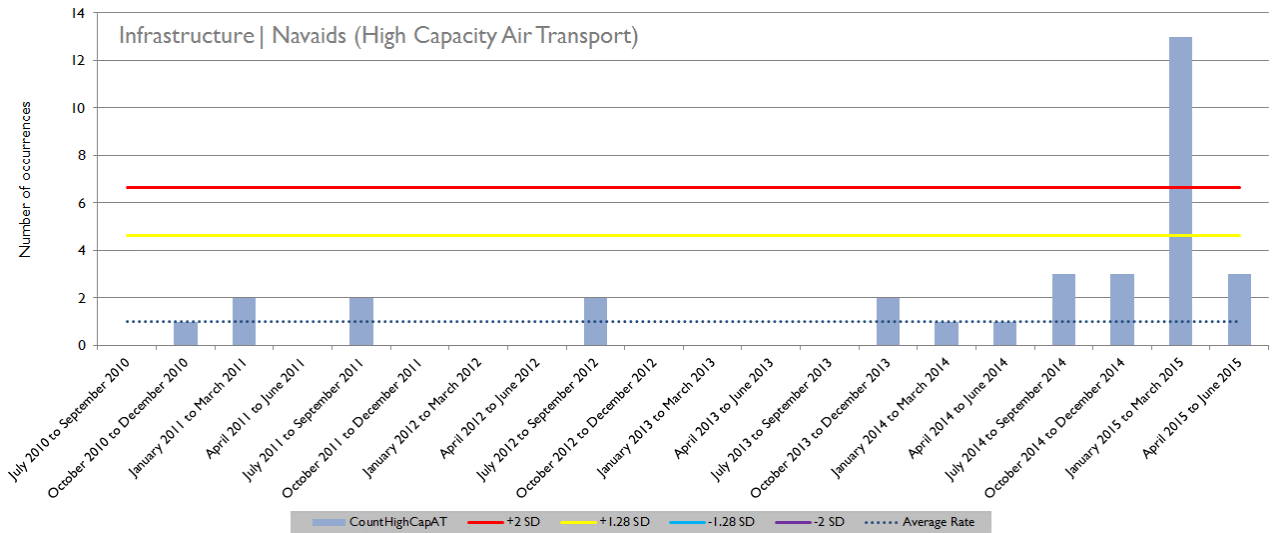
Infrastructure | Navigation aids – High capacity air transport

The Jan - Mar 2015 quarter had the highest number of reported *Infrastructure | Nav aids* occurrences in the 5-year reporting period. Twelve of the 13 occurrences involved one operator landing at Sydney aerodrome using the GNSS Landing System (GLS). The GLS is an ILS replacement technology currently installed at Sydney, previously trialled by one operator, which is now available to all GLS equipped operators. For the majority of these occurrences the aircraft was operating under Visual Meteorological Conditions (VMC) with none resulting in missed approaches. All of these occurrences were classified by the ATSB as low risk with no ‘accident’ outcome and none were investigated.

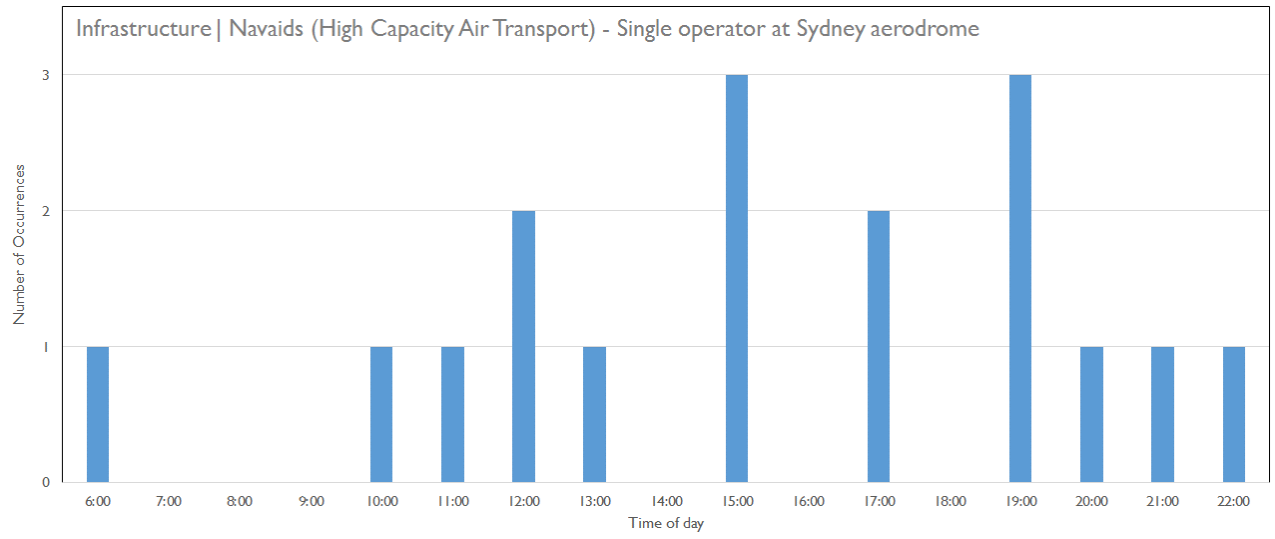
Over the reporting period, the disruption of the GLS was more likely to occur in the afternoon and on Monday, Tuesday, Friday and Saturday.

The ATSB will continue to monitor. However, the quarterly trend above suggests that these occurrences may now be reducing. Airservices is also aware of this issue.
