# AVIATION SAFETY DIGEST

No 18, JUNE 1959

Prepared in  
the Division of  
Air Safety Investigation  
Department of Civil Aviation

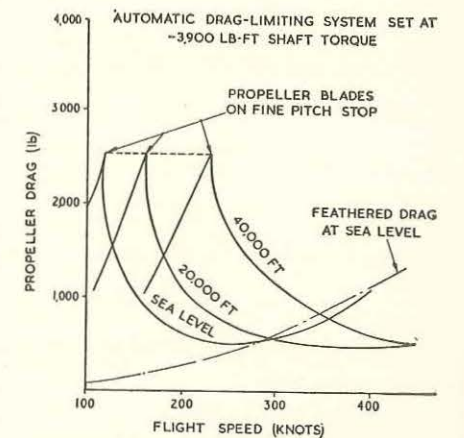
Fig. 3. Response values for an automatic drag-limiting system.

The response in terms of propeller drag is shown in Fig. 3. With the engine power lever in positions from low cruising power to take-off, the setting of the drag-limiting system is at a slightly positive value of torque. Thus in the event of engine failure in this range the propeller feathers. With the engine power lever at flight idle, the torque setting of the drag-limiting system is 3,900 lb. ft. compared with a normal torque of 1,000 lb. ft. de-

livered by the engine at flight idle. In the event of engine failure with the power lever in the flight idle position the engine torque will at first drop below the setting of the drag-limiting system, thus causing the blades to coarser until a value of 3,900 lb. ft. is restored. The blades will then continue to move to govern the torque to this value under the varying flight conditions.

The drag is thus automatically limited to the values shown on Fig. 3, which may be compared with the unrestricted values given in Fig. 2 (b). Manual feathering can, of course, be accomplished at any convenient time to reduce the drag to an even lower value.
