Aviation Safety Digest

NO. 20, DECEMBER 1959

Prepared in the Division of Air Safety Investigation.

The STALL

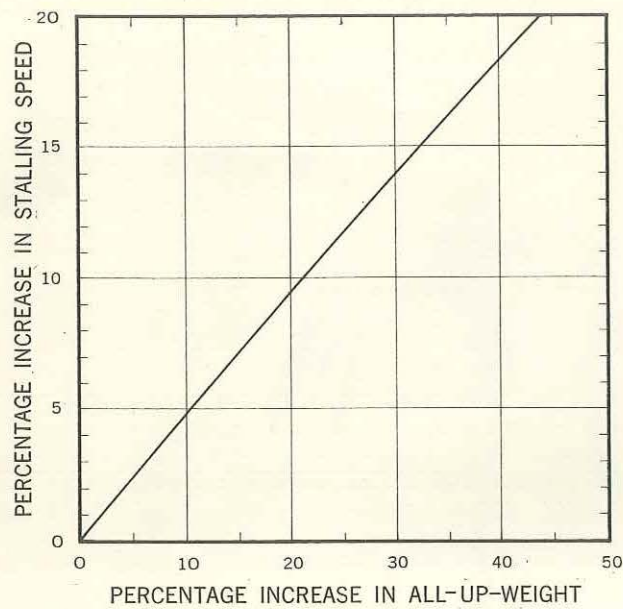
Fig. 1

THE RELATIONSHIP BETWEEN STALLING SPEED AND ALL-UP-WEIGHT

It will be readily apparent how the values in this example may also be obtained from the graph at Fig. 1, which is applicable to all orthodox types of fixed wing aircraft.
