Aviation Safety Digest

- 3 Carbon monoxide poisoning
- 6 Electronic checklist for general aviation aircraft
- 8 Flight deck management
- 9 Propeller feathering on light twin-engine aircraft
- 10 Low level turbulence
- 13 Unpredictable birds
- 14 Air safety incident reporting — the Australian system
- 16 An unreported incident
- 17 Selected incidents
- 19 Pilot contribution
- 20 Corrosion prevention for piston engines
- 21 Unfamiliar navigation equipment
- 22 Servicing older helicopters
- 23 Polarised instrument glass
- 24 Some thoughts from a Met. man
- 25 Fuel ice
- 26 The man on the other side
- 28 MD and the jet fuel
- 30 Learn to say 'No'

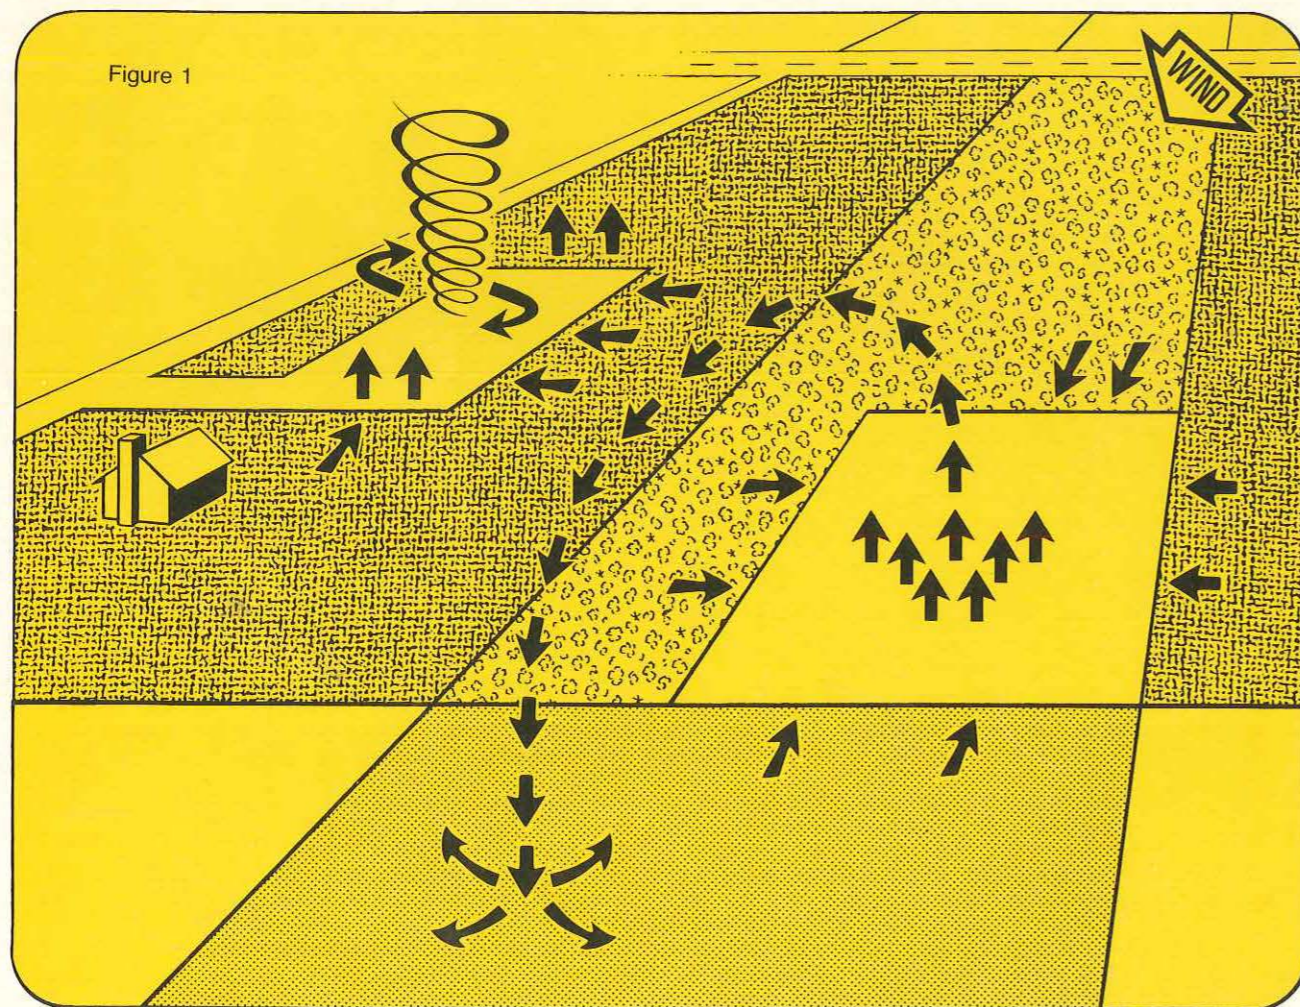
Figure 1

Rising parcels of air (thermals) are caused by air being warmed to different temperatures over different surfaces. For example, on a sunny day, a newly worked-up paddock in sandy country, surrounded by fully stooled crops which cover the ground with a thick green canopy, will have a much higher surface temperature. The bare ground will supply much more heat to the air than will the surrounding crops. This hotter air will rise by convection and an aircraft flying over the crops, then the bare paddock, will be carried upwards by the rising air when it comes to it (Figure 1). The upward motion will cease as the aircraft flies out of the rising air.

Of course some air has to replace the rising air over the bare paddock. Cooling parcels of air descend in other places and move in to replace the rising air. Both are happening at the same time and this raises and lowers aircraft flying through the various parcels of rising and descending air (Figure 1). Aircraft operating in close proximity to the ground are most obviously affected.
