# Aviation Safety Digest

# Contents

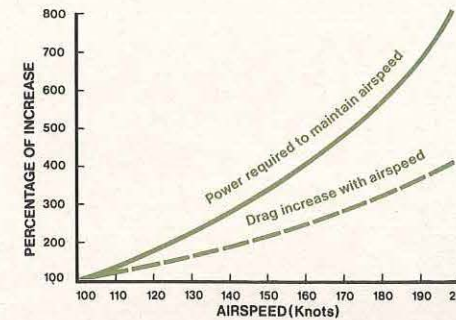
Figure 2. Effect of airspeed on drag - and power required to maintain that airspeed while in level flight.

increased because the gear and flaps are down and the propeller is windmilling, more power will be required. Not so obvious, however, is the fact that drag also increases as the square of the airspeed, while power required to maintain that speed increases as the cube of the airspeed (see Figure 2).

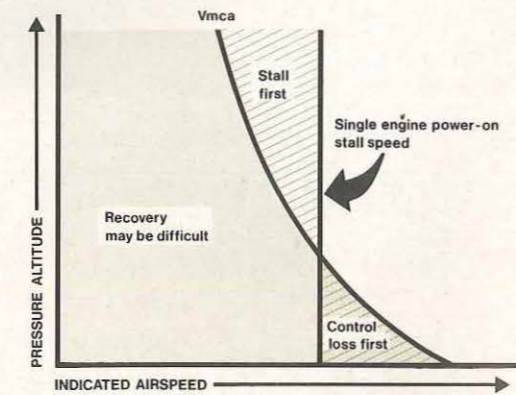
Figure 7. Relationship between stall speed and Vmca for aircraft with normally aspirated engines.

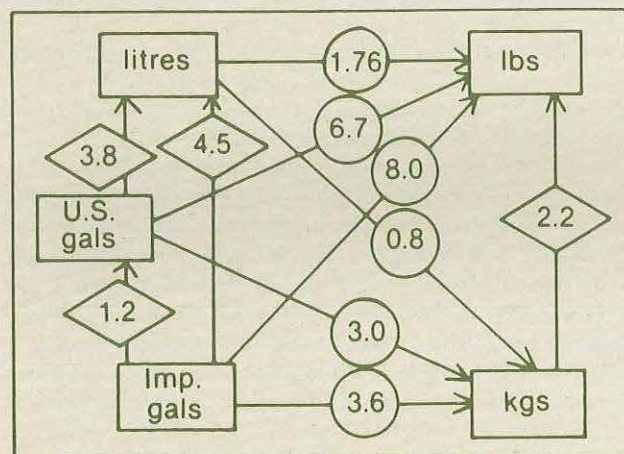
#### For jet A calculations turbine SG 0.8

- follow the arrow and multiply
- backtrack the arrow and divide

These small charts need only a hand held calculator to use. They enable you to convert fuel figures from any volume units to any weight units, and vice versa.

All the figures in the diamond-shaped boxes are precise while all the figures in the circles are 'about' right. The qualification 'about' right is necessary because those circled figures depend on the specific gravity of

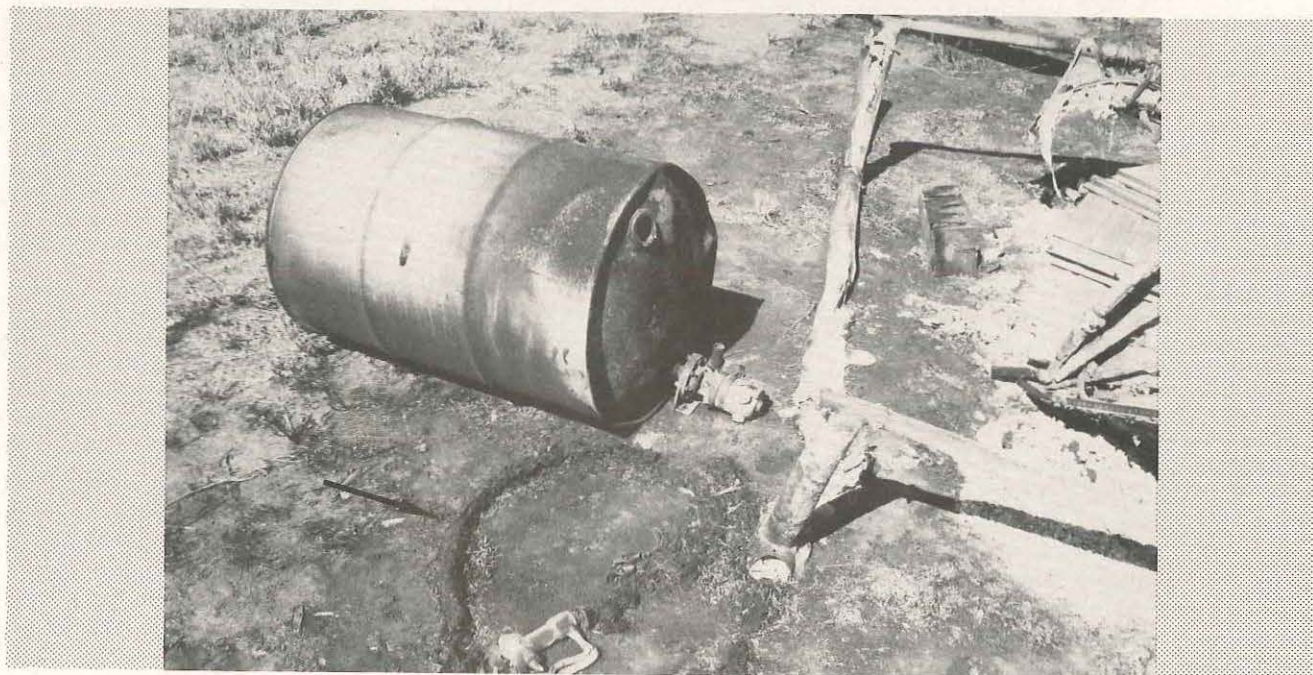
Photograph shows proximity of fuel drum, battery and helicopter. Arrow indicates remains of fuel nozzle and hose.
