Aviation Safety Digest

Navaid Calibration in Australia

30 seconds to save your life!

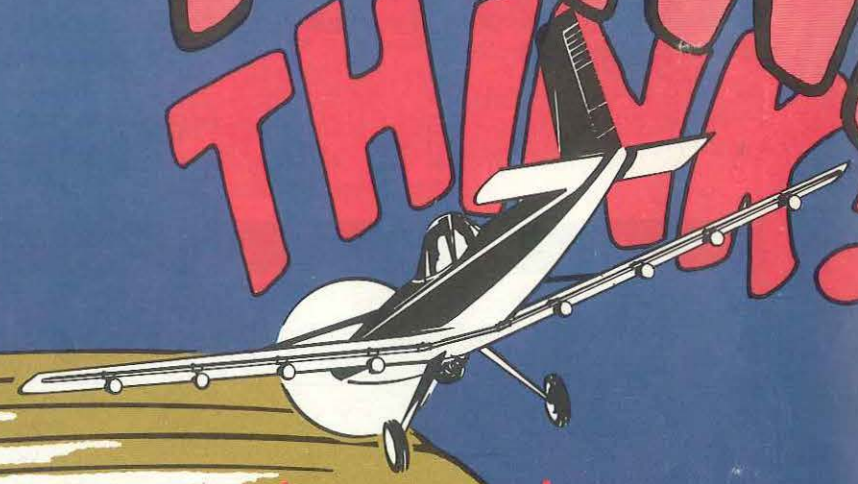
**EXTRA
HAZARD
CHECK!**

Whenever possible carry out clean up runs away from wires so that the problem has been dealt with and preferably into wind to reduce ground speed.

The check takes so little time — see the heading. The representation above and on the back cover is John's example of a method of rechecking hazards affecting clean-up runs.

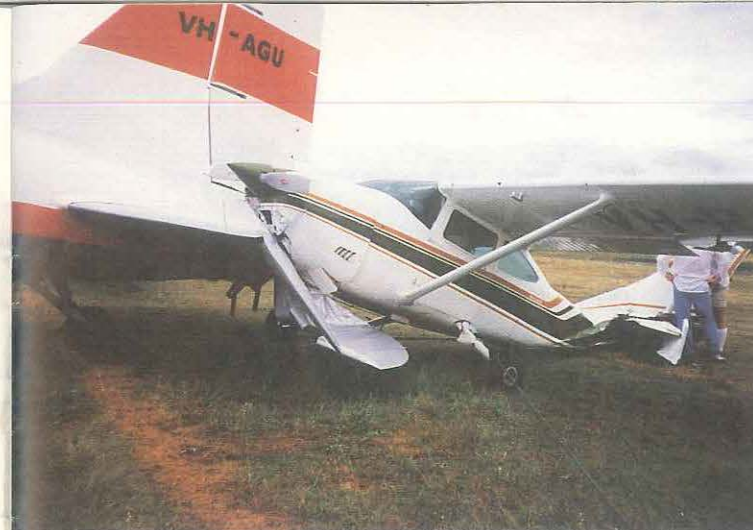
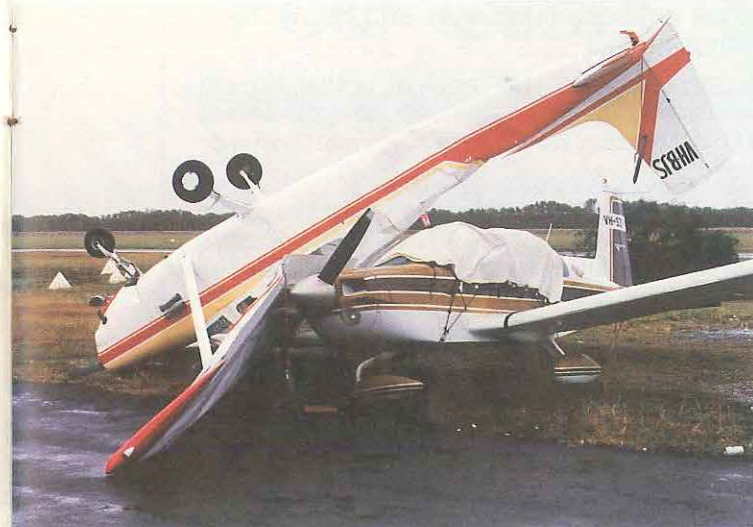
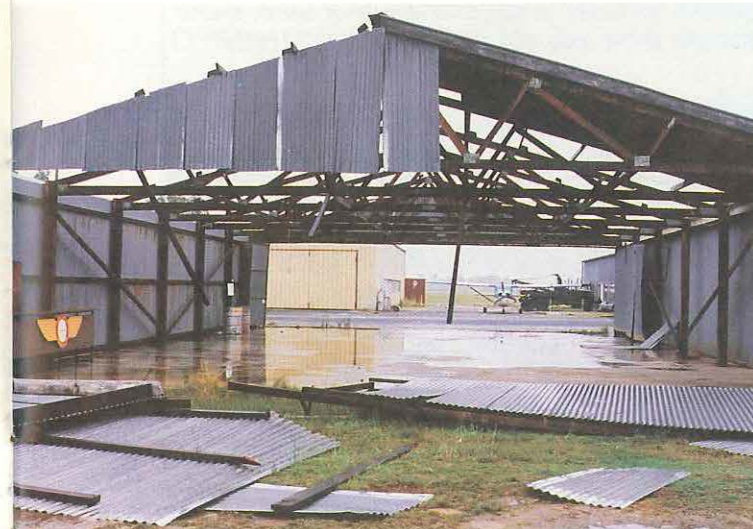
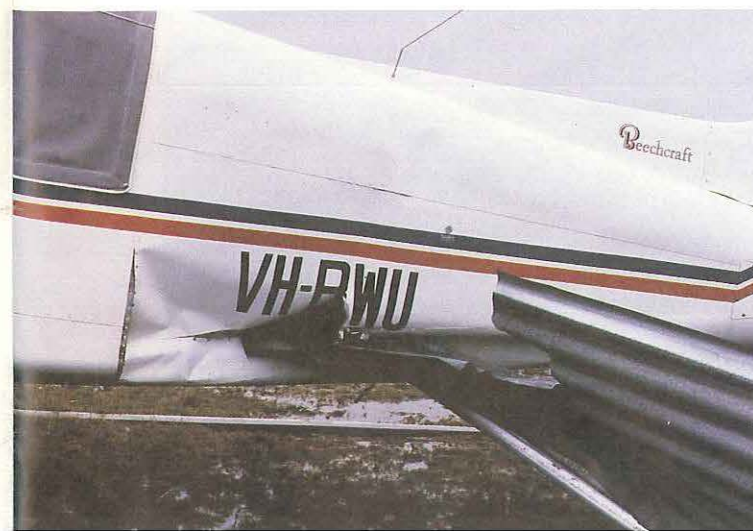
The final cause of damage at Redcliffe was the destruction of one hangar in a row of four similar hangars. The doors were of the folding type that are pegged top and bottom at each fold. The pegs were old and bent (or missing) and the hangar doors just imploded and this inrush of wind ripped off every sheet of iron from the roof and end wall — some carried about 250 yards and one 20' length actually speared right through a parked Musketeer. So the condition of hangars or buildings can also be the cause of significant damage in these circumstances.

In summary it is apparent that most damage is caused in these situations by aircraft (or debris) that break loose, running into, or flying into other aircraft that may be very securely and responsibly tied down. Screw in anchor type stakes are very common in U.S.A. for use by General Aviation aircraft and would probably be very useful here in soft ground situations. Would it be appropriate for CAA or some similar body to conduct comparative tests on the different types available and report through the Aviation Safety Digest?

What was significant at Redcliffe was that it was high wing Cessnas that were up-ended, — the low wing aircraft that were securely tied down surviving with varying lesser damage caused by flying debris or Cessna aircraft that had come adrift, colliding with the low wing aircraft. In one case a Cessna 172 had pulled the star picket stakes it was secured to clean out of the ground and then been up-ended on top of the Grumman Tiger next to it that was securely tied down. Both aircraft appeared to be writeoffs.

Aircraft secured to common wire tie-downs had all been pushed sideways by the wind, sliding their individual tie-downs along the wire until all the aircraft were in contact with each other bunched at the end of the wires. More damage! So maybe another lesson to be learnt — some means of securing an aircraft's tie-down ropes (or ideally chains) to the wires to that they cannot slide sideways.
