Bureau of Air Safety Investigation

An Analysis of Incidents Involving Aircrew Failing to Comply with Air Traffic Clearances June to August 1996

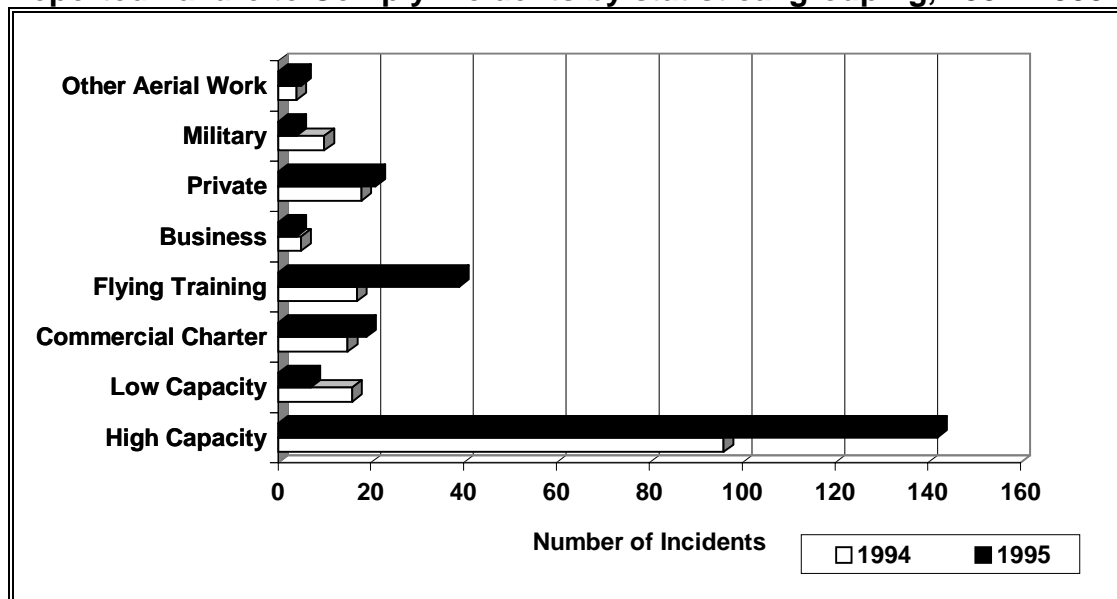
Figure 1 indicates that the majority of FTC incidents in the 2-year period involved HCRPT aircraft. FTC incidents during flying training increased in the same period although the total number in this type of operation remains relatively small.

FIGURE 1
Reported Failure to Comply incidents by statistical grouping, 1994–1995

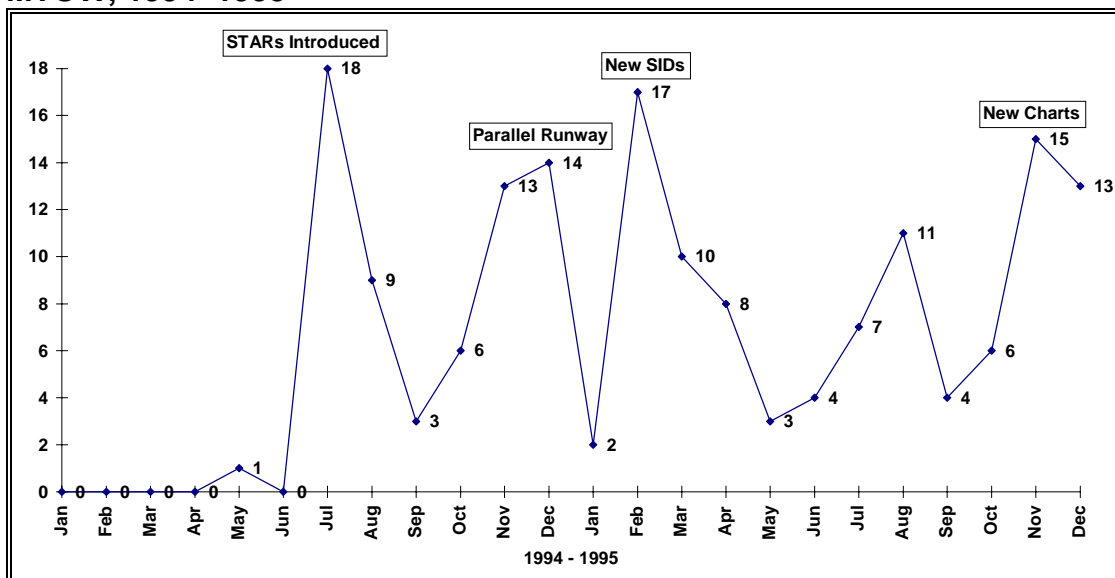
Figure 2 presents the number of FTC incidents at Sydney, involving aircraft over 5,700 kg, by month for 1994 and 1995. There were significant increases in July 1994, December 1994, February 1995, and November 1995.

FIGURE 2
Failure to Comply incidents at Sydney involving aircraft > 5,700 kg MTOW, 1994–1995

These increases in incidents coincided with the major changes in procedures outlined below:

- June 1994 The former Civil Aviation Authority introduced STARs to Australia. STARs were introduced at Sydney and Melbourne followed by progressive implementation at other major ATS locations.
- Nov. 1994 Opening of parallel runway (16L/34R) at Sydney airport.
- Feb. 1995 New SIDs introduced at Sydney airport.
- Nov. 1995 New charts were issued regarding ATS procedures including STARs and SIDs.

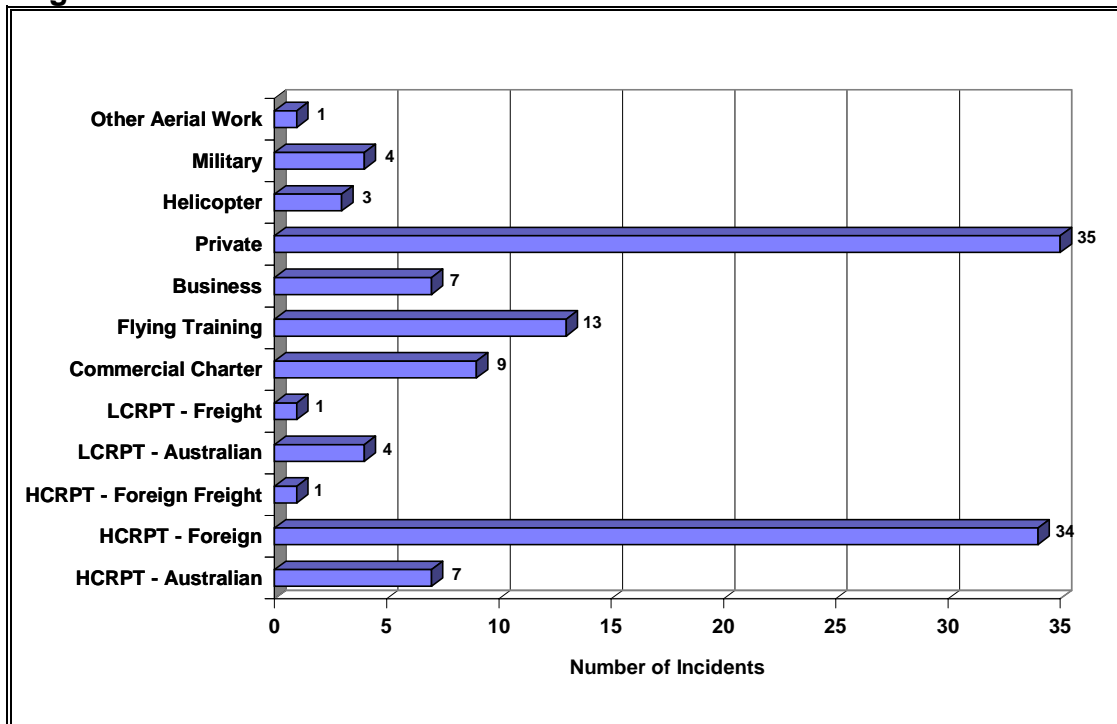
Figure 3 indicates that HCRPT aircraft were involved in 42 FTC incidents in the period June to August 1996, more than any other statistical group. HCRPT aircraft accounted for 35% of all FTC incidents, of which foreign high-capacity operators represented 87%.

Private aircraft contributed 29% of the recorded FTC incidents and flying training incidents continued to occur in significant numbers.

FIGURE 3
Reported Failure to Comply incidents by statistical grouping, June–August 1996

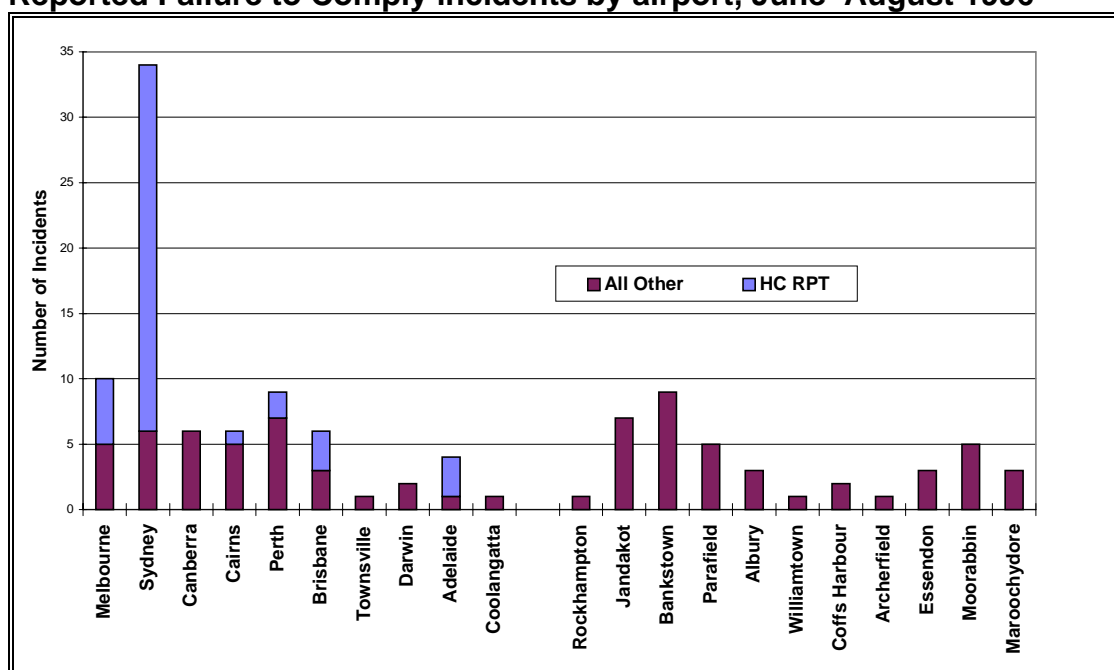
Figure 4 shows FTC incidents for all aircraft and illustrates that the pattern shown in table 1 is continuing, with Sydney ATS reporting the largest number of FTC incidents for the 3-month period.

FIGURE 4
Reported Failure to Comply incidents by airport, June–August 1996

Figure 4 shows the major airports at which incidents associated with high-capacity aircraft are occurring. Sixty-seven per cent of all the reported HCRPT incidents in the 3-month period occurred at Sydney (28 FTC incidents), with the next highest, 12%, occurring at Melbourne.

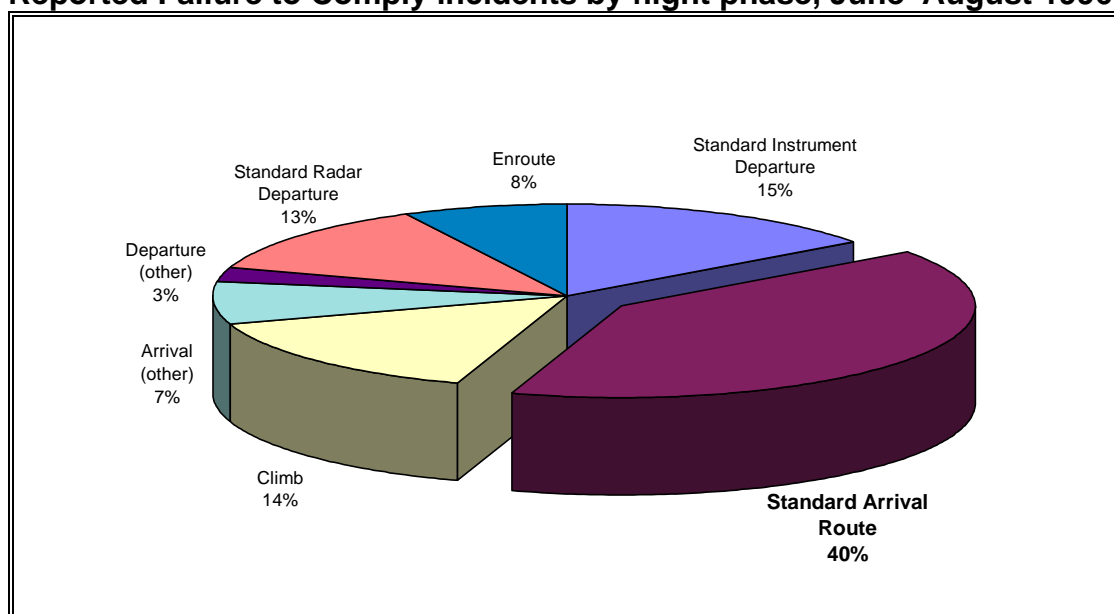
In the survey, the pilots were asked to categorise their incident into one of seven phases of flight. Figure 5 illustrates their responses, showing that the greatest number of reported FTC incidents occurred while flying a STAR. These accounted for 40% of all FTC incidents during this period.

FIGURE 5
Reported Failure to Comply incidents by flight phase, June–August 1996

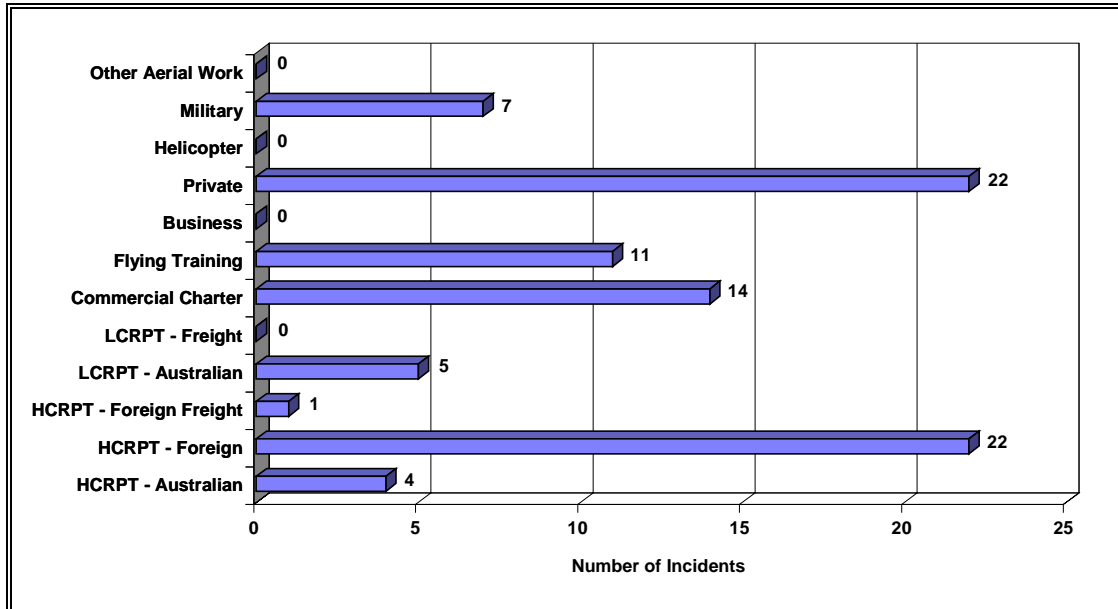
Figure 6 shows that HCRPT aircraft were involved in 30% of reported FTC incidents. Foreign operators accounted for 85% of all HCRPT incidents. Private aircraft were involved in 26% of incidents. There was an increase in the level of FTC incidents for commercial chartered aircraft, compared to the study period.

FIGURE 6
Reported FTC incidents by statistical grouping, September–October 1996

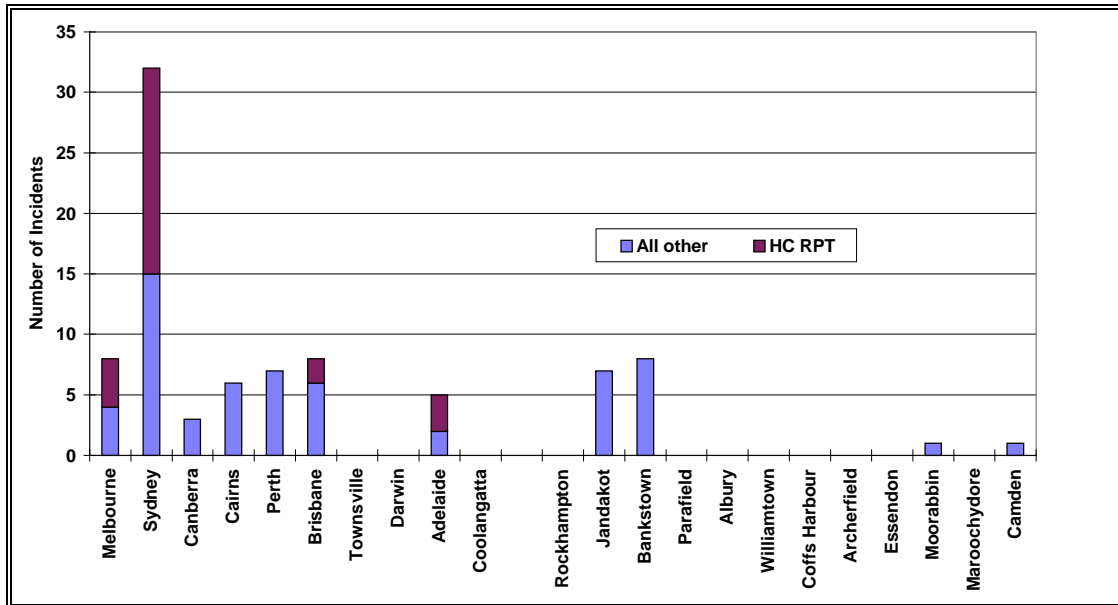
Figure 7 illustrates the distribution of FTC incidents by location. Again, Sydney accounted for the greatest proportion of incidents with 37%, an increase of 8% on the 3-month study period. The next highest level of FTC incidents occurred at Melbourne, Brisbane and Bankstown with 9% each. HCRPT incidents accounted for 53% of FTC incidents at Sydney, a decrease of 29% from the 3-month study period. In real terms however, the number of high-capacity FTC incidents in Sydney remained consistent with 8.5 per month, compared with 9.3 per month in the 3-month study period.

FIGURE 7
Reported Failure to Comply incidents by airport, September–October
1996
